Final Investigation Report
on
Serious Incident to M/s SpiceJet Limited
Aircraft DHC-8 Q-400, VT- SUW
on 22 November 2021

SYNOPSIS

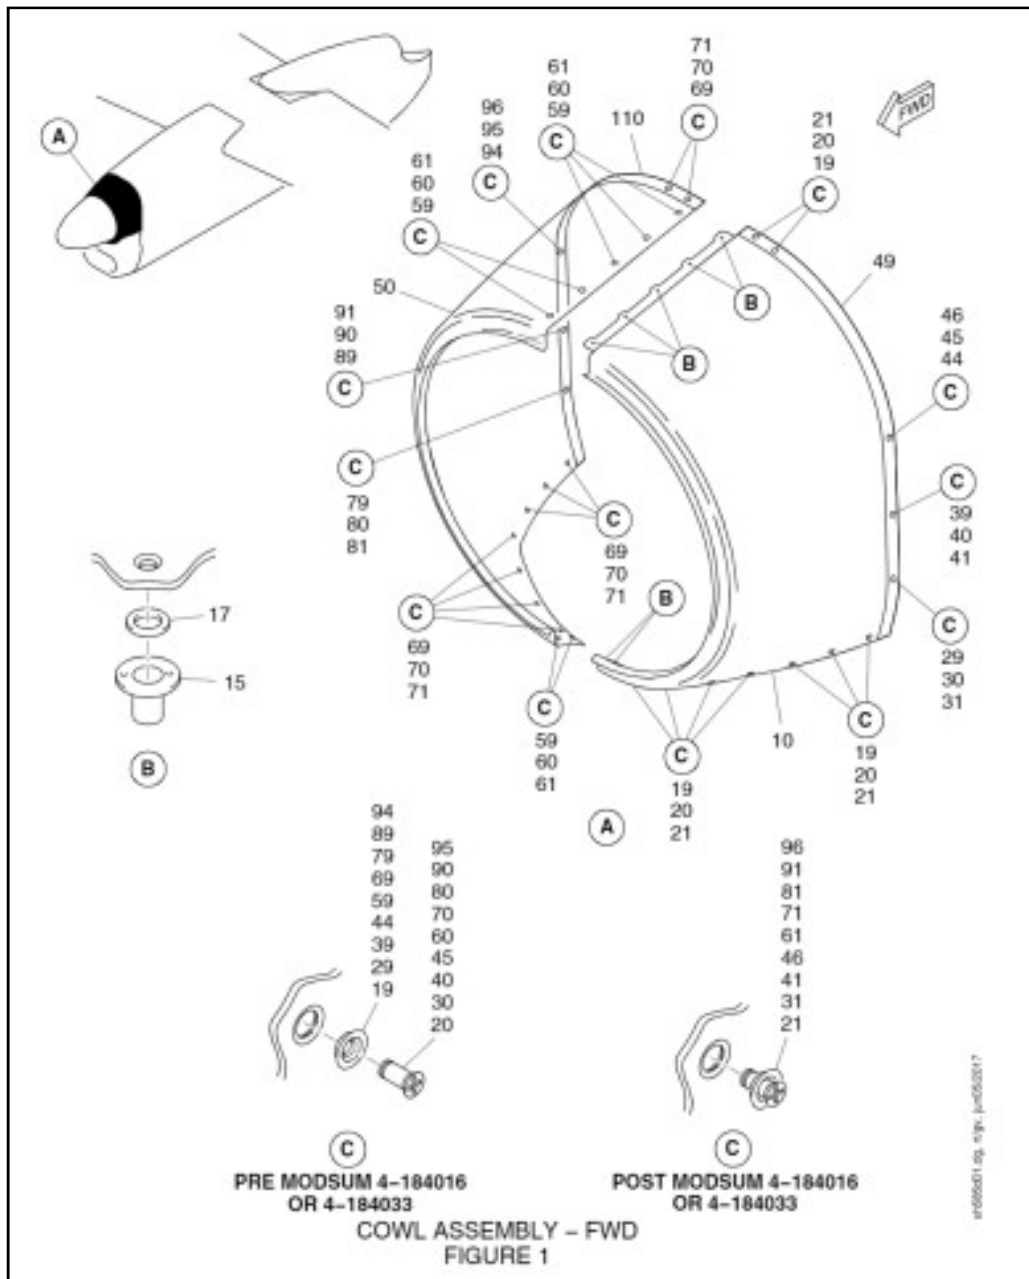
Figure 3 Upper Forward Cowl

The engine upper forward cowl (Part No 87144002-005) comes under the forward nacelle access panel (Refer fig: 3). It is made up of carbon epoxy composite, with copper mesh High Intensity Radio Frequency (HIRF) Lightning protection provided on its outer surface. The cowl is attached to the nacelle using Camloc fasteners. The cowl is sealed on its aft and lower edges using a non-conductive elastomeric seal bonded in place. The cowl is installed in an area subjected to multiple sources of vibrations from spinning propeller, rotating equipment inside the engine and also from the aerodynamic swirl from the propellers.

The outboard and inboard upper forward cowls are joined together by means of metal straps, at top and bottom of the Upper forward cowls. Top and bottom metal strap are riveted to inboard composite upper forward cowl by rivets. However, outboard upper forward cowling is seated on the metal straps and fastened by Camloc fasteners. The receptacles are riveted to the metal straps. Further as per OEM's load analysis; the maximum load that can be sustained by a rivet and a Camloc fastener were found 47 lbs and 141lbs respectively.

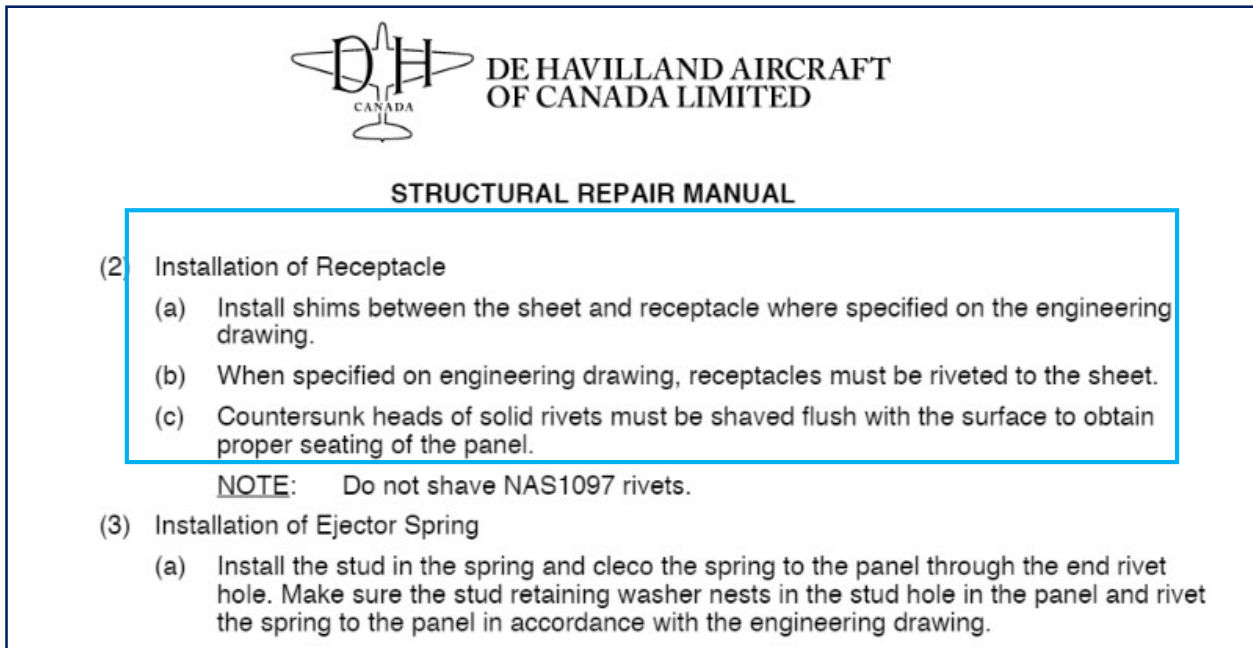
Figure 6 Extract from SRM

As per OEM's drawing specification and IPC, Shim is an optional component and if it is required to be installed, it should be installed between receptacle unit and the metal strap. Extract from the SRM is appended below:

As per OEM's drawing specification and SRM, there is no allowance for elongated holes in the metal strap in UFC.

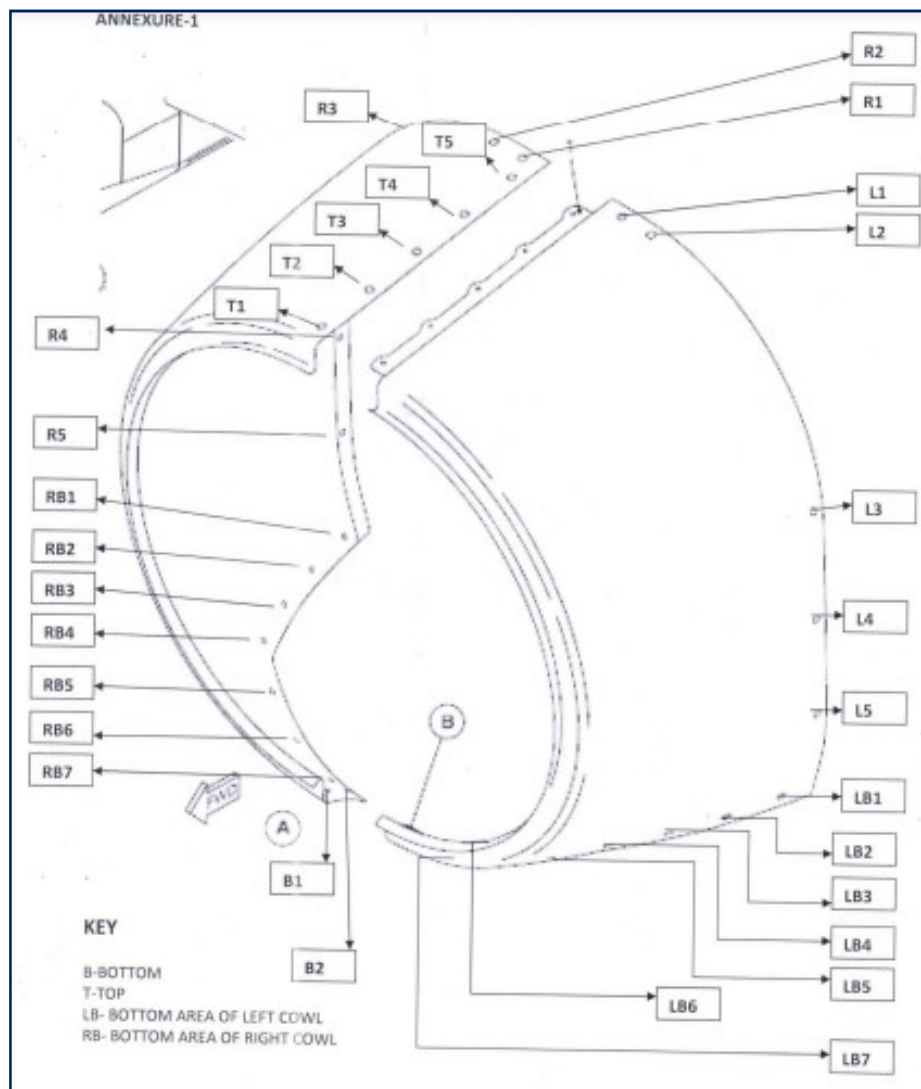
Figure 7 Fasteners Identification

Further this circular also states that “The purpose of this circular is to re-emphasize upon the certifying staff the requirement to identify and record the specific fastener as per the attached Annexure-1” (The diagram given in the Annexure -1 is shown in fig: 7).

Aircraft records were examined and as per aircraft records, fasteners were also found missing in preceding last six months on seven occasion which includes layover inspection, Pre flight inspection and Transit inspection. Few maintenance personnel indicate the location of the missing/installed fasteners as per operator's Engineering circular (Refer fig: 7), whereas on some occasion maintenance personnel did not indicate the location of the missing/installed fasteners. Consequently, records are insufficient to identify the locations of missing fasteners.
