**Final Investigation Report on Accident involving Pawan Hans' S-76D helicopter
bearing registration VT-PWI at Mumbai Off-Shore on 28 June 2022**

**Aircraft Accident Investigation Bureau
Government of India
Ministry of Civil Aviation**

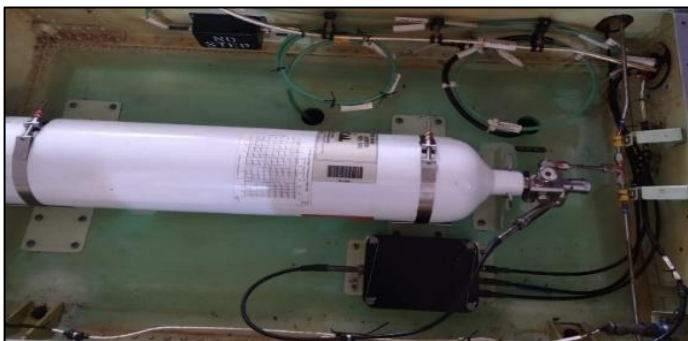
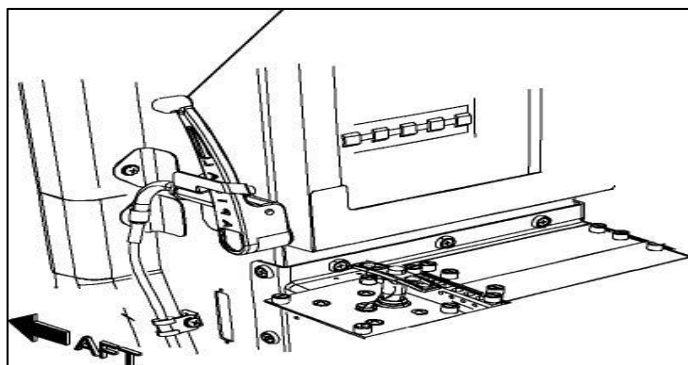
Figure 13: Life Raft Reservoir (top) and Release Handle (bottom)

There are two options of the pilot Release Handle that may be installed in the S-76D cockpit. A T-Handle Release Lever, that is installed in the center console or a Handle Release that is installed on RH side of the controls console. VT-PWI was installed with handle release on RH side of the controls console. The pilot is required to manually disengage the safety mechanism and pull lever. The handle was found in released condition on VT-PWI during wreckage examination after retrieval from sea.

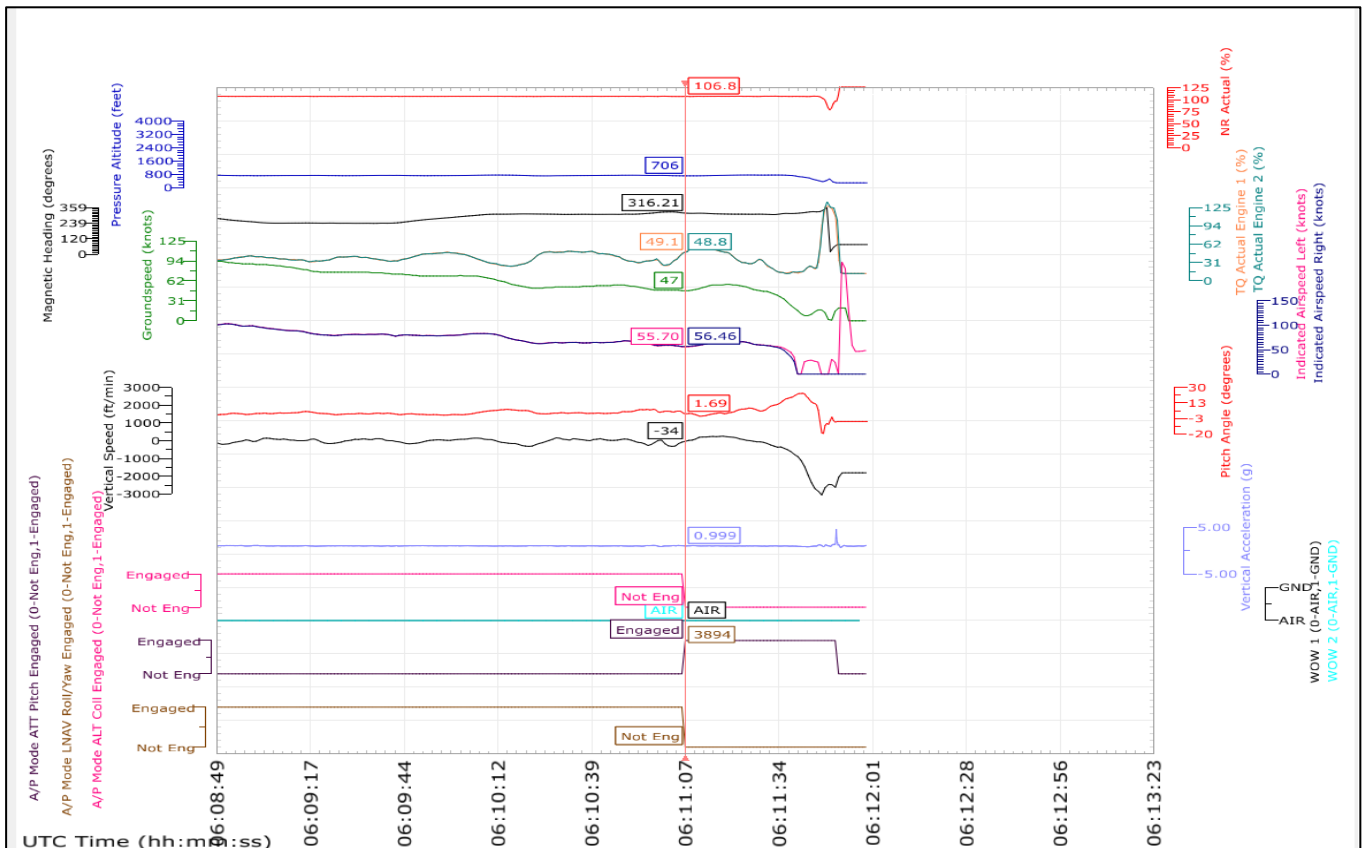
Figure 18: Graphical representation of flight data parameters before and after autopilot decoupling

The helicopter took-off at 05:37:55 UTC from Juhu. Helicopter climbed to a Pressure Altitude of 910 ft at 05:39:29 UTC and performed another climb to 3,210 ft at 05:54:29 UTC. Helicopter reached a maximum altitude of 3234 ft at 05:55:38 UTC. As per the DFDR data, the helicopter descended to a Pressure Altitude of 723 ft at about 06:07:02 UTC and at 06:11:07 UTC the autopilot was decoupled. **Figure 18** shows the graphical plot derived from DFDR data. The vertical line shows the point when the auto pilot was decoupled.

At 06:11:41 the maximum pitch up angle of about 23.5° was recorded and this more or less coincides with the groundspeed reducing to almost zero. By this time the aircraft had entered an energy deficient state, due to the low torque value and near zero speed. The rate of descent increased to 1136 fpm. High nose-up attitude combined with reducing air speed at low altitude made it practically difficult to recover the helicopter from impact with the water. The onset of uncontrolled flight occurred when the aircraft was pitched to approximately 23° nose up while simultaneously lowering the collective to the full down position.

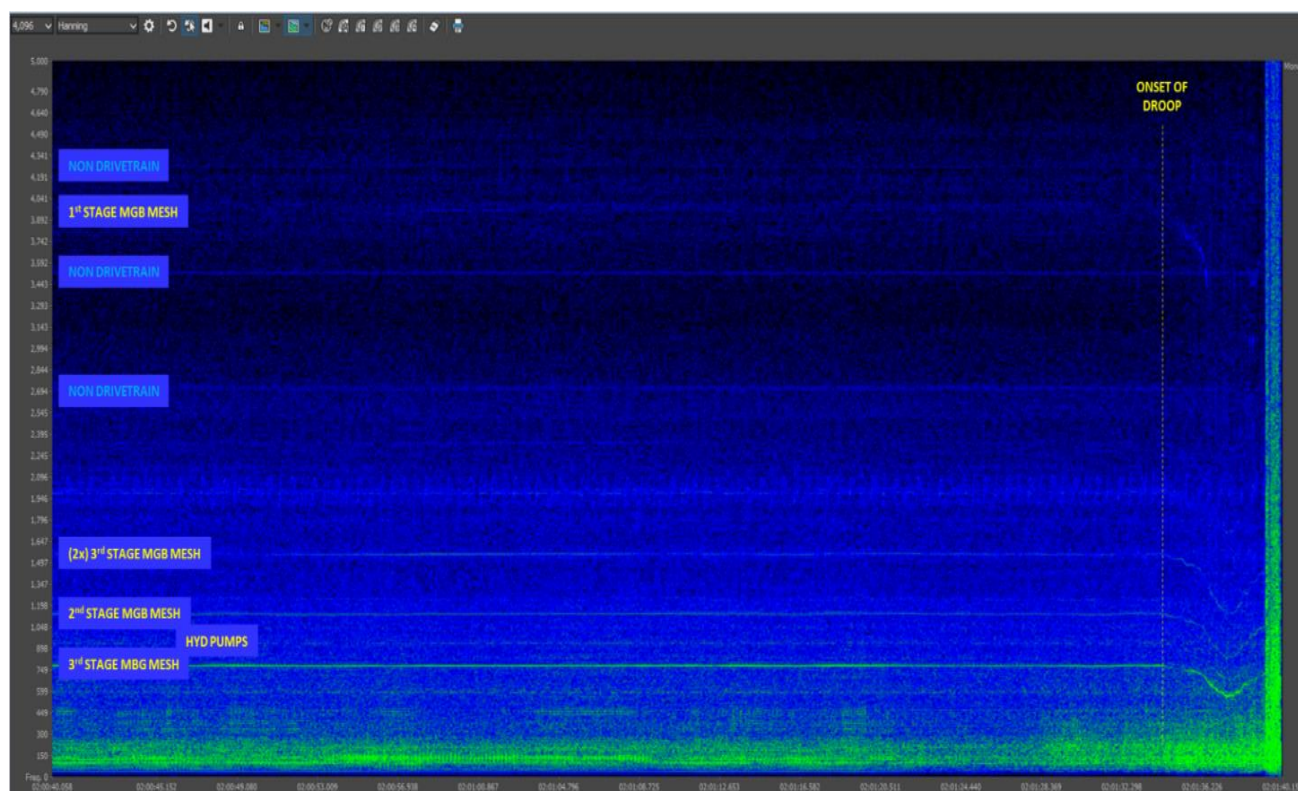
Figure 20: Audit spectrum image

The analysis of the CVR data depicted a typical audio spectrum of an S-76D for frequency content and relative levels. The spectrum image is shown in the figure 20 below:

The analysis detected unusual behavior in the form of a rotor speed droop which initiated ~5.4s prior to the aircraft impacting the surface of the water. The droop initiated at a rate of 3.9% per second to 99.5% N_r and then increased to a droop rate of 15.5% per second to 77.8% N_r . Rotor speed then began to recover at a rate of 10.9% per second to 99.6% N_r before impacting the water.

From the CVR data, the initiating event for the onset of the rotor speed droop appears to be in reaction to the first EGPWS alert to “PULL UP”. This is corroborated by the FDR data which shows that just following the alert there is a rapid Collective up movement and an accompanying rise in Engine Torque. Further, the increased rate of rotor speed droop appears to be in reaction to the second EGPWS alert to “PULL UP”. This is also corroborated by the FDR data which shows another rapid rise of the Collective and a demand in Engine Torque to greater than 125%.

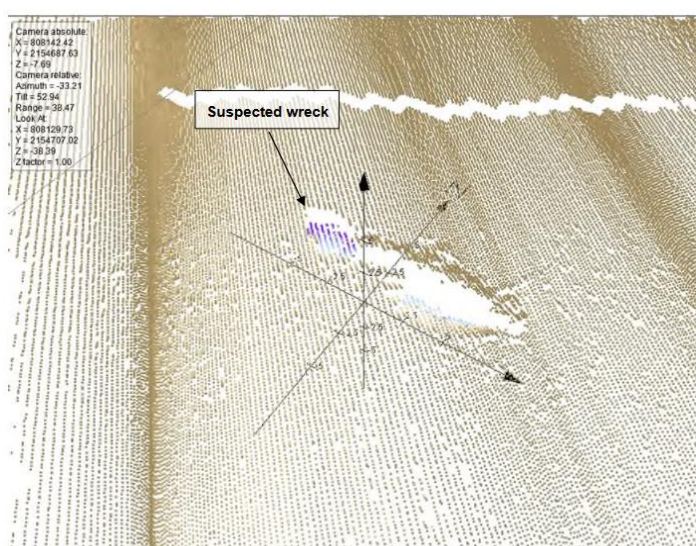
Figure 22: MBES 3D data image showing suspected wreck

Ship Arti” had to return back to port for some repairs. The survey data collected by MV “Great Ship Arti” was analysed and suspected wreckage was later identified by the night of 03rd July 2022. MBES 3-D data image showing wreckage is shown in the figure 22.

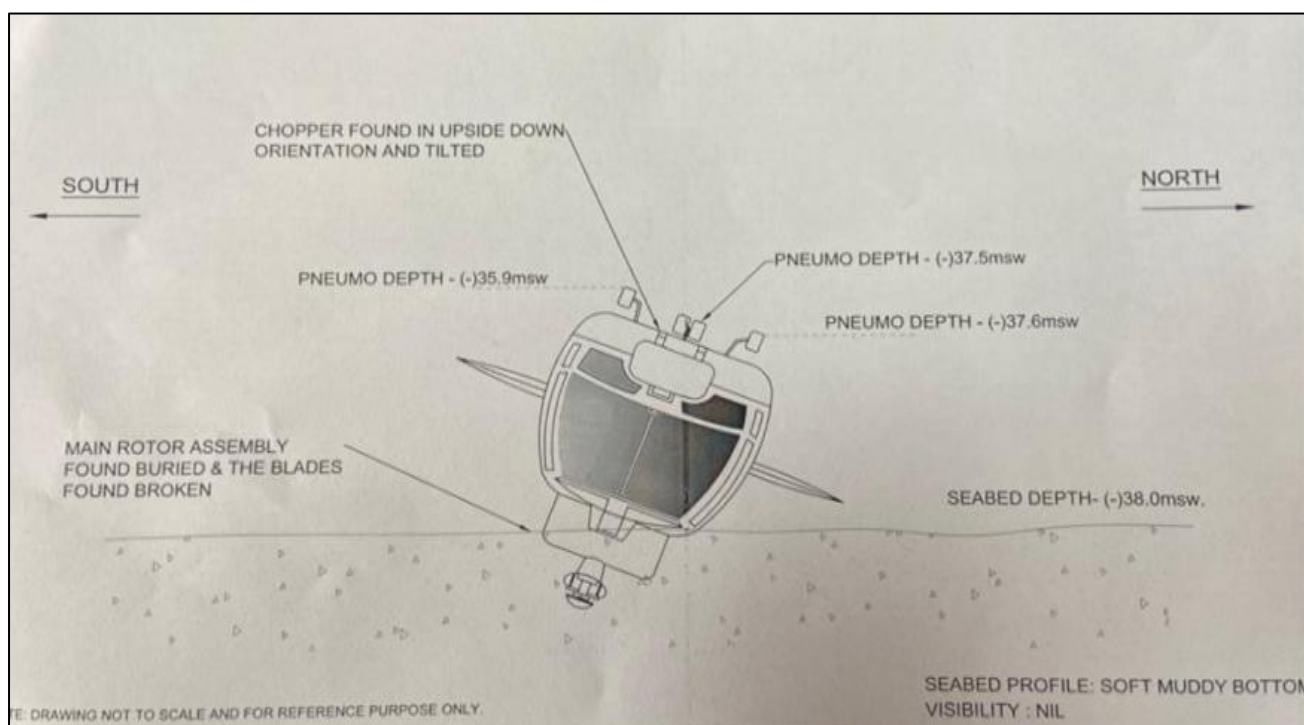
Figure 23: Graphical representation of wreckage

Graphical depiction of wreckage as found on sea bed is shown in the Figure 23 below:

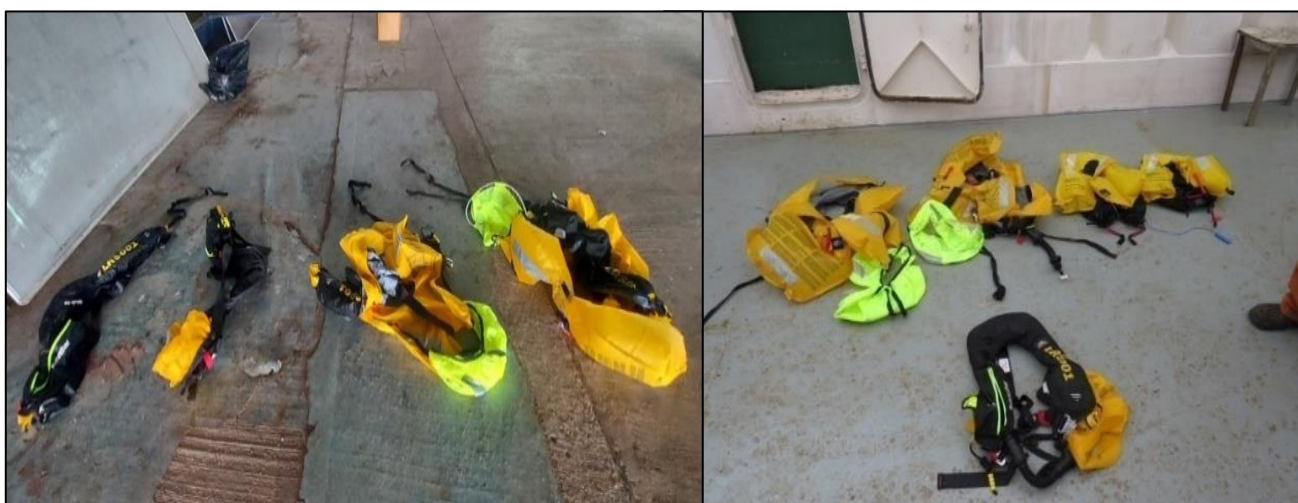
The Life Jackets worn by the passengers were retrieved from the sea and those worn by survivors and deceased were identified. The figure 25 below shows life jackets worn by the deceased and the survivors. **Asphyxia due to drowning** was the cause of death and hence the investigation team carried out detailed examination of the life jackets.

Figure 25: Lifejackets retrieved from deceased (left); Lifejackets retrieved from survivors (right)

During the visual examination, it was observed that the 02 life jackets worn by the passengers who were rescued by Malviya-16 were in inflated condition. The life jackets of the four deceased passengers and one survivor whose life jacket was not inflated were subjected to detailed inspection by Investigation Team at Mumbai and later at OEM's facility to ascertain if the passenger could have faced any problem in operating and using the Life Jackets. During physical examination at Mumbai, it was observed that

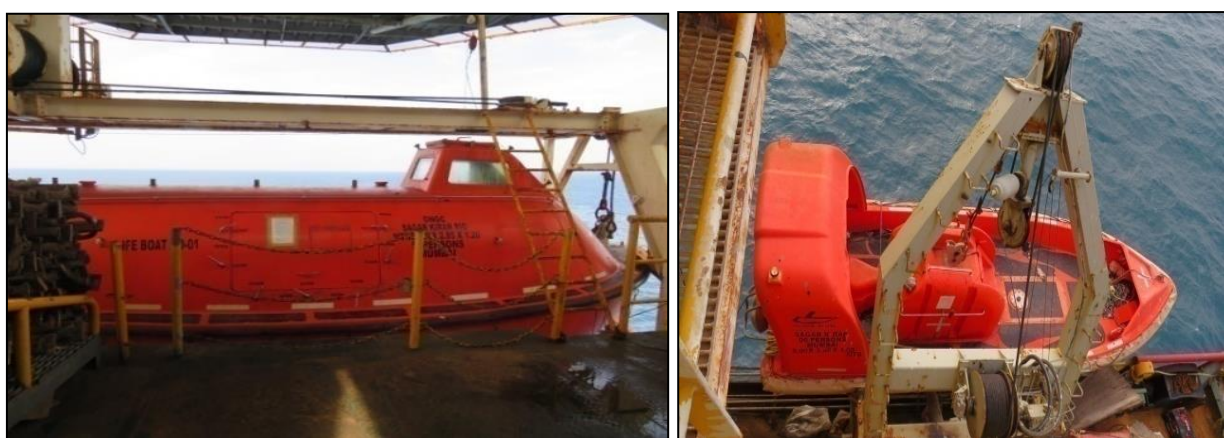
Figure 31: Lifeboat (TEMPSC) and Rescue Boat available on the Rig

case of an emergency. A Rescue Boat is also available on the Rig, but it was informed to the Investigation Team that the Rescue boat was not serviceable since last one year and hence the life boat (TEMPSC) was designated to be used as Rescue Boat as well. As per technical specifications of TEMPSC, it can be used as a Rescue Boat with capacity restricted to 06 persons.

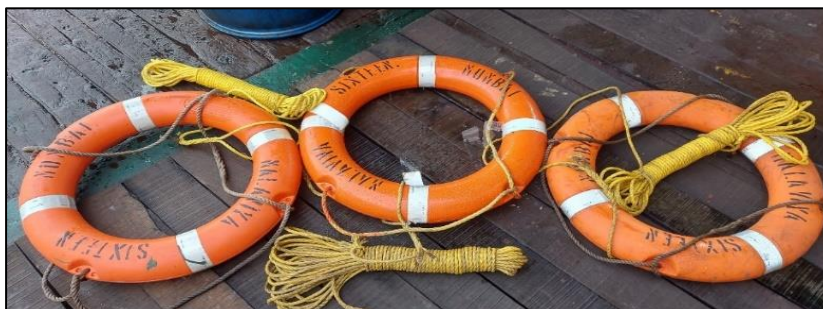
(a) Life Buoys – The life buoys used for rescuing the survivors were found in good condition.

Figure 32: Life buoys

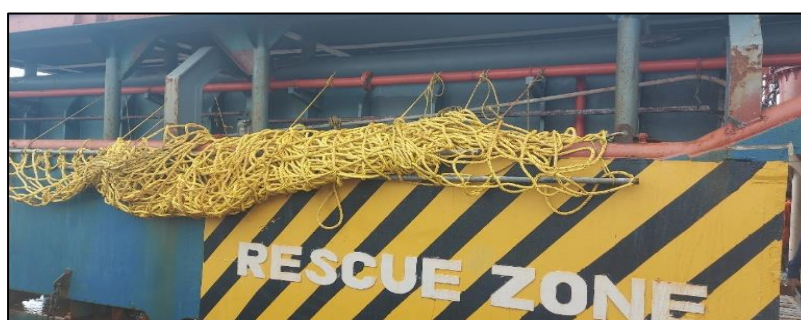
(b) Scramble net – The scramble net used for rescuing the survivors was found in good condition.

Figure 33: Scramble Net

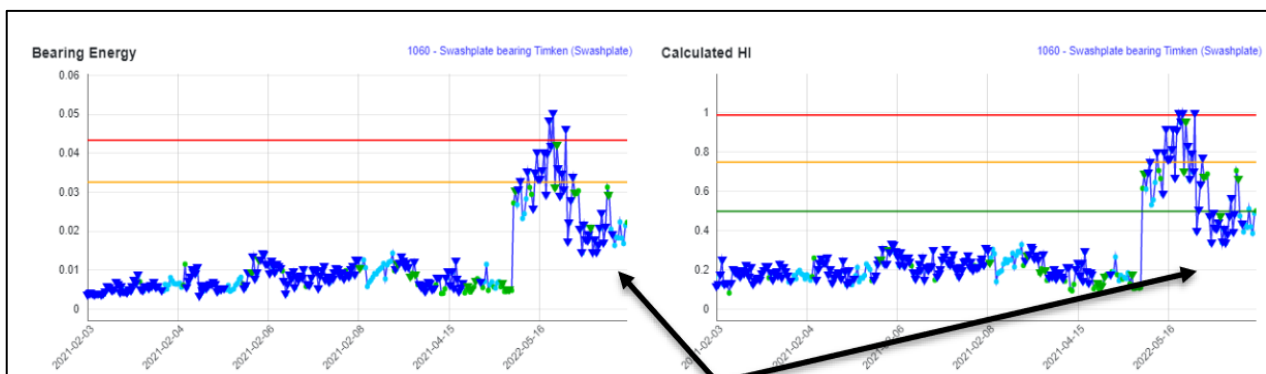
In May 2022, Pawan Hans engineers monitored elevated swash plate bearing trends on SGBA. The issue was raised to the OEM and PHL was advised to re-grease the swash plate bearings and monitor. The re-greasing of swash plate bearing was carried out and subsequently, no alerts were observed on SGBA related to Swash Plate bearing. On 7 June 2022, Pawan Hans also confirmed to OEM that no further alerts related to swash plate bearing were noticed. The last HUMS data download was carried out on 27 June 2022.

Figure 35: Swash plate bearing trends dropping to normal range

Bearing Energy and Calculated HI readings went back to normal fleet range.
