**Final investigation report on accident involving Cessna aircraft VT-FAO  
operated by M/s Flytech Aviation Academy  
on 26.02.2022 near village Thungathurthi, Nalgonda (Telangana)**

**Aircraft Accident Investigation Bureau  
Government of India  
Ministry of Civil Aviation**

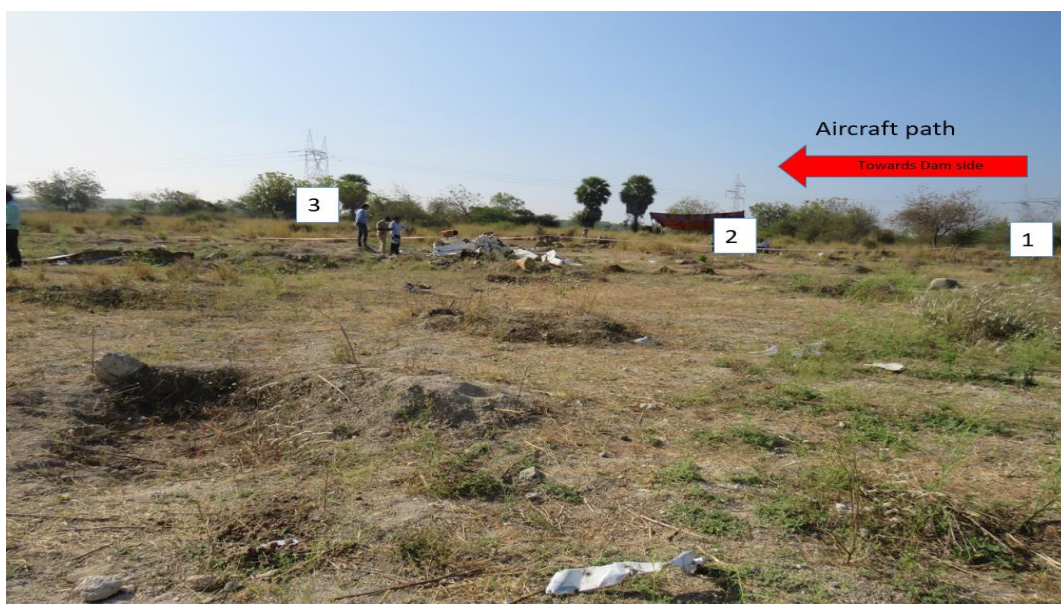
**Figure 9: Aircraft path before making 180° turn**

Based on eyewitness statements, the aircraft initially followed a path alongside the electric towers, as depicted in Figure No. 9. Subsequently, the aircraft descended and performed two

loitering maneuvers. However, aircraft again gained some height and subsequently made a 180 degree turn. According to eyewitnesses, following the 180-degree turn, the aircraft continued along the trajectory (Figure 9).

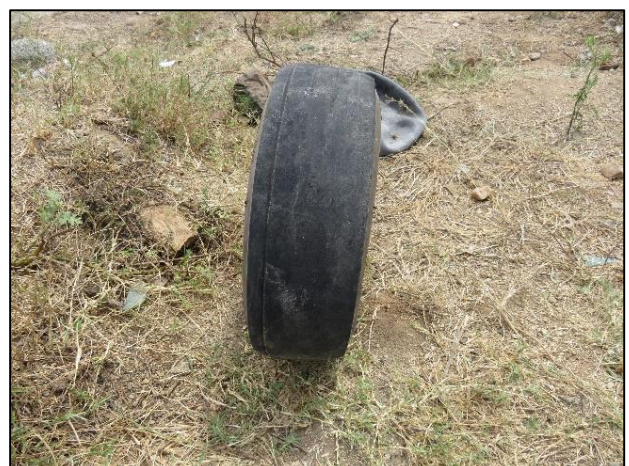
**Figure 11: Aircraft Tyre**

The engine got separated from the firewall completely and found at a distance of approximately 17 feet from the main wreckage. Propeller hub of each blade was found stuck into the ground adjacent to damaged engine and were found broken from the center mount. RH main landing gear tyre was found detached from the assembly hub. Further, tyre grooves were found beyond the limits. Some of the wreckage photographs are provided at the Annexure D of the report.

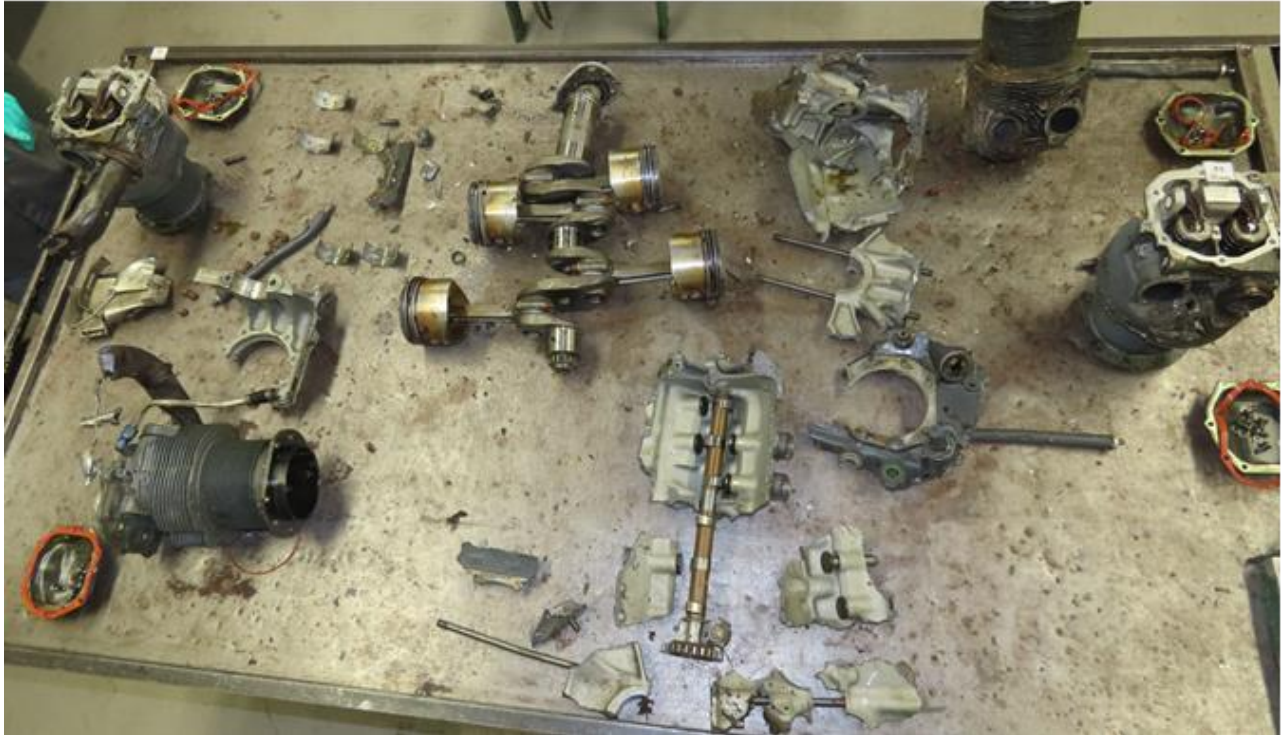
**Figure 22: Cylinder & Piston**

- All connecting rods were removed from the crankshaft except for the number 1. The crankshaft suffered an approximate 8 degree bend which pinched the connecting rod onto the crankshaft journal. The connecting rods bearing were removed (7 out of 8) and examined. No lack or loss of lubrication conditions were observed, and the surface of the available bearings were found unremarkable.
- The crankshaft main bearings were examined and no lack or loss of lubrication conditions were observed. The surface of the available bearings were found unremarkable.

- a) Spark plugs appeared to have minimal wear, and exhibited signatures consistent with normal operation.
- b) The piston heads were coated in light tan deposits consistent with normal combustion.
- c) The crankshaft and camshaft journal surfaces were free of significant wear, and the camshaft lobes were in good condition and displayed an appropriate lift.
- d) There was no evidence of pre-accident catastrophic failure or lubricant exhaustion.

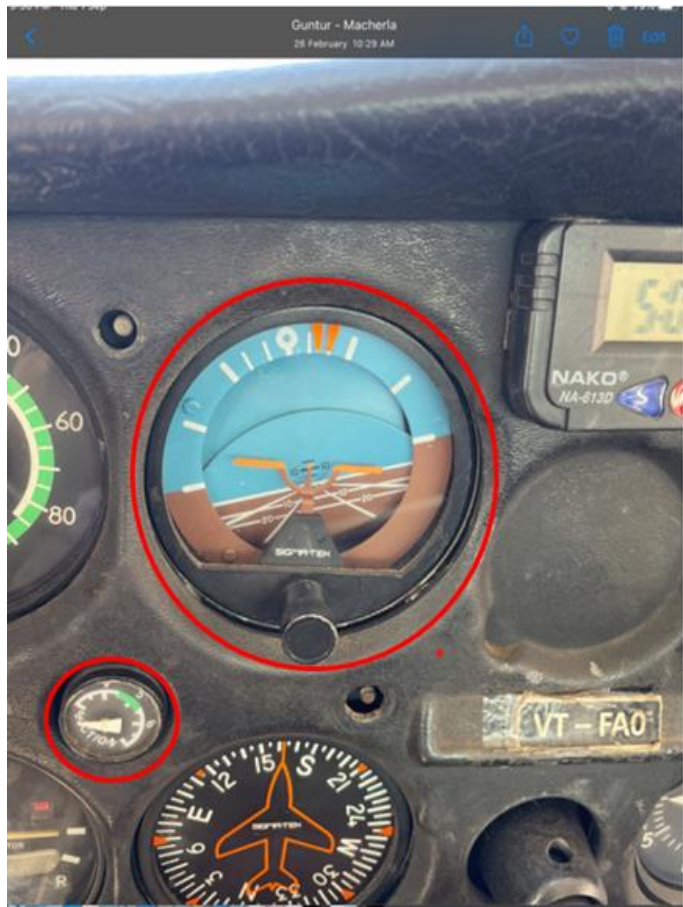
**Figure 26: Attitude Indicator and Suction Gauge**

The iPad was locked, however, the family member of student pilot was able to access the stored data, and photos from the iPad were provided to the Investigation team. One of the photographs obtained from the iPad showing the attitude indicator, directional indicator and suction gauge is shown in the Figure 26. The date and time of photograph was verified through properties and it was found

that photograph was taken on the day of accident, 26 Feb 2022 at 10:29 IST (0459 UTC). This implies that the photograph was clicked once the aircraft took off from Nagarjunasagar airfield. (As per flight plan, takeoff time from Nagarjunasagar airfield was 0456 UTC).

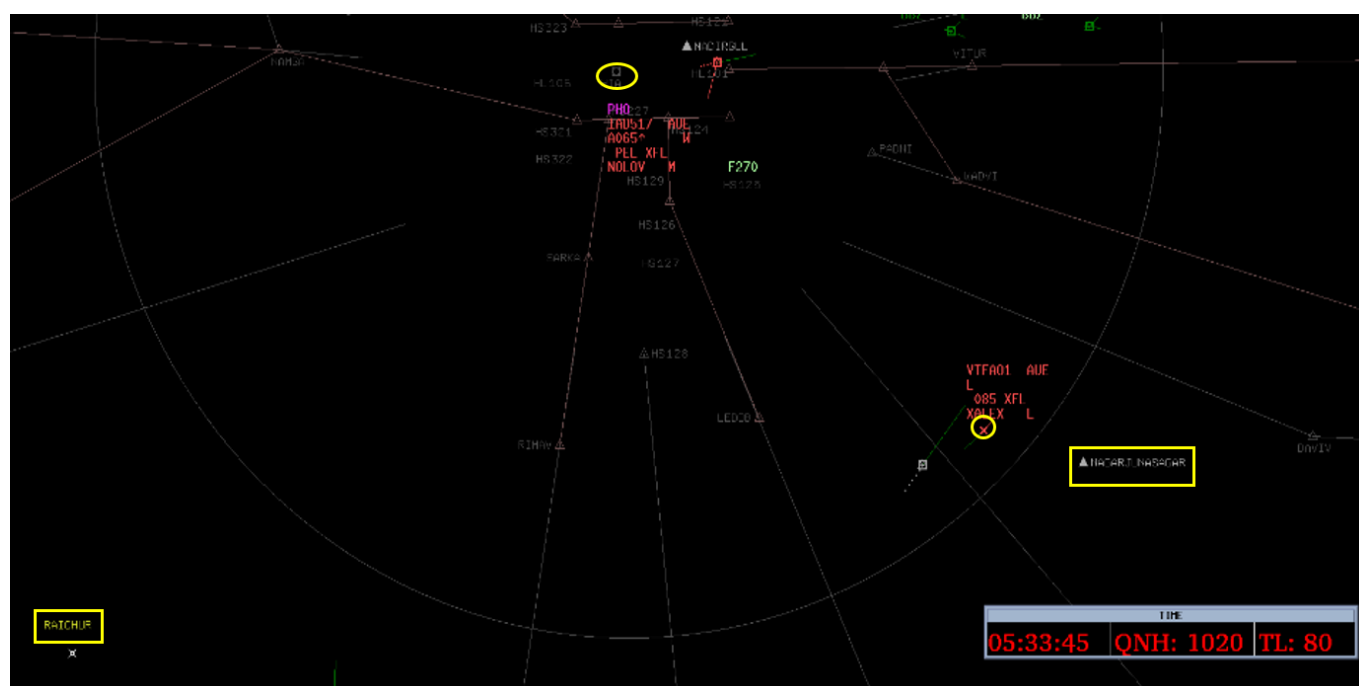
**Figure 31: Aircraft first appeared on Radar Screen**

As per the Radar Snapshot, the first RPS (radar position symbol) corresponding to VTFAO aircraft was observed on Radar at time 05:33:45 UTC on a bearing 298 and 10.8 Nm from Nagarjunasagar with no Mode-C information. After a while the RPS was dropped (Refer Fig No. 27 & Fig No. 28).

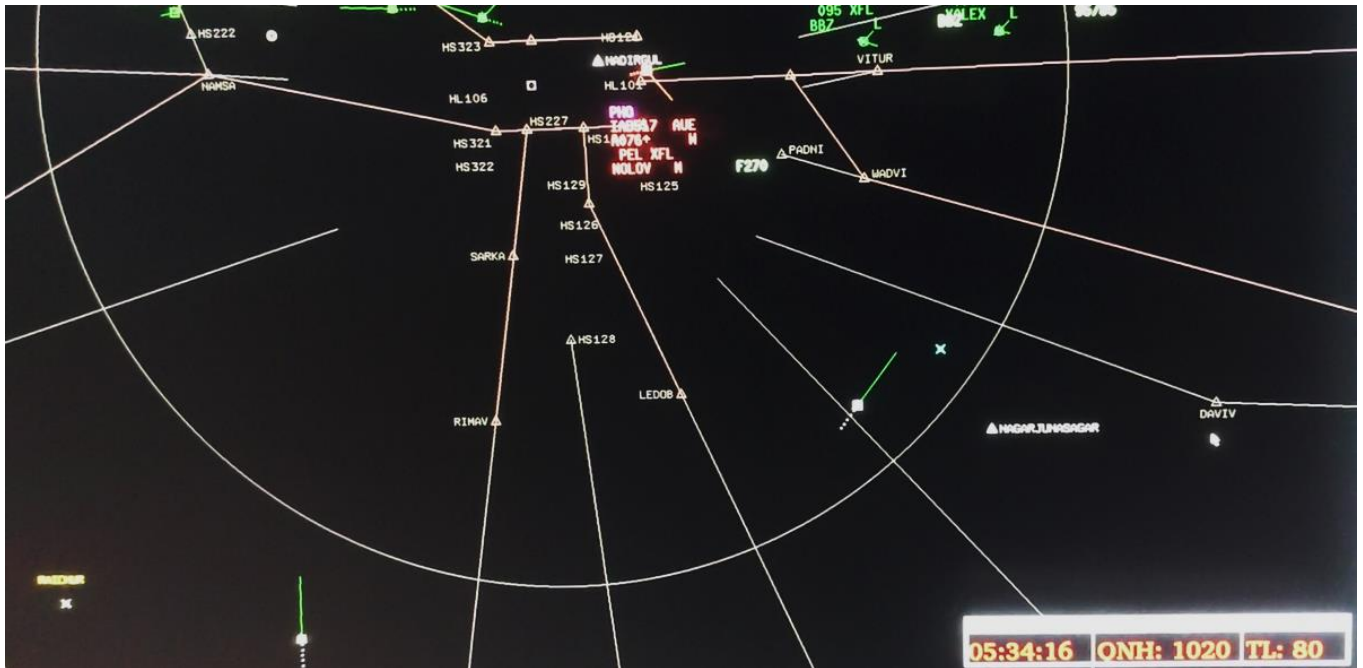
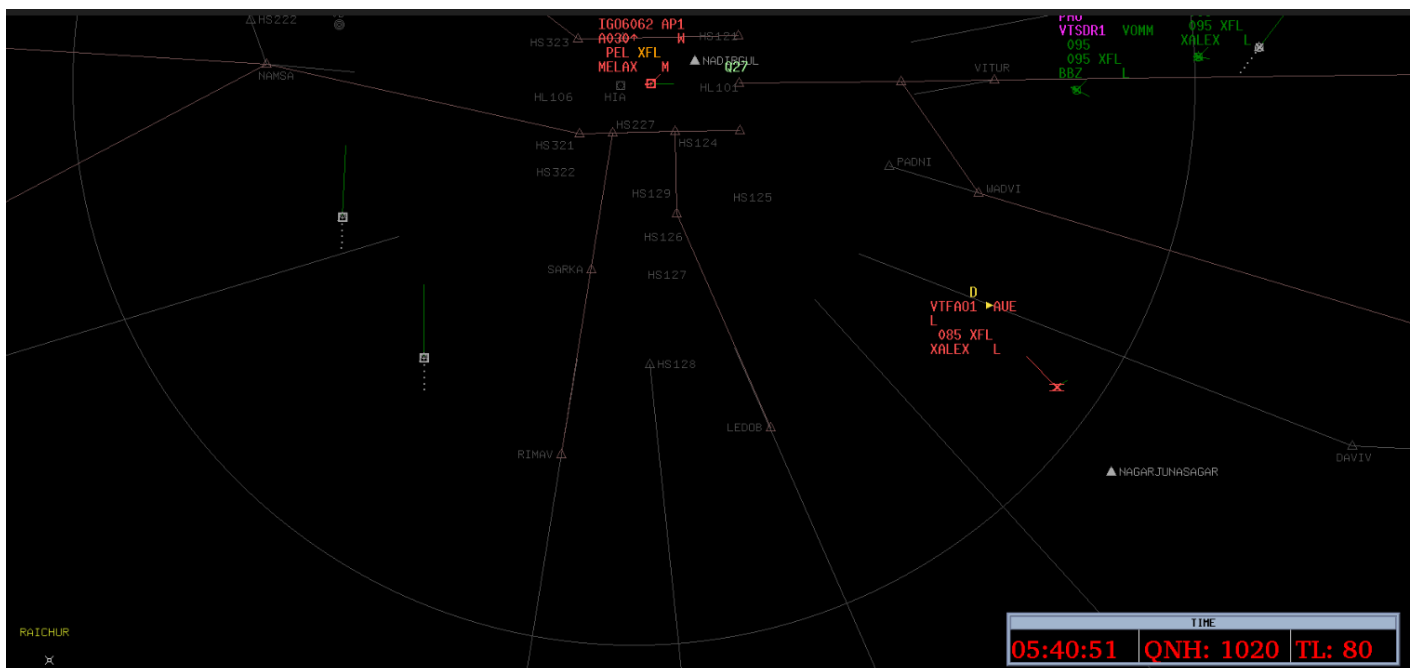
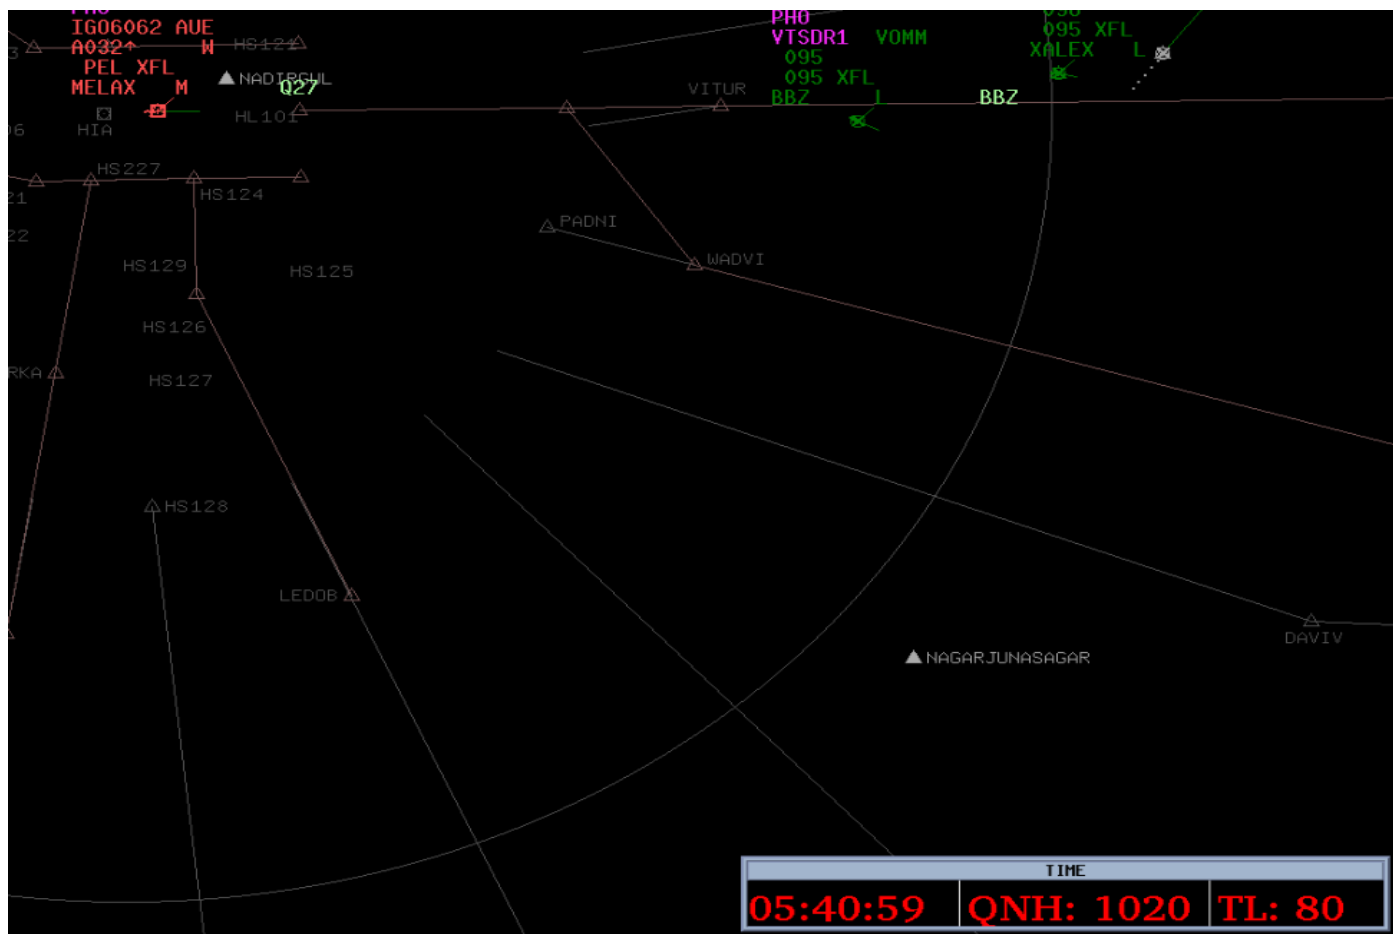
Aircraft reappeared on radar screen at time 05:36 UTC but its flight level continuously kept fluctuating between 3700 feet to 3200 feet AMSL. The last flight level captured was FL34 and thereafter aircraft disappeared from Radar screen at time 05:40:59 UTC. At that time the RPS was observed on a bearing of 329 and 10.7 Nm from Nagarjunasagar with no Mode-C information.

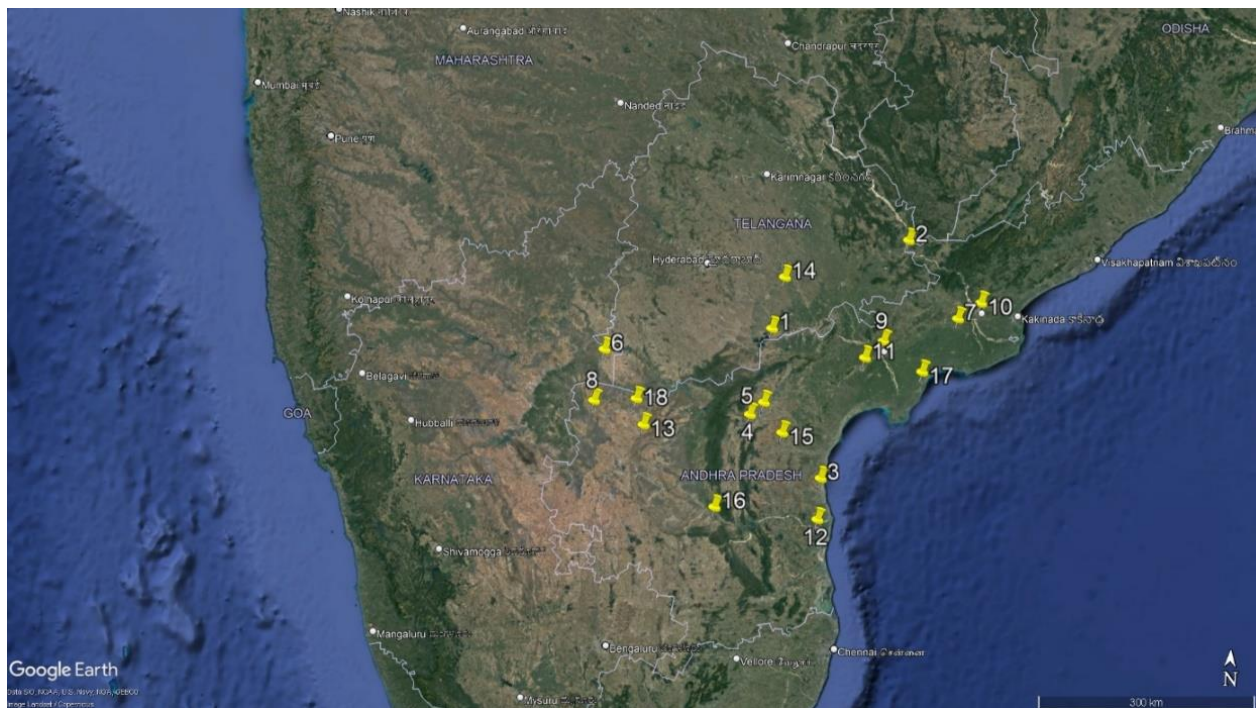
**Figure 35: Cross country routes defined in FOB**

During the investigation, it is observed that M/s FAA is following the inspection frequency given for mild/moderate Corrosion environment. However, most of the cross country flying route being followed by M/s FAA lies almost in severe corrosion environment. Example of some cross country flying routes followed by M/s FAA are shown in the below Figure.

As per OEM prescribed Corrosion Severity Guidelines, the AMP of the organization should cater for the enhanced inspections as per the CPCP for 'severe' areas. The same were however, found to be in compliance with the 'Moderate' areas only and the FTO did not revise the same after shifting their base for operations to Nagarjunsagar. Therefore, the level of maintenance inspections for corrosion was inadequate. This becomes all the more important in view of the fact that all the aircraft of the FTOs except one are more than 40 years old.

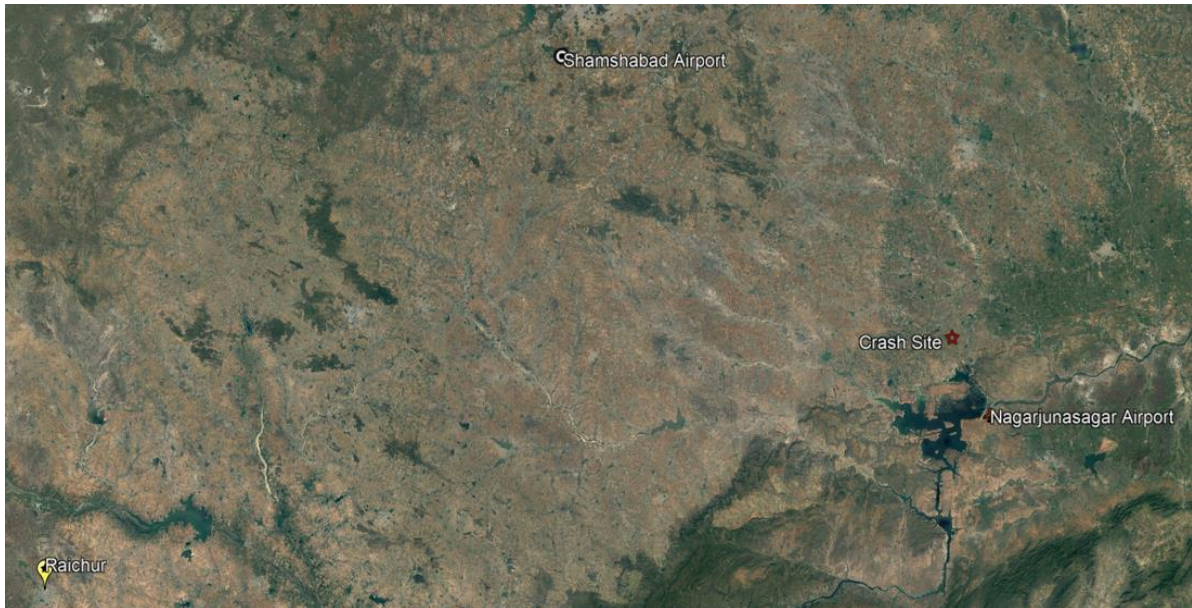
**Figure 36: Crash Site**

The crash site shown in below fig is matching with the position of aircraft when it was last displayed on Radar screen.

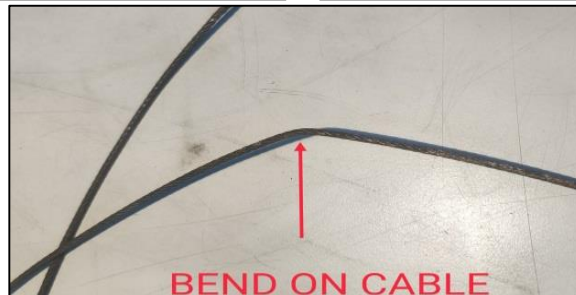
### 1. Right and left flap cable

1. Condition of cable brownish mark on some areas.
2. At one location 3 strands broken.

**Remarks-** Brownish marks and broken strand reflect poor maintenance practice.

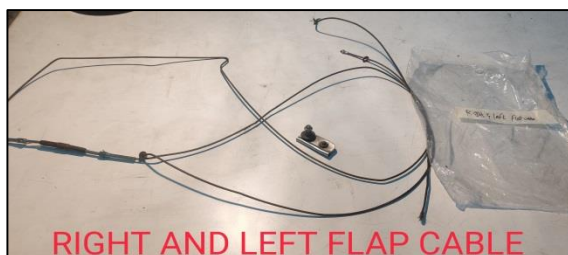
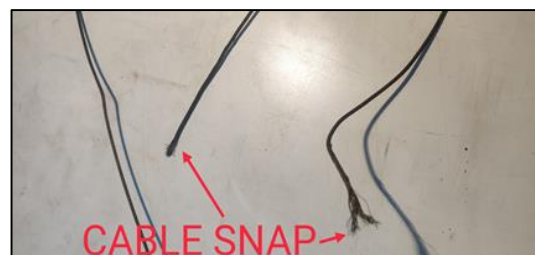
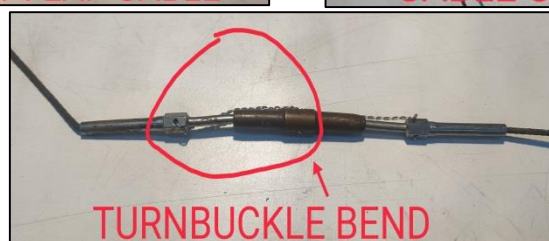
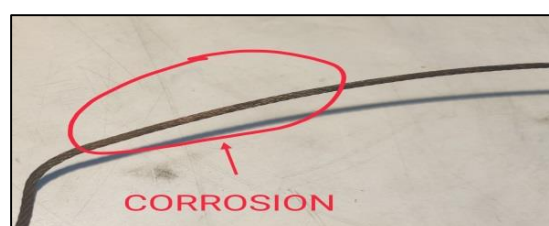
### 2. Right and left flap cable

1. Cable found broken
2. Engineer opinion- Cable snap during crash. At the location of snap there is no substantial brown marking. Reason of cable snapping is accident.
3. Multiple corrosion observed on cable.
4. Cable broken at one point.
5. At one location there is a kink in the cable.

**Remarks-** Brownish marks and corrosion show poor maintenance practices. However, at the cable snapping location there are no brown marks.

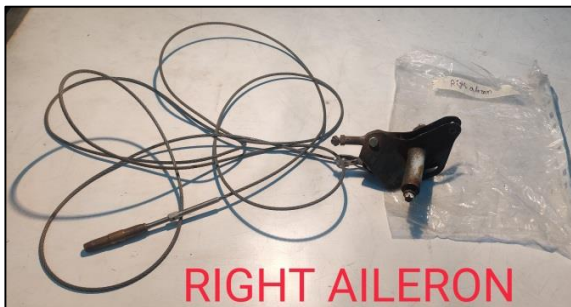
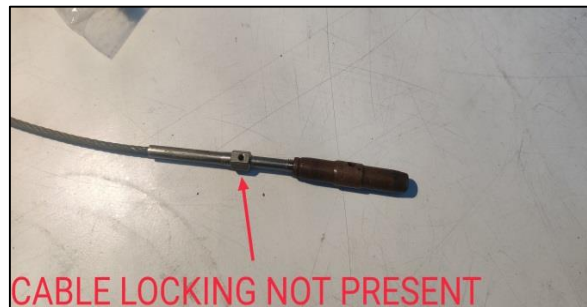
### 3. Right aileron

1. Cable locking not present, may be removed by engineer after crash.
2. Quadrant- welding crack found may be due to crash.

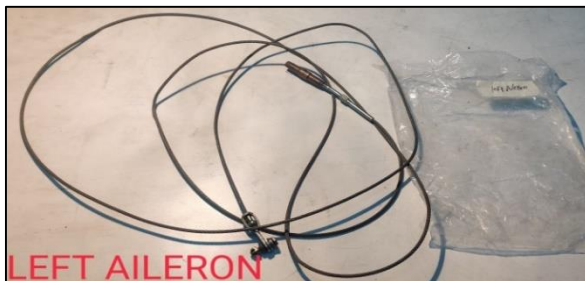
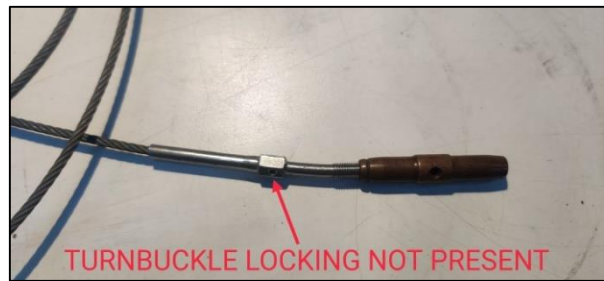
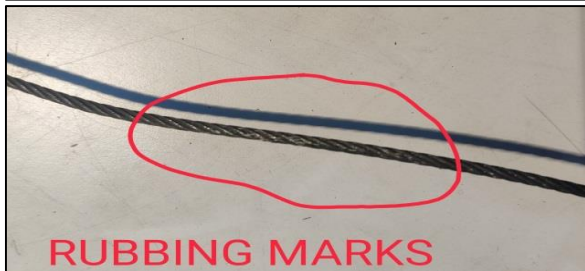
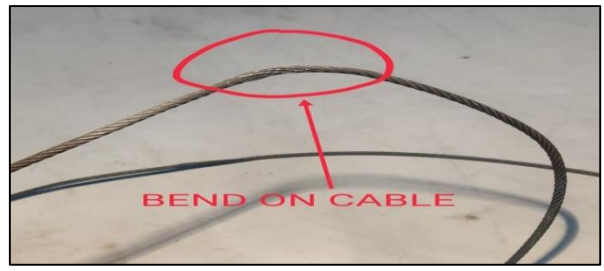
**5. Left aileron**

1. Turnbuckle locking not present (may be removed by engineer)
2. Rubbing marks observed on some part of cable. May be due to slip of the cable over pulley.
3. Bend found on the cable may be at the time of accident.

**Recommendations-** Check condition of pulley rotation and cable tension on regular interval

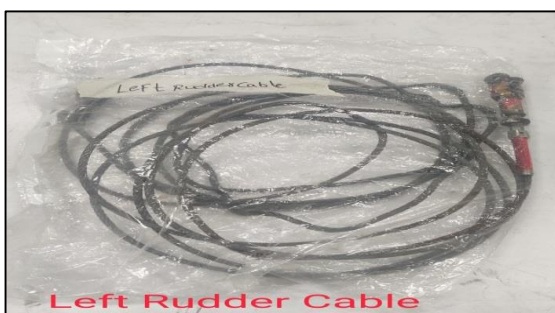
**6. Left rudder cable**

1. Cable found corroded at many places and many strands found broken 26 cm away from adjustable fork end.
2. No locking found on adjustable fork end.
3. Cable found bend at 38 cm from fixed fork end.
4. At one location , cable found untwisted ( 8 cm long) at 75 cm from fixed fork end and at 100 cm from the fixed fork end (untwisted length 3 cm).
5. corrosion observed on many places.

**Remarks-**Strand broken reflective of poor maintenance practices. Unwind in cable does not unless cable is mishandled.

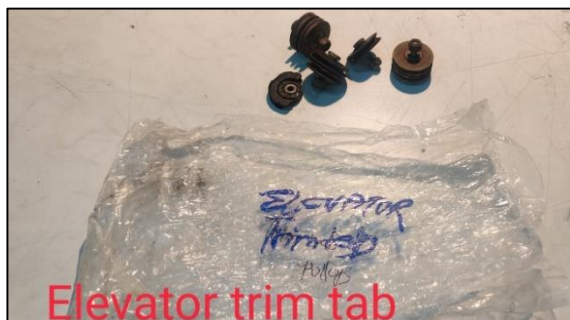
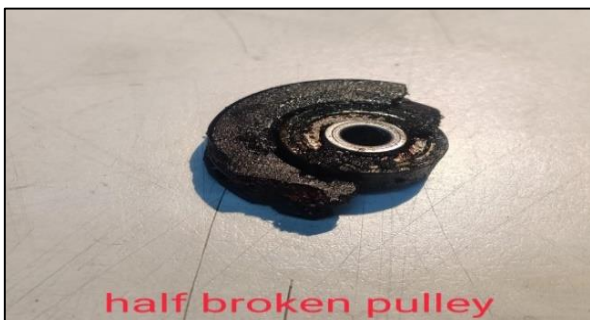
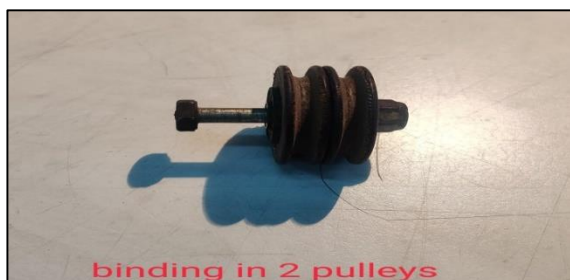
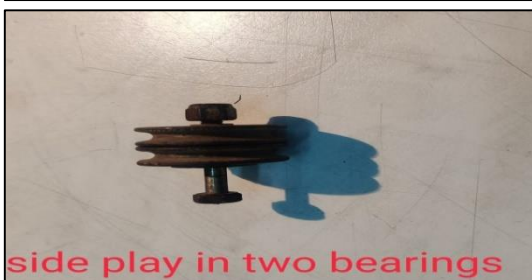
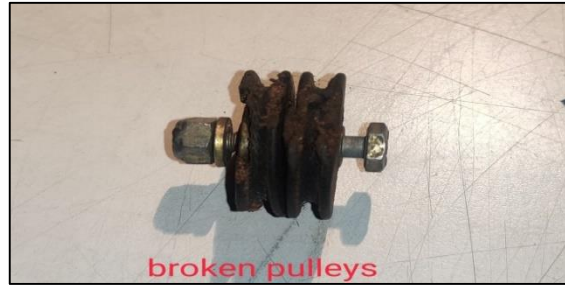
#### 7. Elevator trim tab

1. One pulley found half broken. Bearing found free of rotation.
2. Two pulleys have binding.
3. Two pulleys have got side play in bearing (bearing worn out).
4. One pulley broken and binding observed. Another pulley broken and free of rotation.

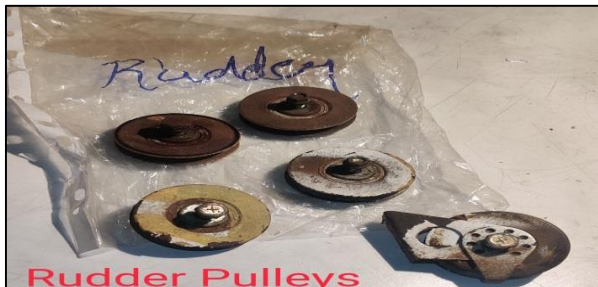
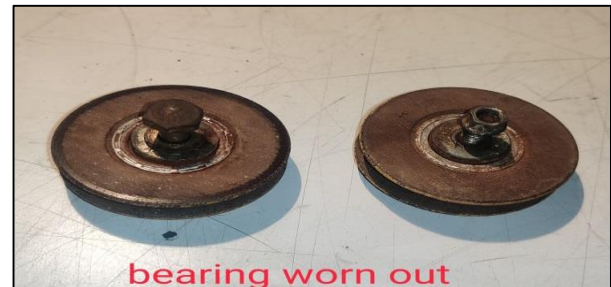
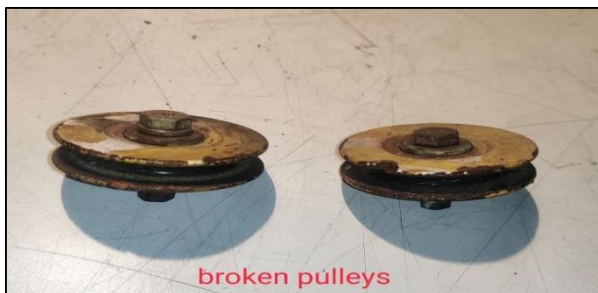
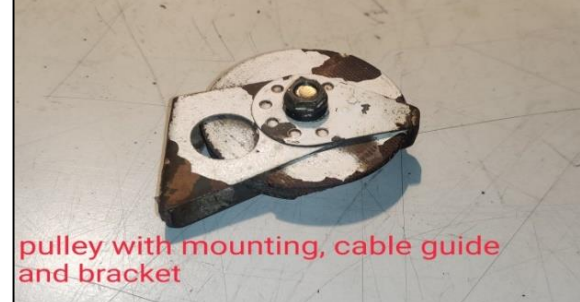
#### 8. Rudder pulleys

1. In two pulleys, inner race of the bearing found loose and have play ( bearing worn out).
2. Two pulleys broken but bearing free to rotate.
3. One pulley with mounting, cable guide and bracket found broken. Bearing rotation found satisfactory.

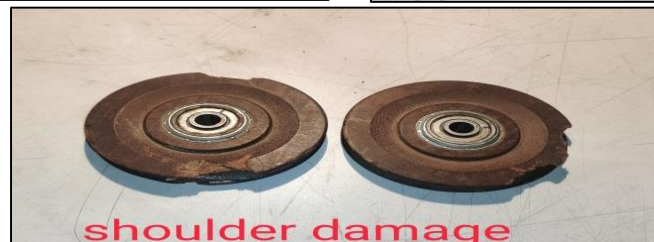
#### 9. Flap and ailerons pulleys

1. One pulley bearing comes out of the pulley.
2. On one pulley, bearing comes out of the pulley and pulley shoulder also found broken.
3. Crack found on pulleys on one of the pulley and bearing found jammed.
4. Another bearing found broken and binding observed in bearing.
5. On one pulley minor damage observed. However, bearing is free to rotate.
6. On two pulley ( **dia- 750 mm** ) pulley shoulder broken . Bearing is free to rotate.

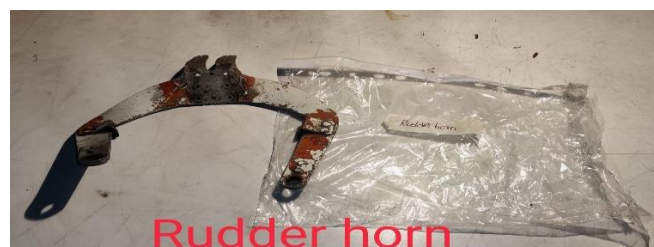
#### 10. Rudder horn

1. Rudder horn found distorted and slight damage marks observed, may be due to accident.

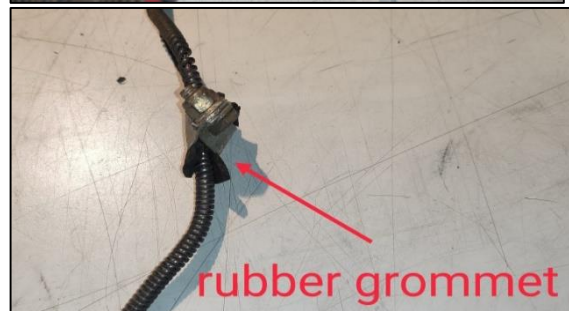
## 11. Flap cable

1. Outer flexible helicoil conduit found strached at many location.
2. Inner cable found broken at many places.
3. Clamp and rubber grommet found damaged.

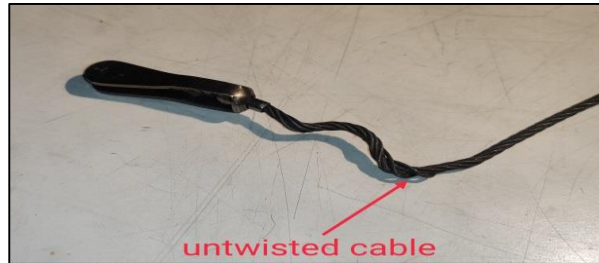
## 12. Right rudder cable

1. At 25 cm from the adjustable fork end, cable found corroded and 50 % of the strand found broken.
2. No locking wire found on the adjustable fork end.
3. Cable found untwisted (approx 10 cm) from the fixed fork end.
4. At approx ( 1 m) from the fixed fork end, cable found bend and some of the strands found broken.

**Findings**-Broken strands - unacceptable maintenance practices

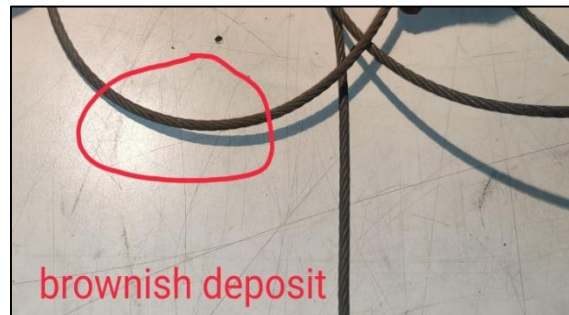
#### 13. Right through left aileron

1. At some places, brownish deposit found.
2. Trunbuckle found bend, locking wire found broken

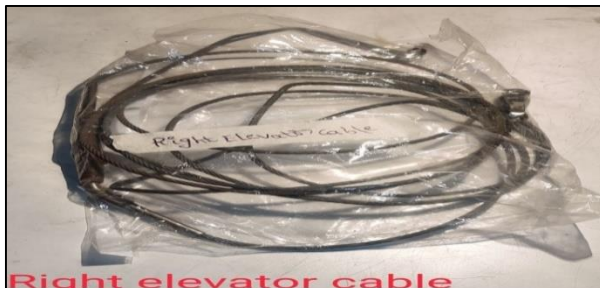
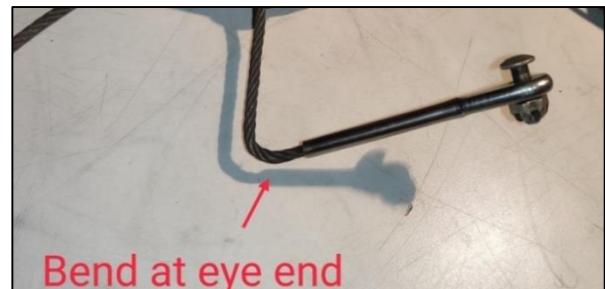
#### 15. Right elevator cable

1. Bend found on cable, 8 cm from eye end .
2. Bend found on trunbuckle.
3. Brown deposite found on cable (66 cm from fixed fork end).
4. At 66 cm from fixed fork end, strand found broken and wear marks (8 cm long) found on the cable.
5. 26 cm from the eye end , slight damage found on the cable.

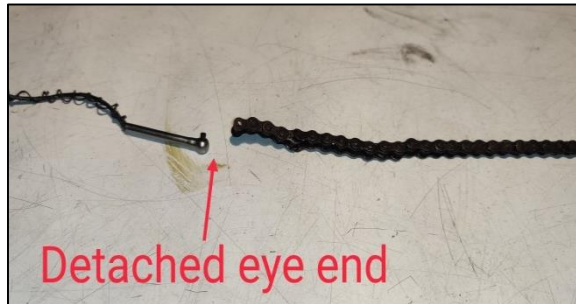
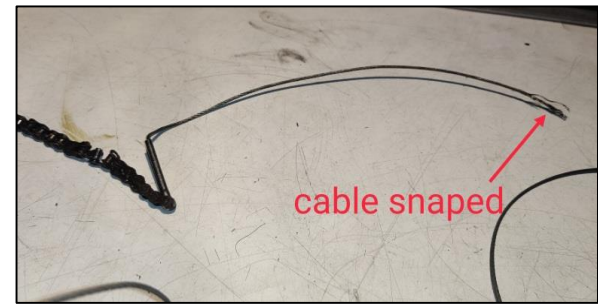
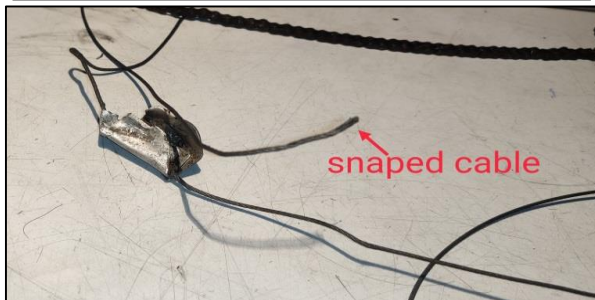
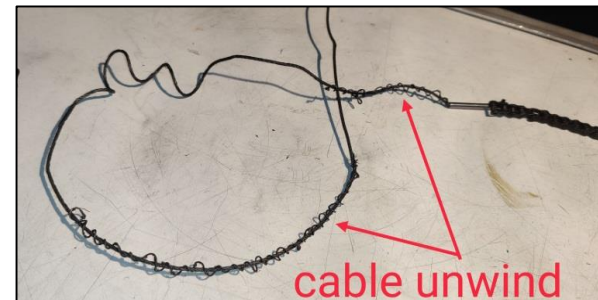
## 16. Trim tab cable

1. Chain found broken.
2. One eye end from chain found detached.
3. Another end (30 cm from eye end) found snapped.
4. From detached end, cable found unwinded and broken. At 60 cm from detached eye end, strand found broken.
5. At 30 cm from detached end cable found snapped.
6. Turnbuckle found bend and wire locked.
7. At many places wire is untwisted.

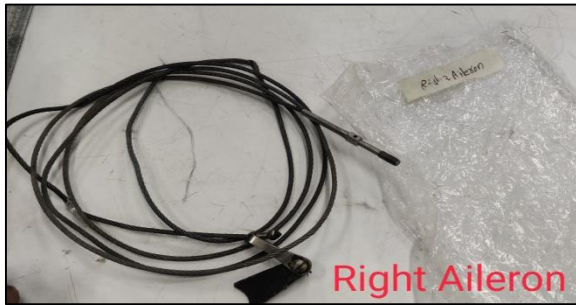
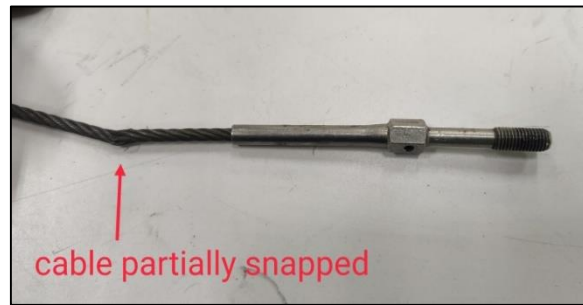
## 17. Right aileron

1. At one meter from fork end cable found bend.
2. Slight untwisted cable observed at many places.
3. 11 cm from the turnbuckle end, cable found partially snapped.
