Final Report
on
Serious Incident of Airprox
between two A320 aircraft
VT-ITD (IGO455) and VT-ISV (IGO246)
operated by M/s IndiGo
near Kempegowda International Airport, Bengaluru
on 7 January 2022

AIRCRAFT ACCIDENT INVESTIGATION BUREAU
MINISTRY OF CIVIL AVIATION
GOVERNMENT OF INDIA

Date & Time of Incident	7 January 2022 & 032552 UTC	
Place of Incident	Near Kempegowda International Airport, Bengaluru	
ATS Units	Aerodrome Control and Approach Control Surveillance Units	
Type of Occurrence	Airprox	
Classification of airspace	Class D	
Applicable ATC separation	Surveillance based horizontal separation of 3 NM and vertical separation of 1000 feet	
Recorded Minimum separation	Approx 0.9 NM horizontal (lateral) and 100 feet vertical	
Light conditions	Daylight	
	Aircraft 1 (IGO455)	Aircraft 2 (IGO246)
Type of aircraft	A320- 271N ICAO Type Designator A20N	A320- 251N ICAO Type Designator A20N
Wake turbulence category	Medium	Medium
Nationality	Indian	Indian
Registration	VT-ITD	VT-ISV
Last point of departure and ATD	Kempegowda International Airport, Bengaluru (VOBL) 0325 UTC	Kempegowda International Airport, Bengaluru (VOBL) 0325 UTC
Pont of intended Landing	Netaji Subash Chandra Bose Internat

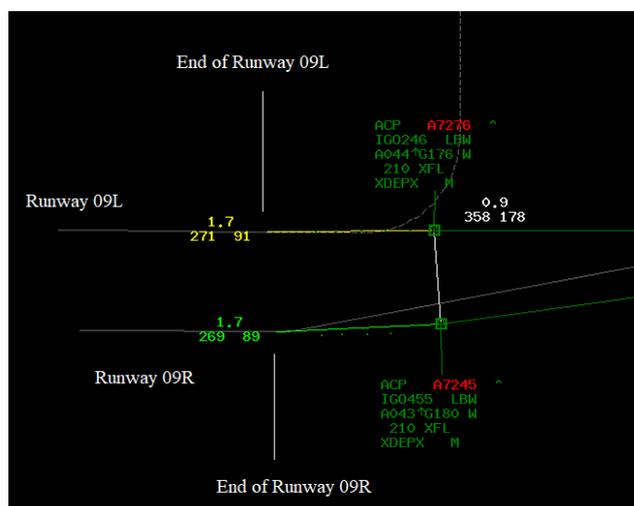
Fig-1

The incident took place when both the aircraft IGO246 and IGO455 were allowed to depart simultaneously from parallel runways 09L and 09R respectively. Simultaneous departures from both runways did not have the approval of the DGCA India. RNAV-1 SIDs for departures from runways 09L and 09R were merging at a waypoint BL401 which was about 6 NM from runway 09R end. However, when IGO455, after departure from runway 09R, just initiated a turn to the waypoint BL401, the Approach Departure controller promptly detected the potential conflict and issued conflict avoidance instructions to both aircraft. The time IGO455, in compliance with ATC instructions, started turning right, the separation between the two aircraft reduced to 0.9 NM laterally and 100 feet vertically (Ref Figure 1 below). Subsequently, the required separation was re-established and both flights continued to their destinations as per ATC clearances.

However, the time IGO455 executed the ATC instruction to turn right, the minimum separation between these two aircraft IGO455 and IGO246 reduced to 0.9 NM and vertical separation reduced to 100 feet (Ref Figure 1). Subsequently, the required separation was re-established and both flights continued their destinations as per ATC clearances.

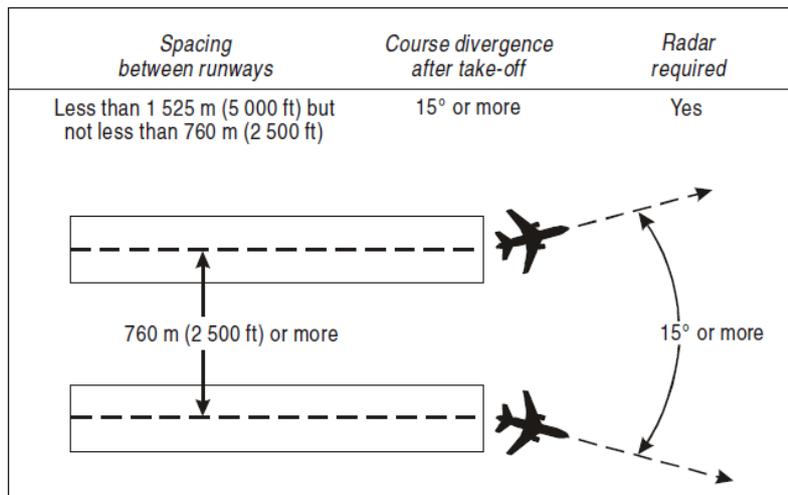
Figure 7

- b) the runway centre lines are spaced by the distance specified in Annex 14, Volume I;
- c) the departure tracks diverge by at least 15 degrees immediately after take-off;
- c) suitable surveillance radar capable of identifying the aircraft within 1.0 NM from the end of the runway is available; and
- d) ATS operational procedures ensure that the required track divergence is achieved.

**Independent instrument departures when
parallel runway spacing is less than 1 525 m (5 000 ft)
but not less than 760 m (2 500 ft)**

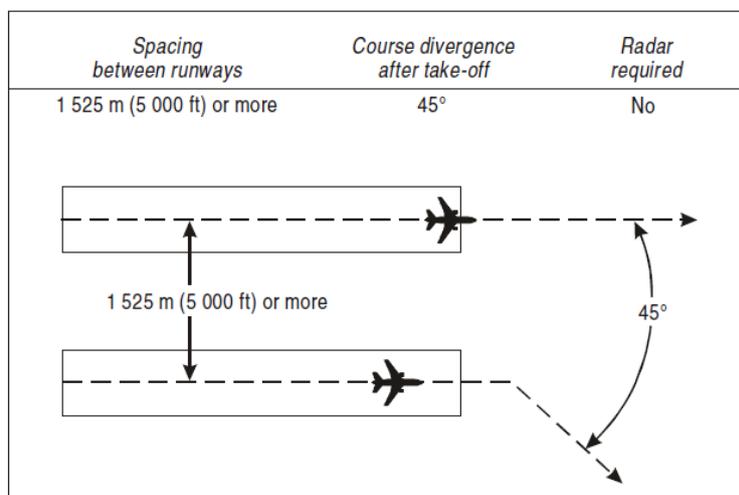
Figure 8

Para 3.2.2 There is no requirement, other than satisfactory two-way radio communications, for any specialized form of control or navigation aid facility for the conduct of independent instrument departures when the spacing between parallel runways is 1525 m or more and a course divergence after take-off of 45 degrees or more can be achieved. See figure 8 below:

**Independent instrument departures when
parallel runway spacing is 1 525 m (5 000 ft) or more**
