**FINAL INVESTIGATION REPORT ON ACCIDENT TO
M/S FALCON AVIATION ACADEMY,
CESSNA 152 AIRCRAFT, VT-PTE ON 05.01.2023
AT UMARI VILLAGE NEAR REWA, M.P**

AIRCRAFT ACCIDENT INVESTIGATION BUREAU

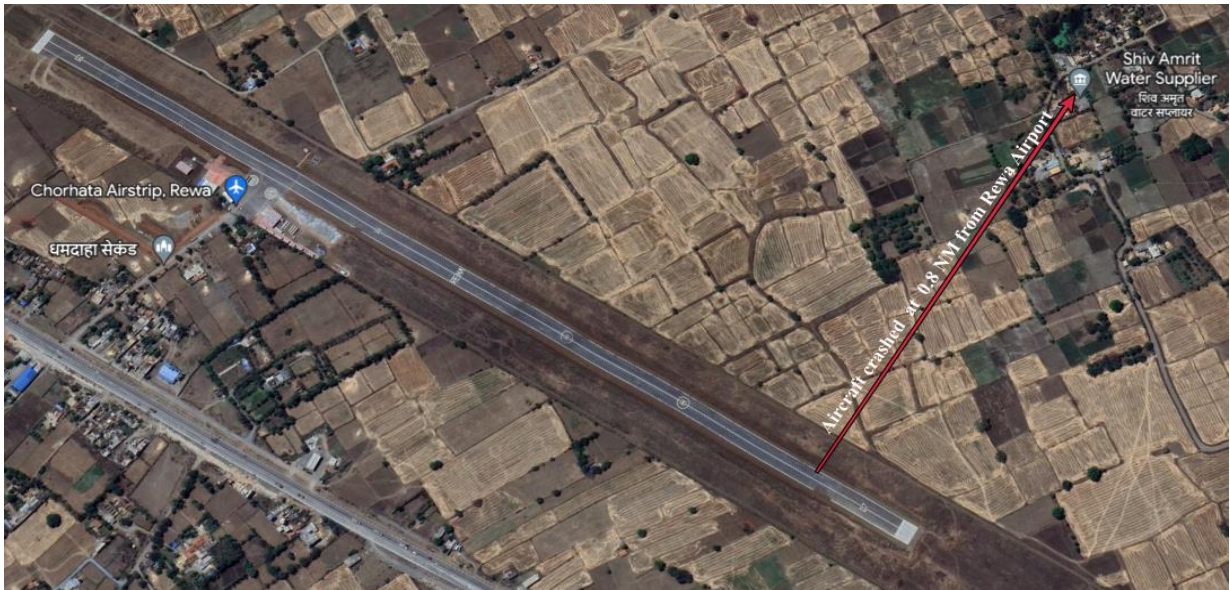
The crew were not able to find any visual cues from ground and in search of the same the crew kept on descending the aircraft. During this process the aircraft hit one of the trees before its landing gear hit the terrace of a house, which was about 15 feet above the ground as evident from the rubbing marks of landing gear tyre on the wall and damages at the same position on the concrete structure. Simultaneously, the left wing hit one of the trees adjacent to the house where there were signs of fuel spillage. Thereafter, the aircraft penetrated through another tree in front of the house, breaking its trunk. The right-side wing of the aircraft then struck a concrete temple tower. Due to the heavy impact the top portion of the temple tower broke and got separated from the structure. The right wing was also found separated from the aircraft structure. Subsequently, the aircraft impacted the ground before coming to the final rest position just in front of a house. The location of the aircraft where it crashed was at a distance of approximately 0.86 Nm from end of runway 25.

FIG 3: LOCATION OF ACCIDENT SITE FROM REWA AIRFIELD.
