**Government of India**  
**Ministry of Civil Aviation**  
**Aircraft Accident Investigation Bureau**

**Interim Report:** Accident involving M/s Aryan Aviation Pvt. Ltd.'s BELL 407 helicopter, bearing registration VT-BKA near Gaurikund, Uttarakhand, India on 15 June 2025.

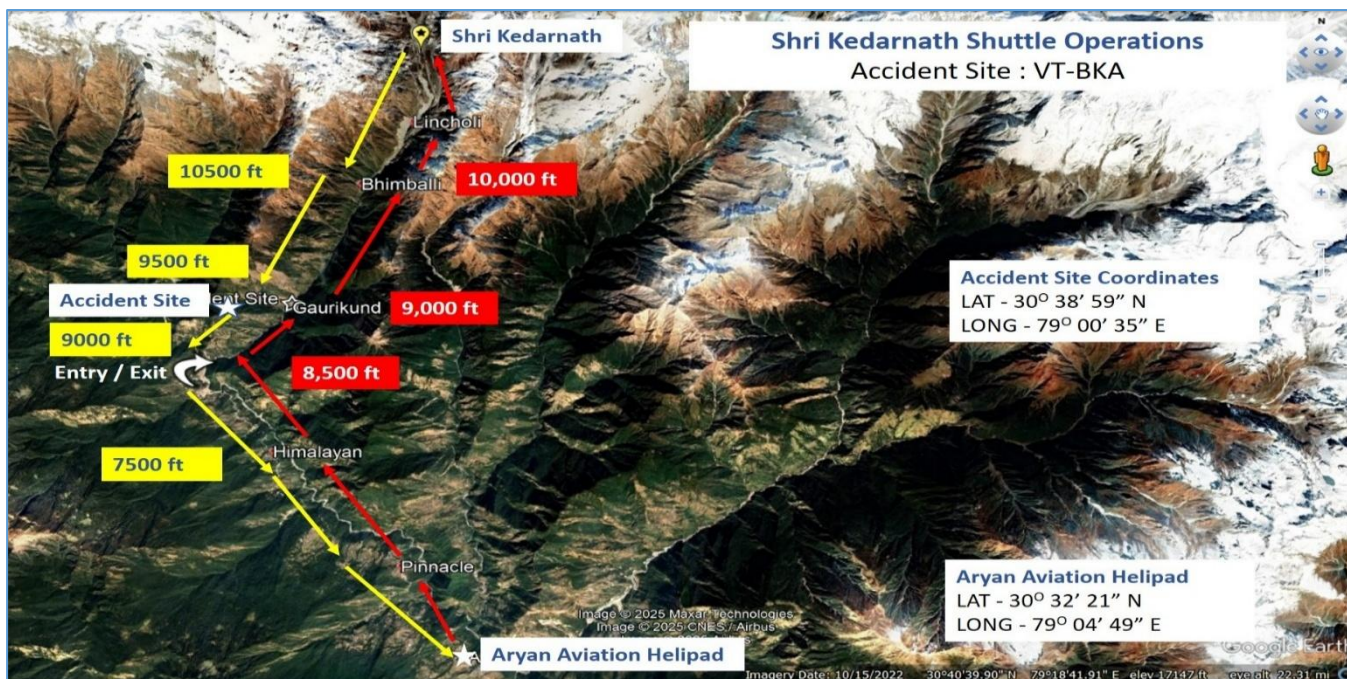
**PIC 3: FLIGHT ROUTE FOR SHUTTLE OPERATIONS IN KEDARNATH VALLEY AS PER SOP**

On analysing the footage of the CCTV camera facing the valley entry/exit point, during the time of accident, it was observed that the valley exit point was covered with clouds and were moving down into the valley. The other two helicopters which were behind the accident helicopter VT-BKA were observed to have exited the valley at a lower altitude by avoiding the clouds.
