**FINAL INVESTIGATION REPORT ON ACCIDENT INVOLVING**  
**GOVERNMENT OF CHHATTISGARH AGUSTA A109E HELICOPTER**  
**VT-CHG AT RAIPUR AIRPORT**  
**ON 12 MAY 2022.**

**GOVERNMENT OF INDIA**  
**MINISTRY OF CIVIL AVIATION**  
**AIRCRAFT ACCIDENT INVESTIGATION BUREAU**

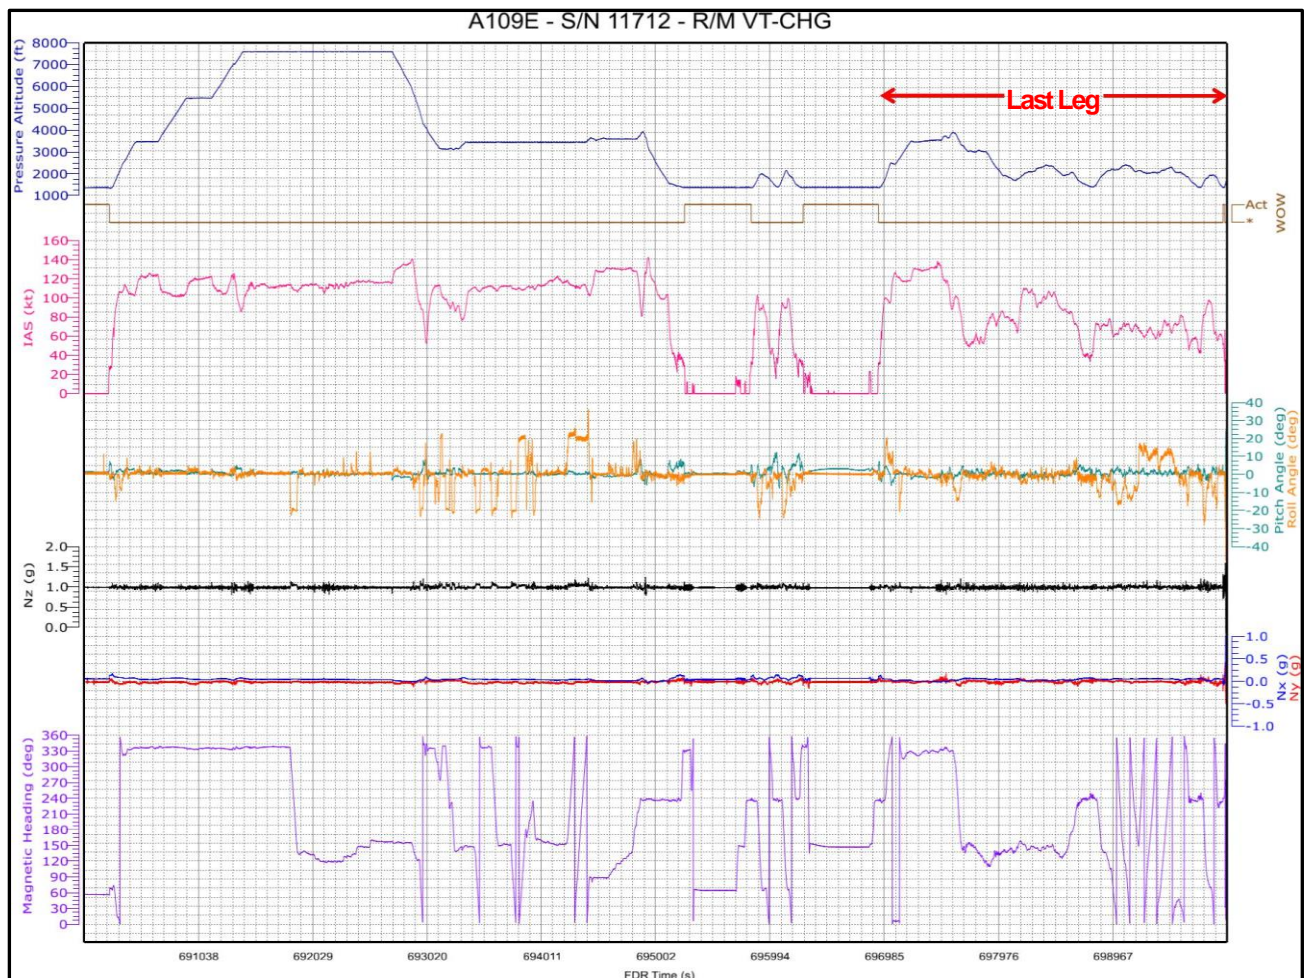
- The helicopter took-off at 14:57 UTC from Raipur.
- The flight was uneventful upto T= 697535s (15:05 UTC), where a slight alteration of the vibratory regime recorded by the CVDR tri-axial accelerometer (primarily on Ny and Nz). Its presence, coupled with the initiation of small periodic un-commanded attitude variation on the Pitch and Roll axis (max 2.5° pitch, 7° roll) may be considered an early indication of the impending malfunction of TR control. At this time the A/C was flying at 3540ft AMSL and 132KIAS.

- No Crew Alerting System (CAS) message was recorded in this phase.
- The Crew reacted to the emergency i.a.w the relevant RFM procedures: PIC controlled the A/C attitude changes with Cyclic inputs and the Tail Rotor Pedal authority was checked immediately, in order to properly identify the issue; TQ demand was managed with progressive and slow actions of the Collective, in order to both achieve a reduction in the need for anti-torque and maintain the current heading with only minimal cyclic inputs. The stabilising effect of the Tail Fin was enough to maintain the desired heading, even when IAS was also progressively reduced from 132 to 60-80kts.

**Fig: 10. Flight Path Data for whole final flight.**

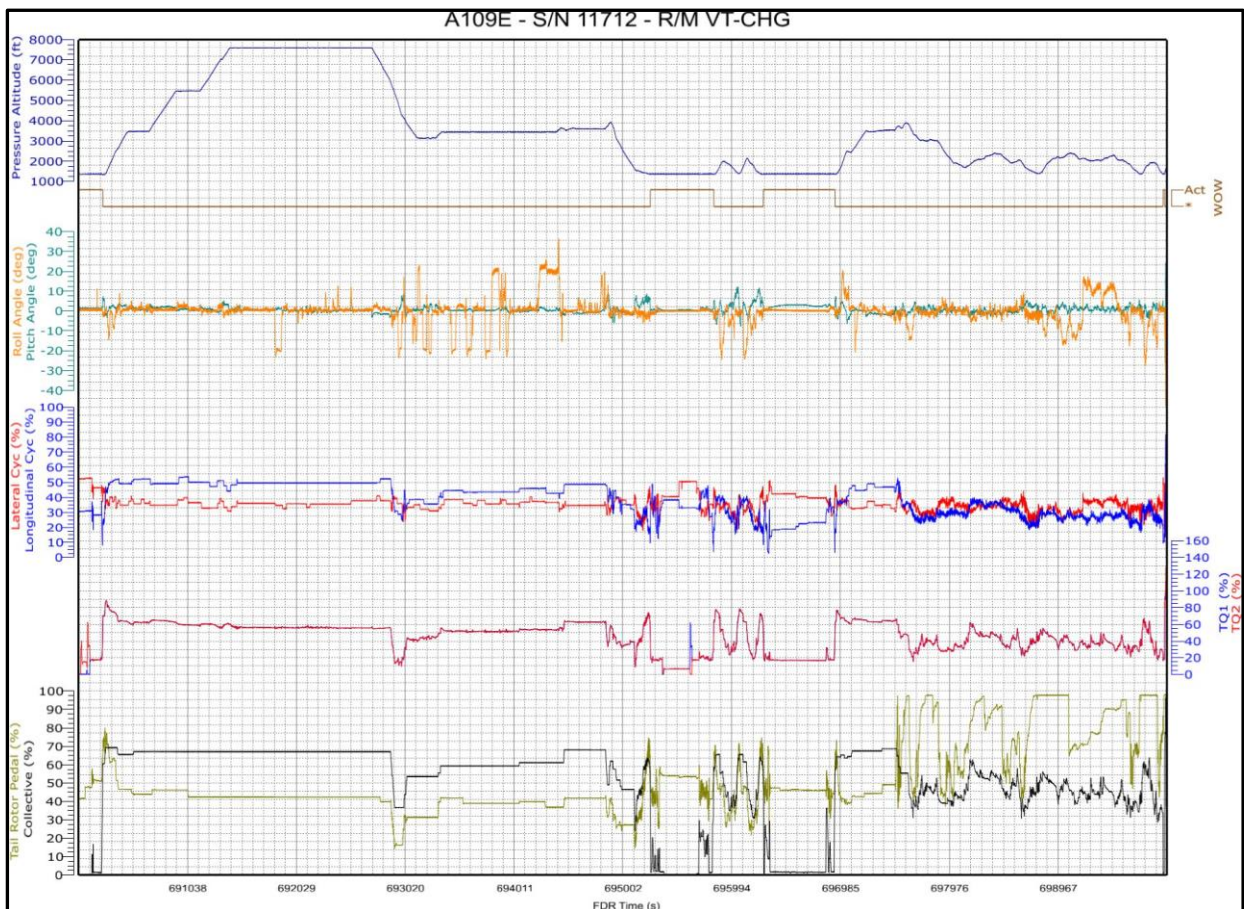
- From the loss of Tail Rotor control onwards the Pedal recording shows a repetitive and progressive Left drift, reaching 100% over several minutes, before it was repetitively re-centered manually. As the Pedal position is recorded in the CVDR via a dedicated potentiometer installed on the control chain near below the Cockpit floor, this behaviour can be explained by the fact that, having lost the connection with the Tail Rotor rotating controls, there wasn't any significant load on the whole control chain beside the residual minimal friction within the connections between bell-crancks and rods. As from that point onwards the PIC was likely flying hands-on and acting on the Force Trim release switch (in order to maintain heading), the Magnetic Brake installed on the Pedal control chain was also de-energised, therefore the Pedals were in a condition of "neutral equilibrium" and thus their progressive drift may have been simply caused by small accelerations or variations in the A/C attitudes. This had of course no effect on the A/C controllability as the pedal was disconnected from the TR pitch controls.

- At T=699720s (approximately 15:43 UTC) a similar attempt as in case of T=698705s was made, which was also aborted. The same considerations on A/C positioning apply here.
- The A/C touched down on the 3rd attempt at T=699925s (15:46:57 UTC), where WOW become active with IAS = 52kts and magnetic Heading changing between 233° and 239°. The small RH yaw at touchdown is likely to be attributed to slight lack of antitorque control as the speed reduced below 60 KIAS.

**Fig: 11. Flight Control Data for whole final flight.**

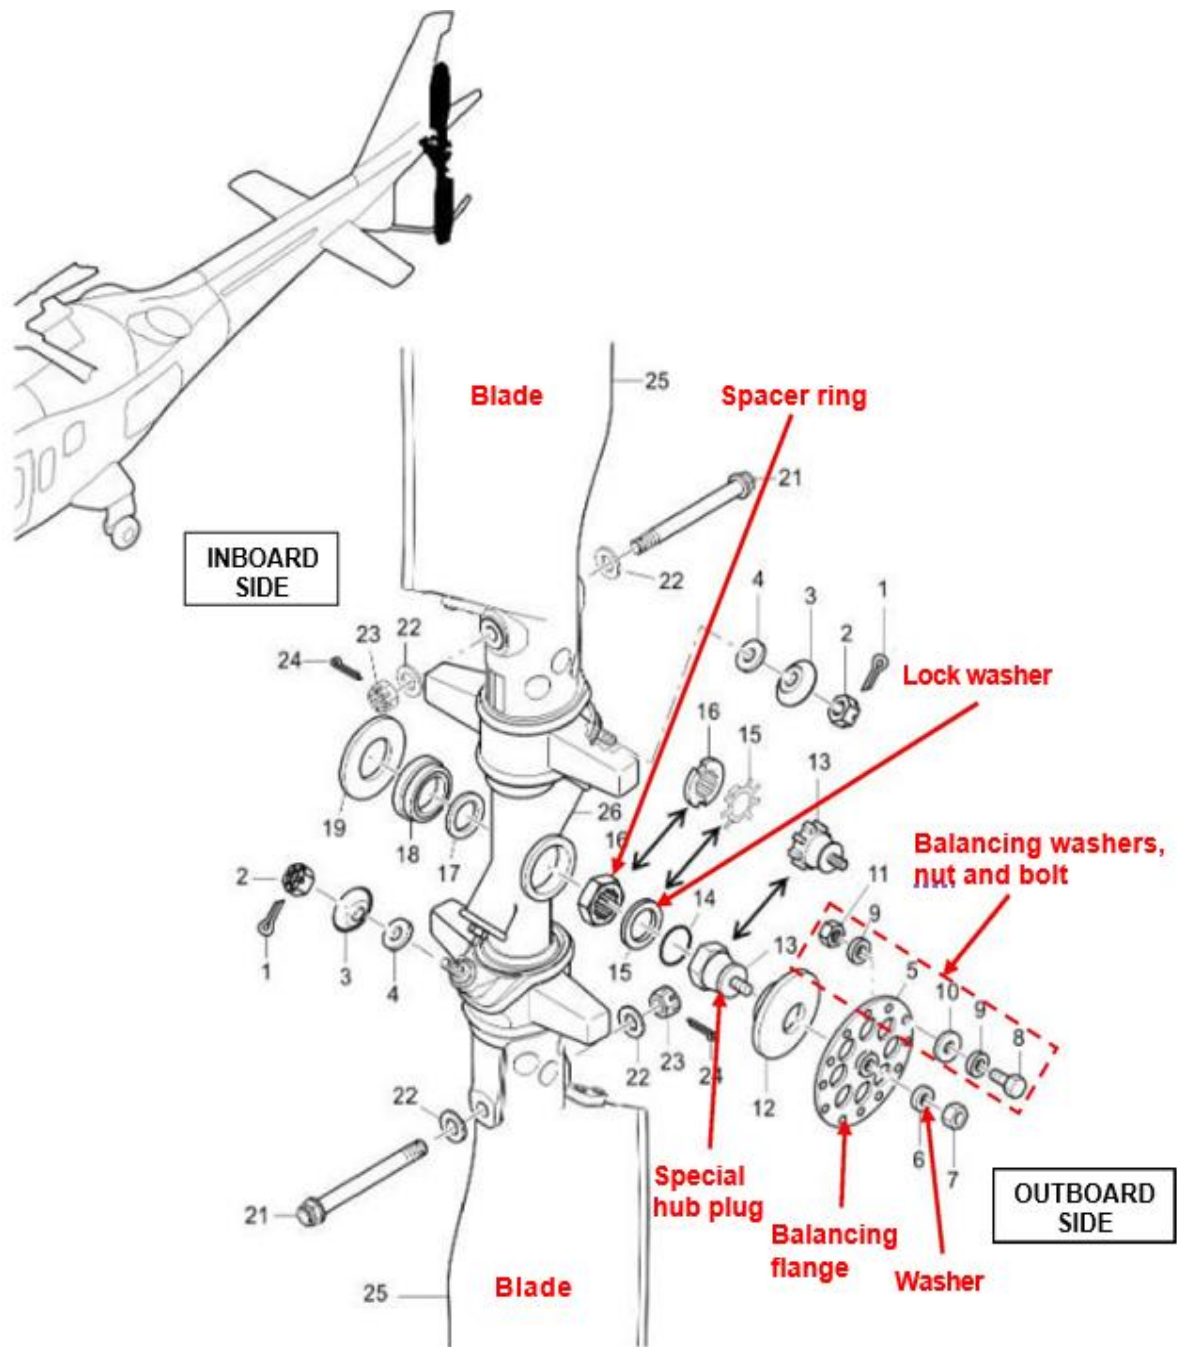
- The washer to be fitted under the locking nut of the special hub plug (mating to the balancing flange) in accordance with the maintenance manual, was not installed (Figures 1 and 2 of App B).
- The balancing flange had some washers applied to four holes close together (Figures 1 and 3, App. B). The maintenance manual states that balancing must be performed by applying appropriate masses to the flange using a combination of washers, nut and bolt in up to four positions (four holes in the flange), without exceeding the weight of 25 grams (including nut and bolt) for each position. The weighing of the masses in the laboratory (Figure 3 of App. B) on each position did not reveal any anomalies.
- It was verified that the blades were free to rotate around their longitudinal axes (Figures 1 and 4, App. B).

Figure 1 – Exploded view drawing of the tail rotor installation, with indication of the relevant parts for the investigation.

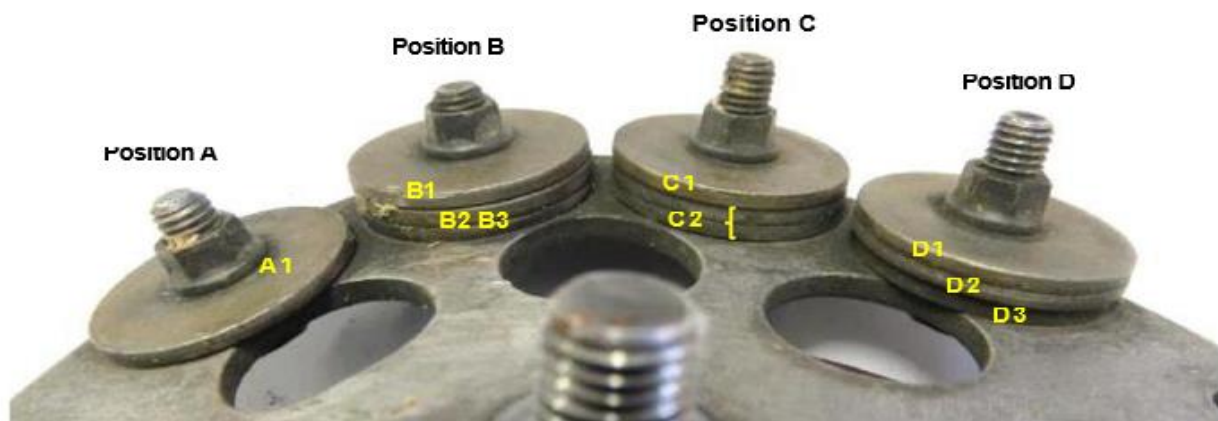
**Figure 3 – Details of the washers applied on the balancing flange and the measured weight of the masses (washers, nut and bolt) for each position, which proved to be compliant with the maintenance manual. The C2 weighing includes two washers that could not be easily separated.**

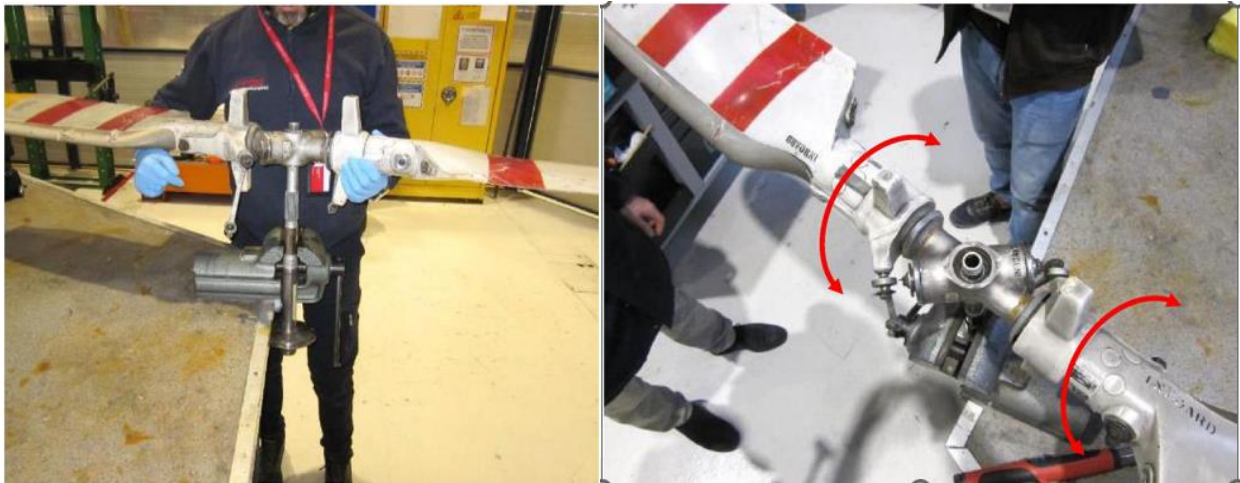
**Figure 4 – Details of the test performed on the blades to verify the freedom of rotation around their longitudinal axis (red arrows). The hub was engaged on a test TR gear box output shaft.**

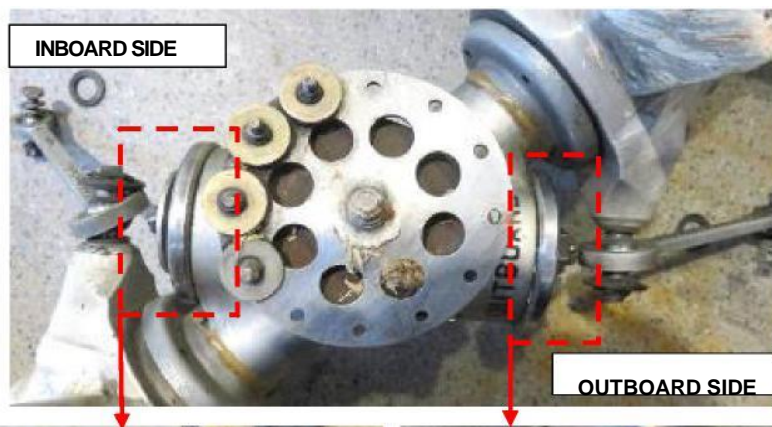
**Figure 6 – Details of the two hub flange assemblies, showing the absence of the washers to be installed mating to them (Fig. 6). Instead of the required washer, two thinner and smaller in diameter washers were installed.**

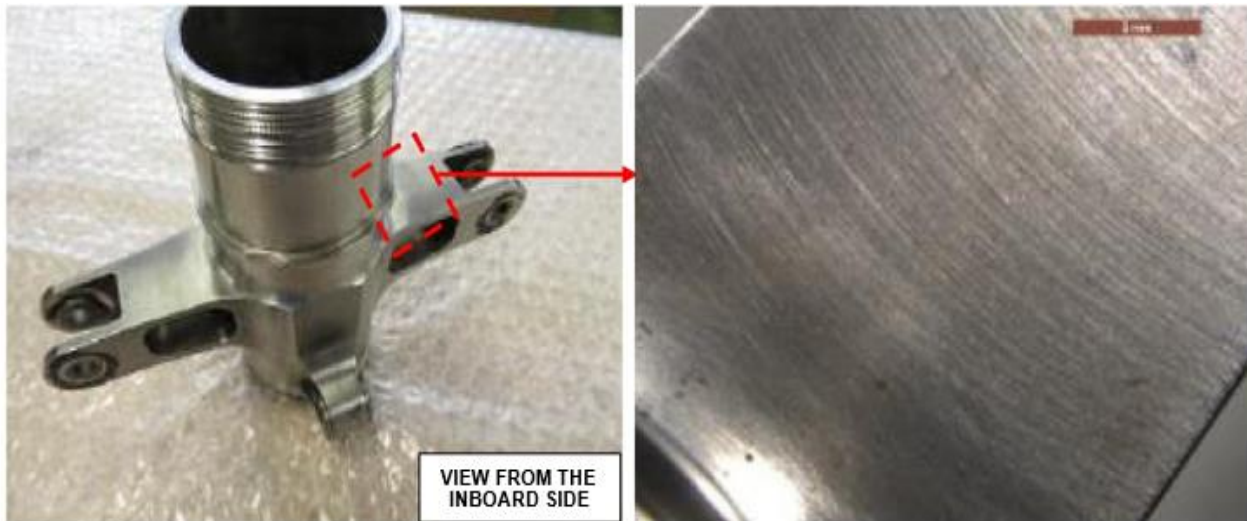
**Figure 12 – Details of the pitch link arms of a comparative slider assembly coming from service showing wear areas.**

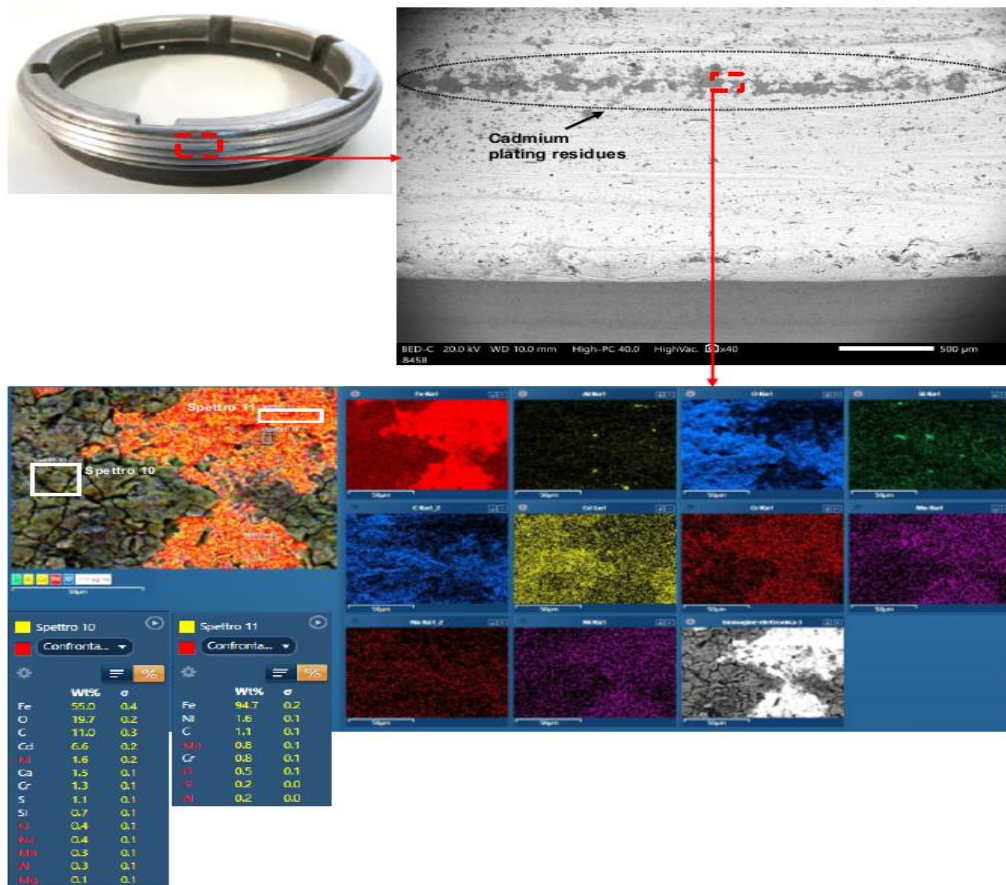
**Figure 21 – Map (in each window the distribution of a specific chemical element in the scanned area is reported) and semi-quantitative analysis of the chemical elements performed by EDS through the SEM on an area of the outboard locking nut characterized by a residue of cadmium plating mixed with elements belonging to the soil and the tail rotor parts with which the nut has come in contact in the event (Spettro 10). Some of these elements have also been detected in the areas free of cadmium plating, characterized by the elements belonging to the nut steel alloy (Spettro 11)**

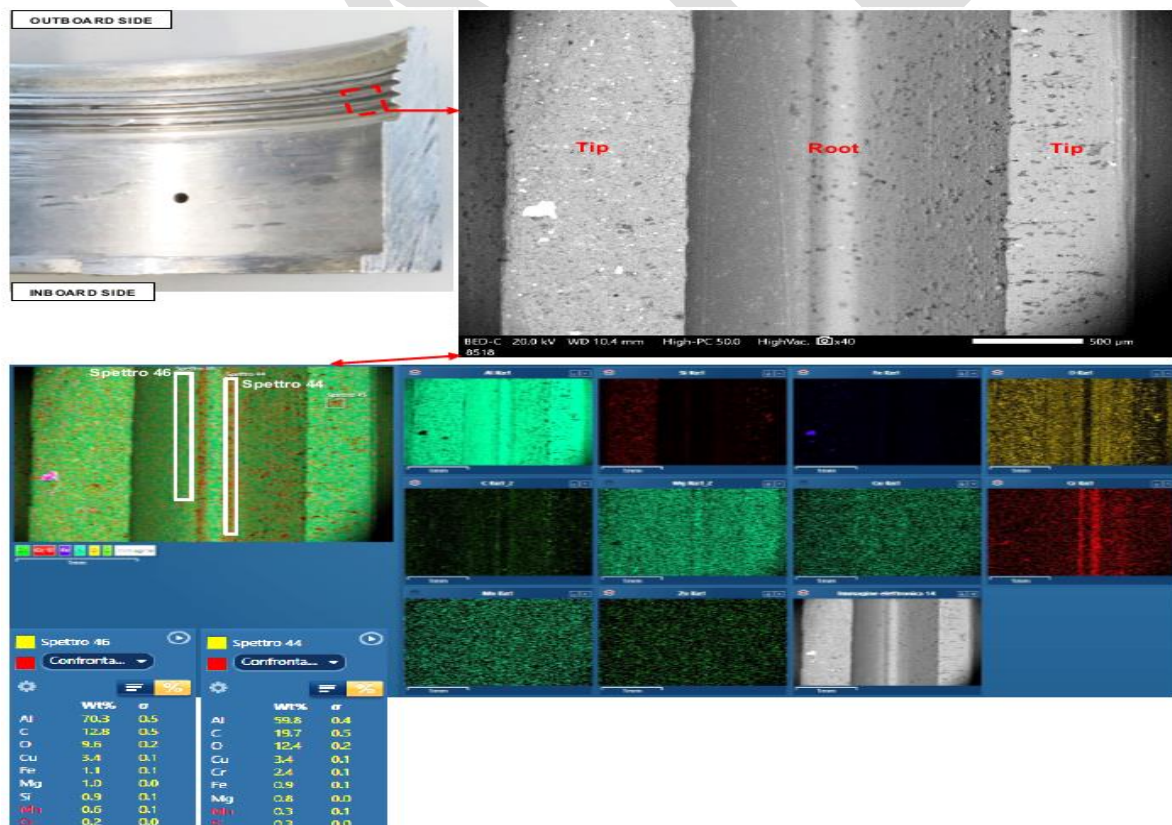
**Figure 28 – Map (in each window the distribution of a specific chemical element in the scanned area is reported) and semi-quantitative analysis of the chemical elements performed by EDS through the SEM on a representative area of the support bearing sleeve assembly thread. Cr is almost completely absent (Spettro 46). A more considerable amount was only detected in the roots of the threads (Spettro 44) being more protected from possible manipulations. All other detected elements belong to the support bearing aluminum alloy and the tail rotor parts with which the support bearing has come in contact in the event.**

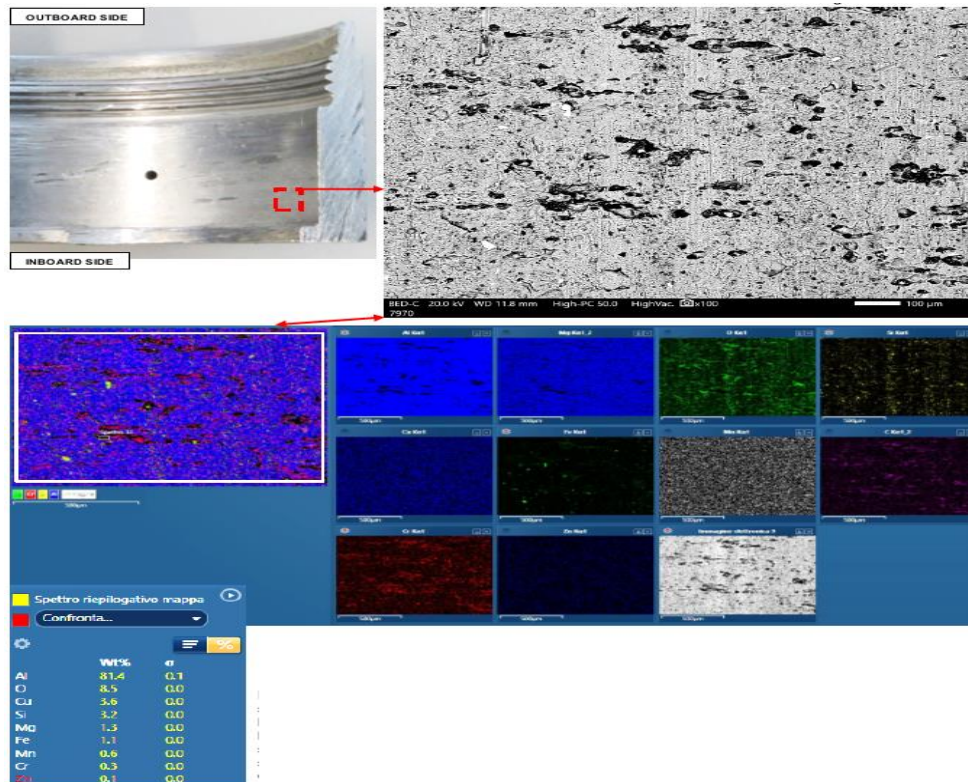
**Figure 29 – Map (in each window the distribution of a specific chemical element in the scanned area is reported) and semi-quantitative analysis of the chemical elements performed by EDS through the SEM on a representative area of the inboard bearing seat of the support bearing sleeve assembly. Cr is almost completely absent (the spectrum is related to the entire scanned area surrounded by the white rectangle). All other detected elements belong to the support bearing aluminum alloy and the tail rotor parts with which the support bearing has come in contact in the event.**

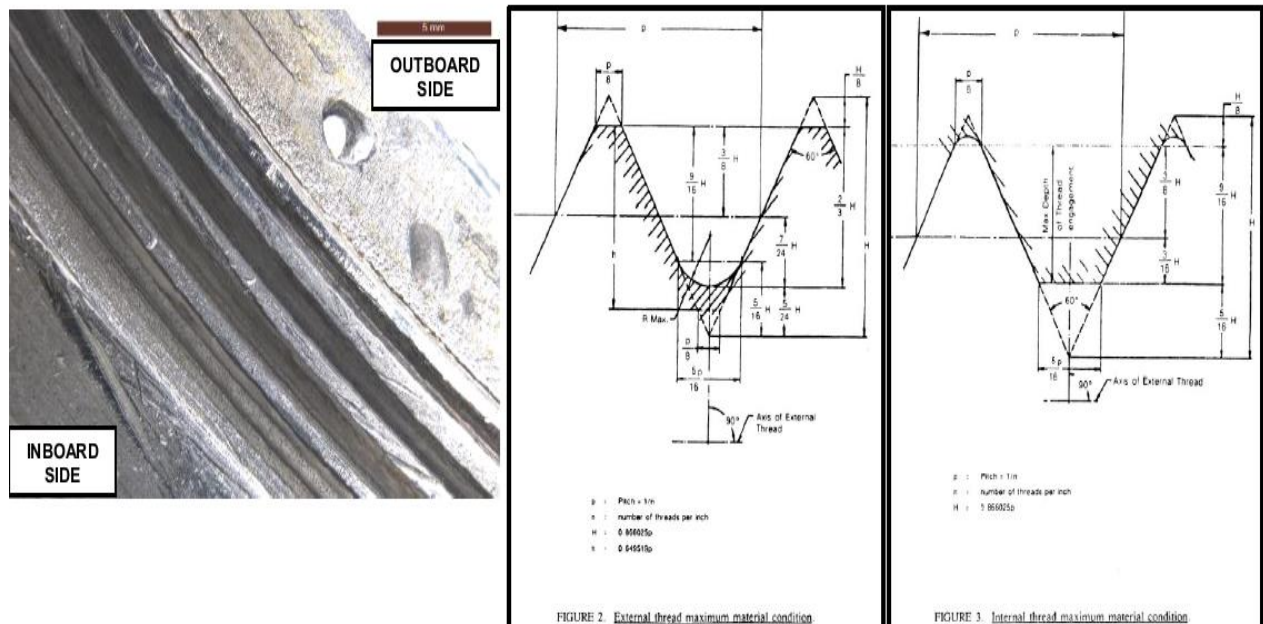
- The counterpart which impacted / slipped with the bearing seat and the thread causing the above damage was not likely the outboard locking nut for installation and size reasons, as its thread is screwed into that of the support bearing. The only possibility of the nut impacting is that it has previously teared the support bearing threads along their entire circumference, but this is to be excluded as the threads appear overall intact, maintaining their original trapezoidal profile required by the drawing (Figure 32, App. B).

**Figure 32 – Detail of the overall intact support bearing sleeve assembly thread, which maintained the trapezoidal profile required by the drawing and excerpt of MIL-S-8879 specification which it refers to.**

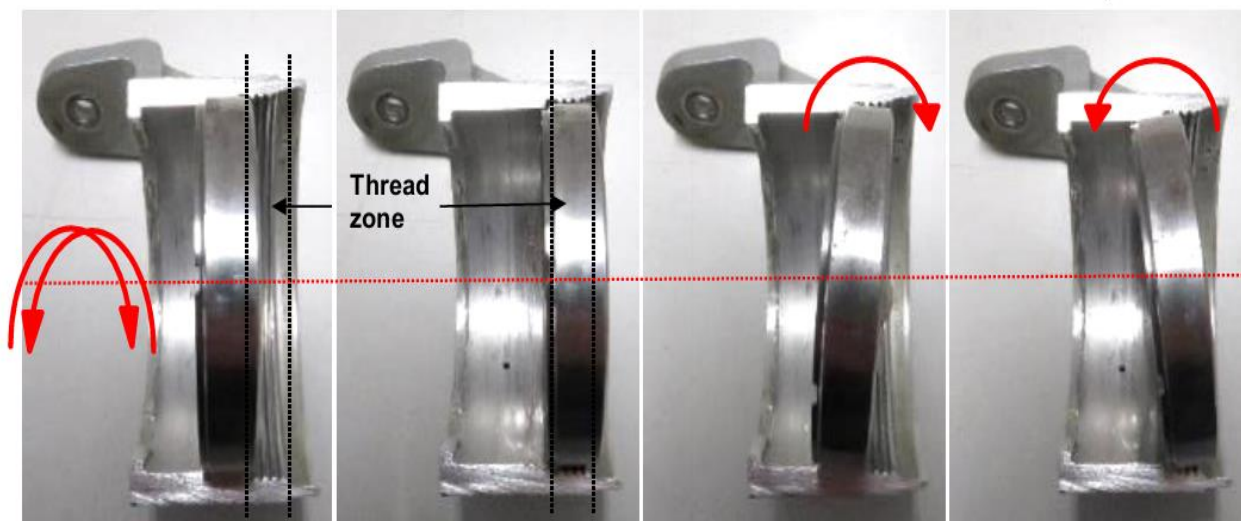
support bearing seat were probably due to the rotation of the outer ring inside it, which necessarily took place together with the unscrewing of the outboard locking nut (a representation of this is in Figure 33, App. B). The absence of damages on the surface mating with the outer ring of the inboard bearing indicates that it has moved less than that of the outboard bearing.

**Figure 33 – Representation of the probable positions assumed by the outboard bearing outer ring as it rotated and tilted during the event, impacting / slipping with the inner surface of the support bearing sleeve assembly.**

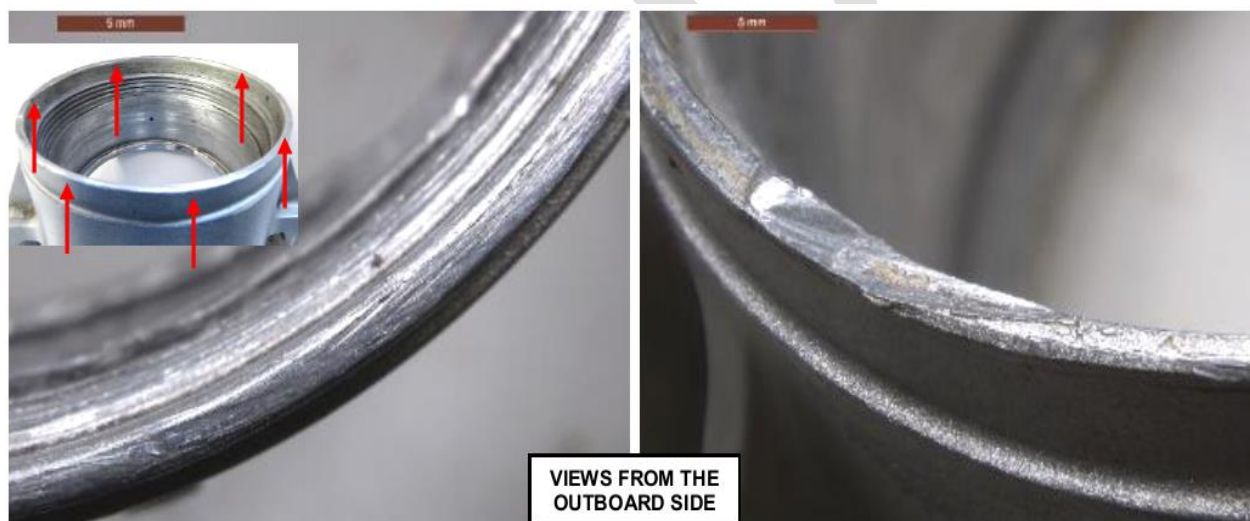
- The outboard edge of the support bearing show crushed areas and inclined nicks (Figure 34, App. B), reasonably due to impact / slipping with the unscrewed outboard locking nut in revolution around the slider assembly central body.

**Figure 34 – Details of some crushed areas and inclined nicks visible on the outboard edge of the support bearing sleeve assembly (red arrows), due to the contact with the outboard locking nut after unscrewing.**

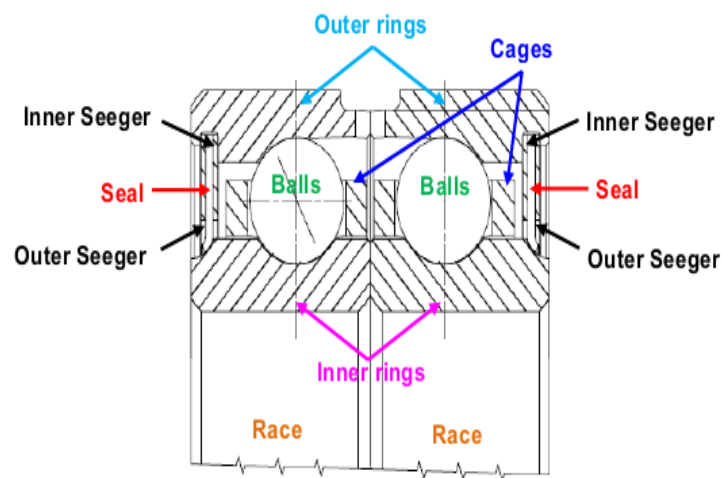
**Figure 39 – Drawing of the duplex bearing section, showing all its parts.**

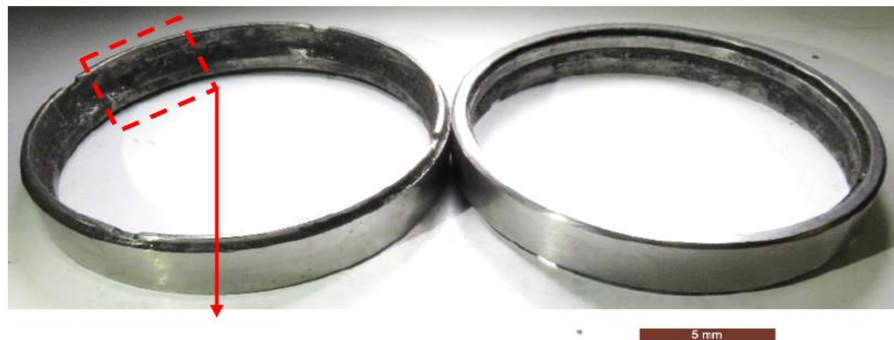
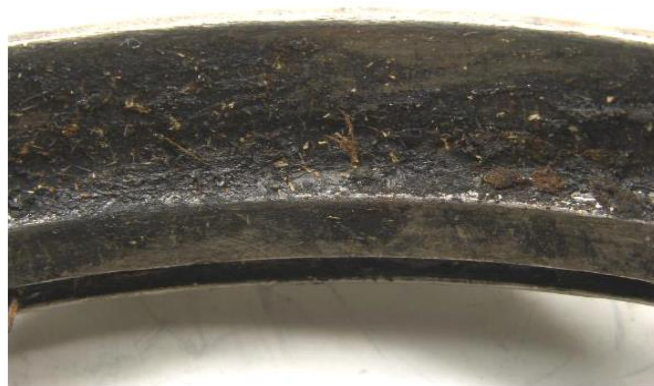
- All rings were covered by soil-rich grease (Figure 40, App. B), therefore they were cleaned before using paper and then an ultrasonic bath of methylethylketone (MEK).

**Figure 40 – Details of the duplex bearing outer rings with inner surface covered by soil-rich grease, as arrived in the laboratory.**

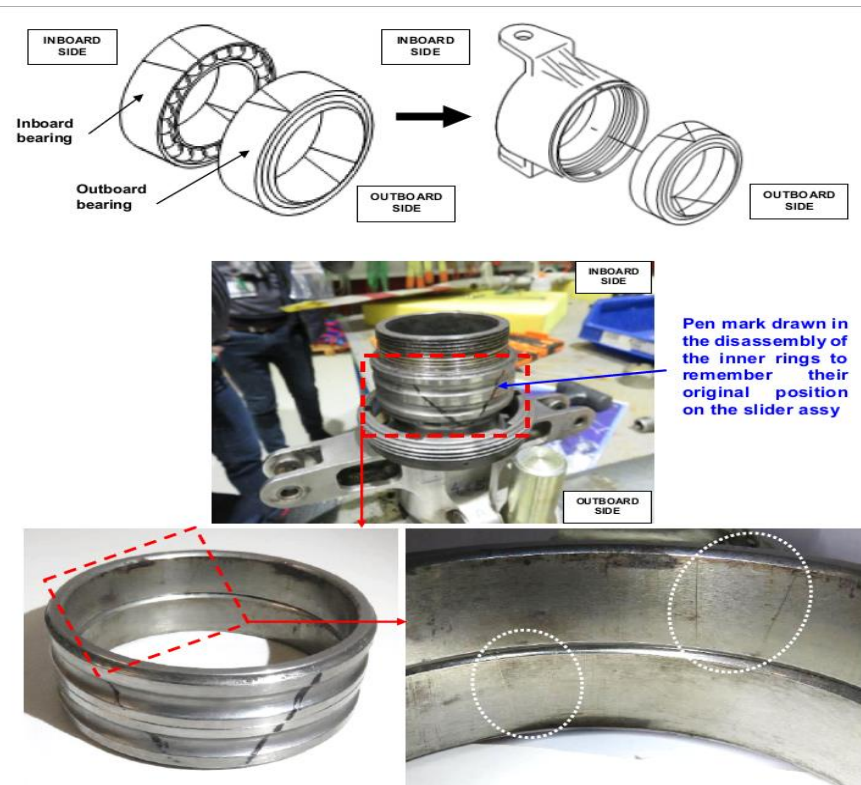
- After removing the inboard locking nut to extract the duplex bearing inner rings, it was verified that they were assembled according to the maintenance manual. The rings were oriented correctly as the engravings on them could form a V-shaped mark, but unlike the maintenance manual, the engravings were not aligned with each other (Figure 41, App. B). This misalignment could be due to the installation of the duplex bearing or could have occurred during the event.

**Figure 41 – Scheme of the duplex bearing assembly and its installation in the support bearing sleeve assembly and details of the engravings on the duplex bearing inner rings (white ellipsis), which were correctly oriented but not aligned with each other to form the V-shaped mark.**
