**on 01 May 2022**

## Ministry of Civil Aviation

## 1.3 Damage to Aircraft

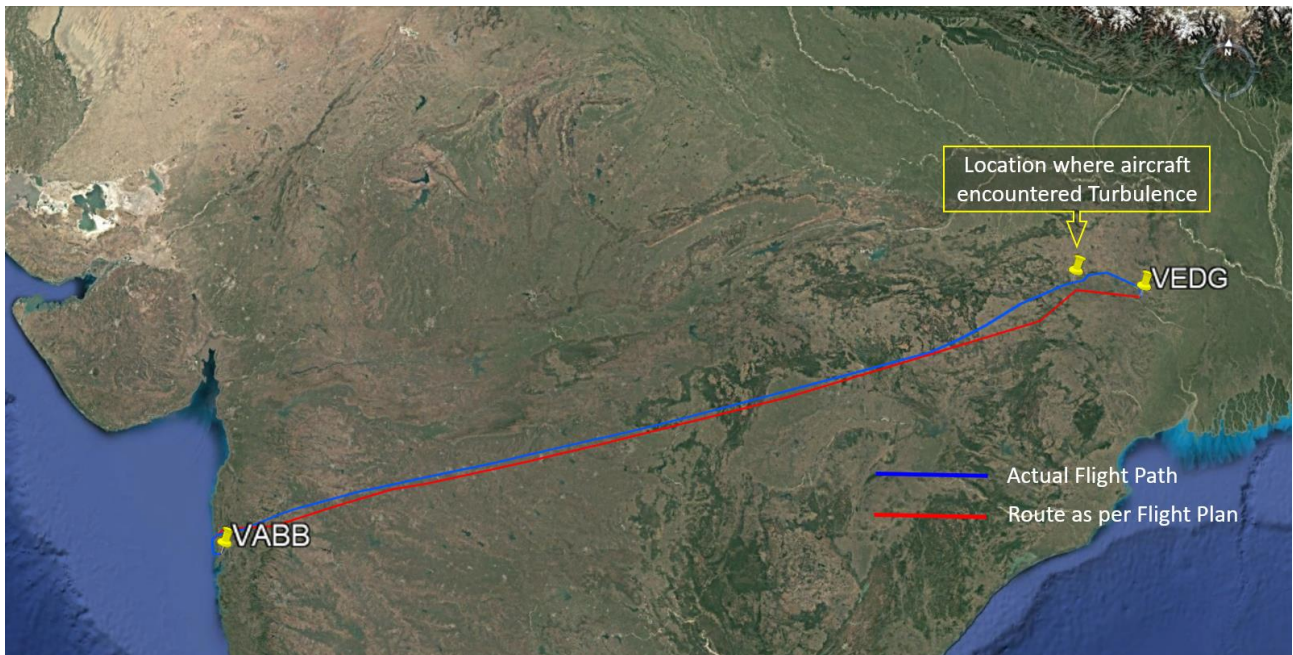
Figure 11

The raw data was downloaded and converted to engineering parameters with assistance from the OEM and the Operator. The DFDR plot has been used to create the flight path plotted on a satellite map shown in figure 11. The flight path as per the Flight Plan is shown in red. The actual flight path flown by aircraft is shown in blue. The location where the aircraft encountered weather is also shown. The DFDR Data Analysis provided by the OEM was not time aligned as the time-stamps were not available. The plots made with respect to elapsed time are shown in Appendix C.

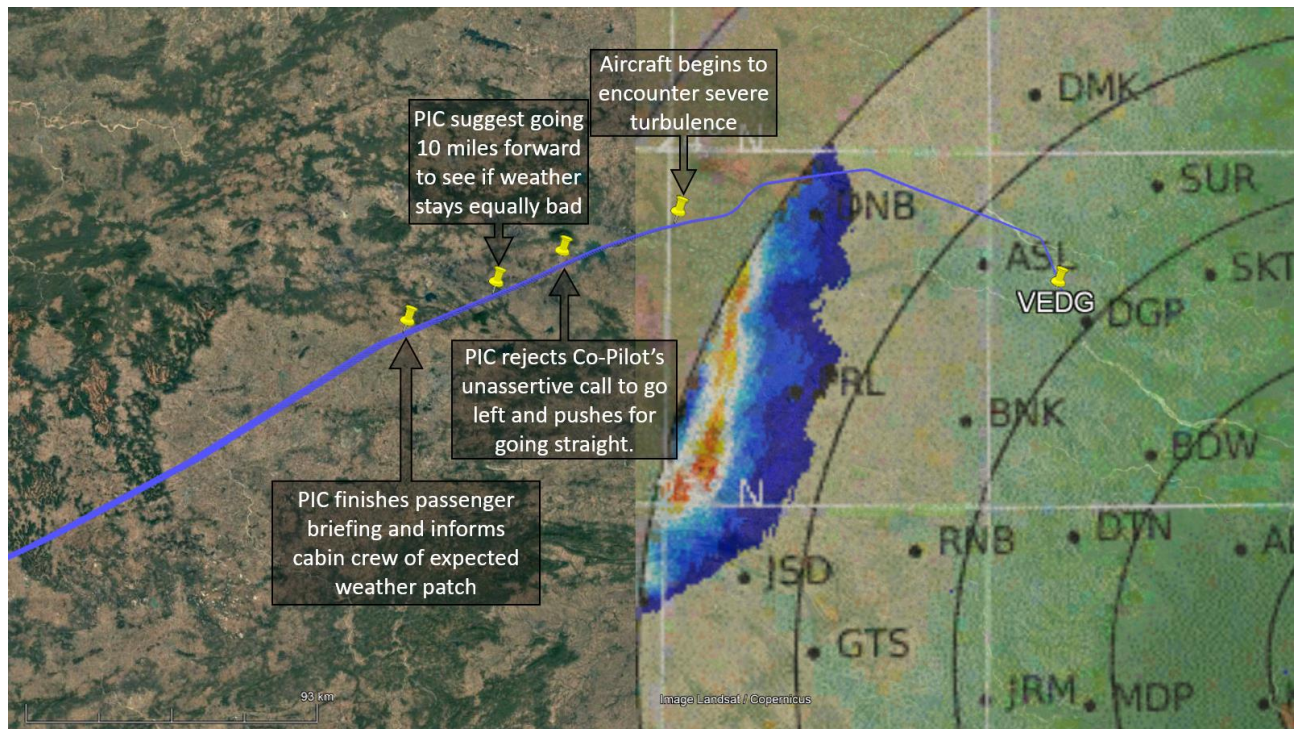
Figure 14

Later at about 1325 UTC, after advancing about 10 NM, the co-pilot makes an unassertive suggestion to go left, however, the PIC is heard saying “I DON’T THINK ***ITNA BURA HONA CHAHIYE (IT WILL BE THIS BAD)*** YOU SAY IF YOU SAY SO I WILL TURN LEFT.” These conversations indicate that the weather radar was functional and the crew anticipated a strong weather patch in their path. They considered the weather to be bad enough. However, they decided to penetrate the weather another 10 NM before making a clear call to deviate or divert.

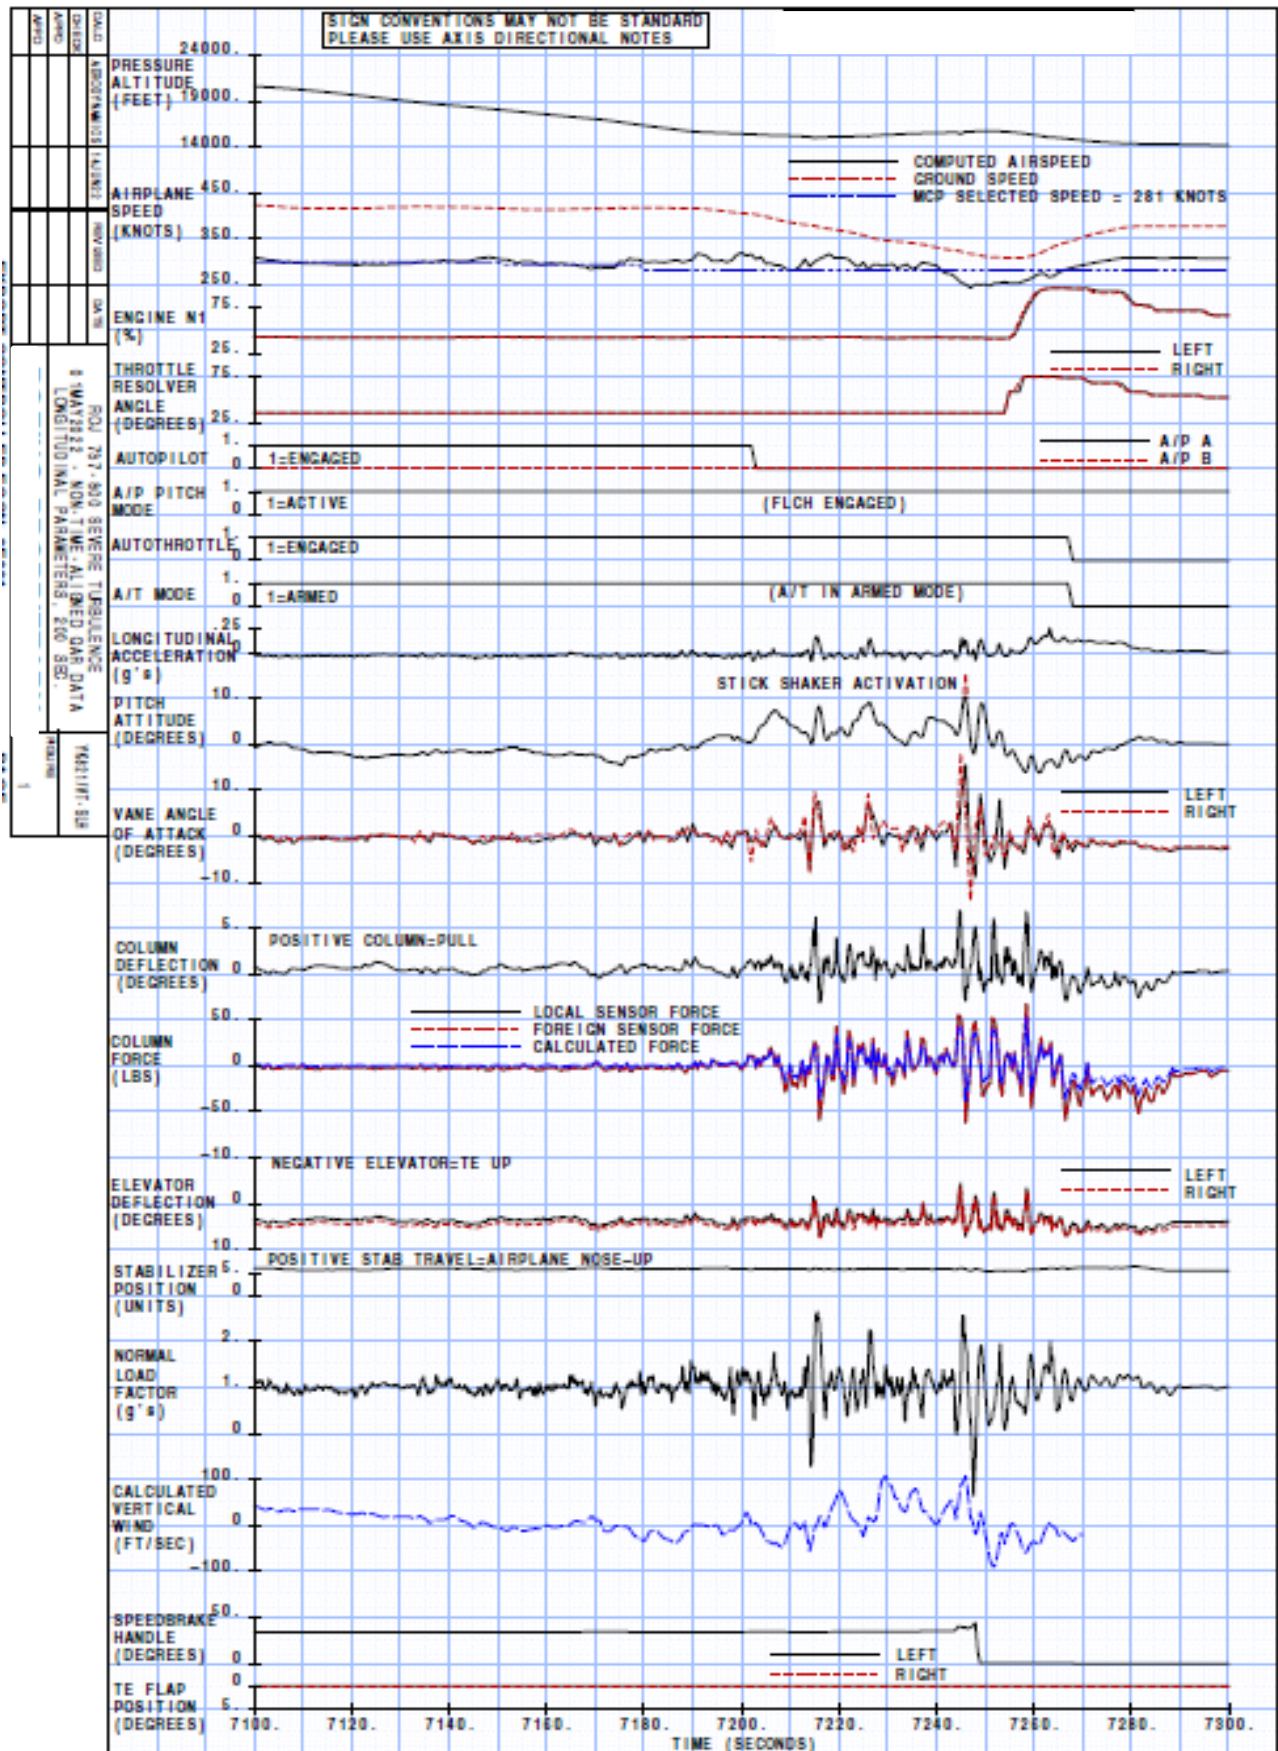
Figure 34

The QAR data show the airplane on descent at approximately 20,000 feet pressure altitude on a magnetic heading of approximately 76 degrees (Figures 34 and 35). The early portion of the presented QAR data, before time 7200 seconds, show stable flight with some turbulence (based on increased fluctuations in the acceleration data, air data parameters, and control deflections). The autopilot and the autothrottle were both engaged (Figure 34). The autopilot pitch mode was Flight Level Change (FLCH), and the autothrottle was in the armed mode. The speedbrakes were also deployed as the speedbrake handle was at approximately 40 degrees. During this period, the calculated vertical winds remained within -40 fps (downdraft) and +40 fps (updraft).

Pitch attitude was nose-down on average (maximum of 3 degrees) as the airplane continued to descend, and the computed airspeed was approximately 280 knots. Longitudinal acceleration variations were between -0.01 and +0.05 g's relative to the steady state average value (Figures 34 and 36). Lateral acceleration was between -0.1 and +0.1 g's (Figures 35 and 37). Control wheel deflections remained between -18 and +18 degrees (Figure 35). These deflections were likely at least partly the result of the wheel being back-driven by the autopilot.

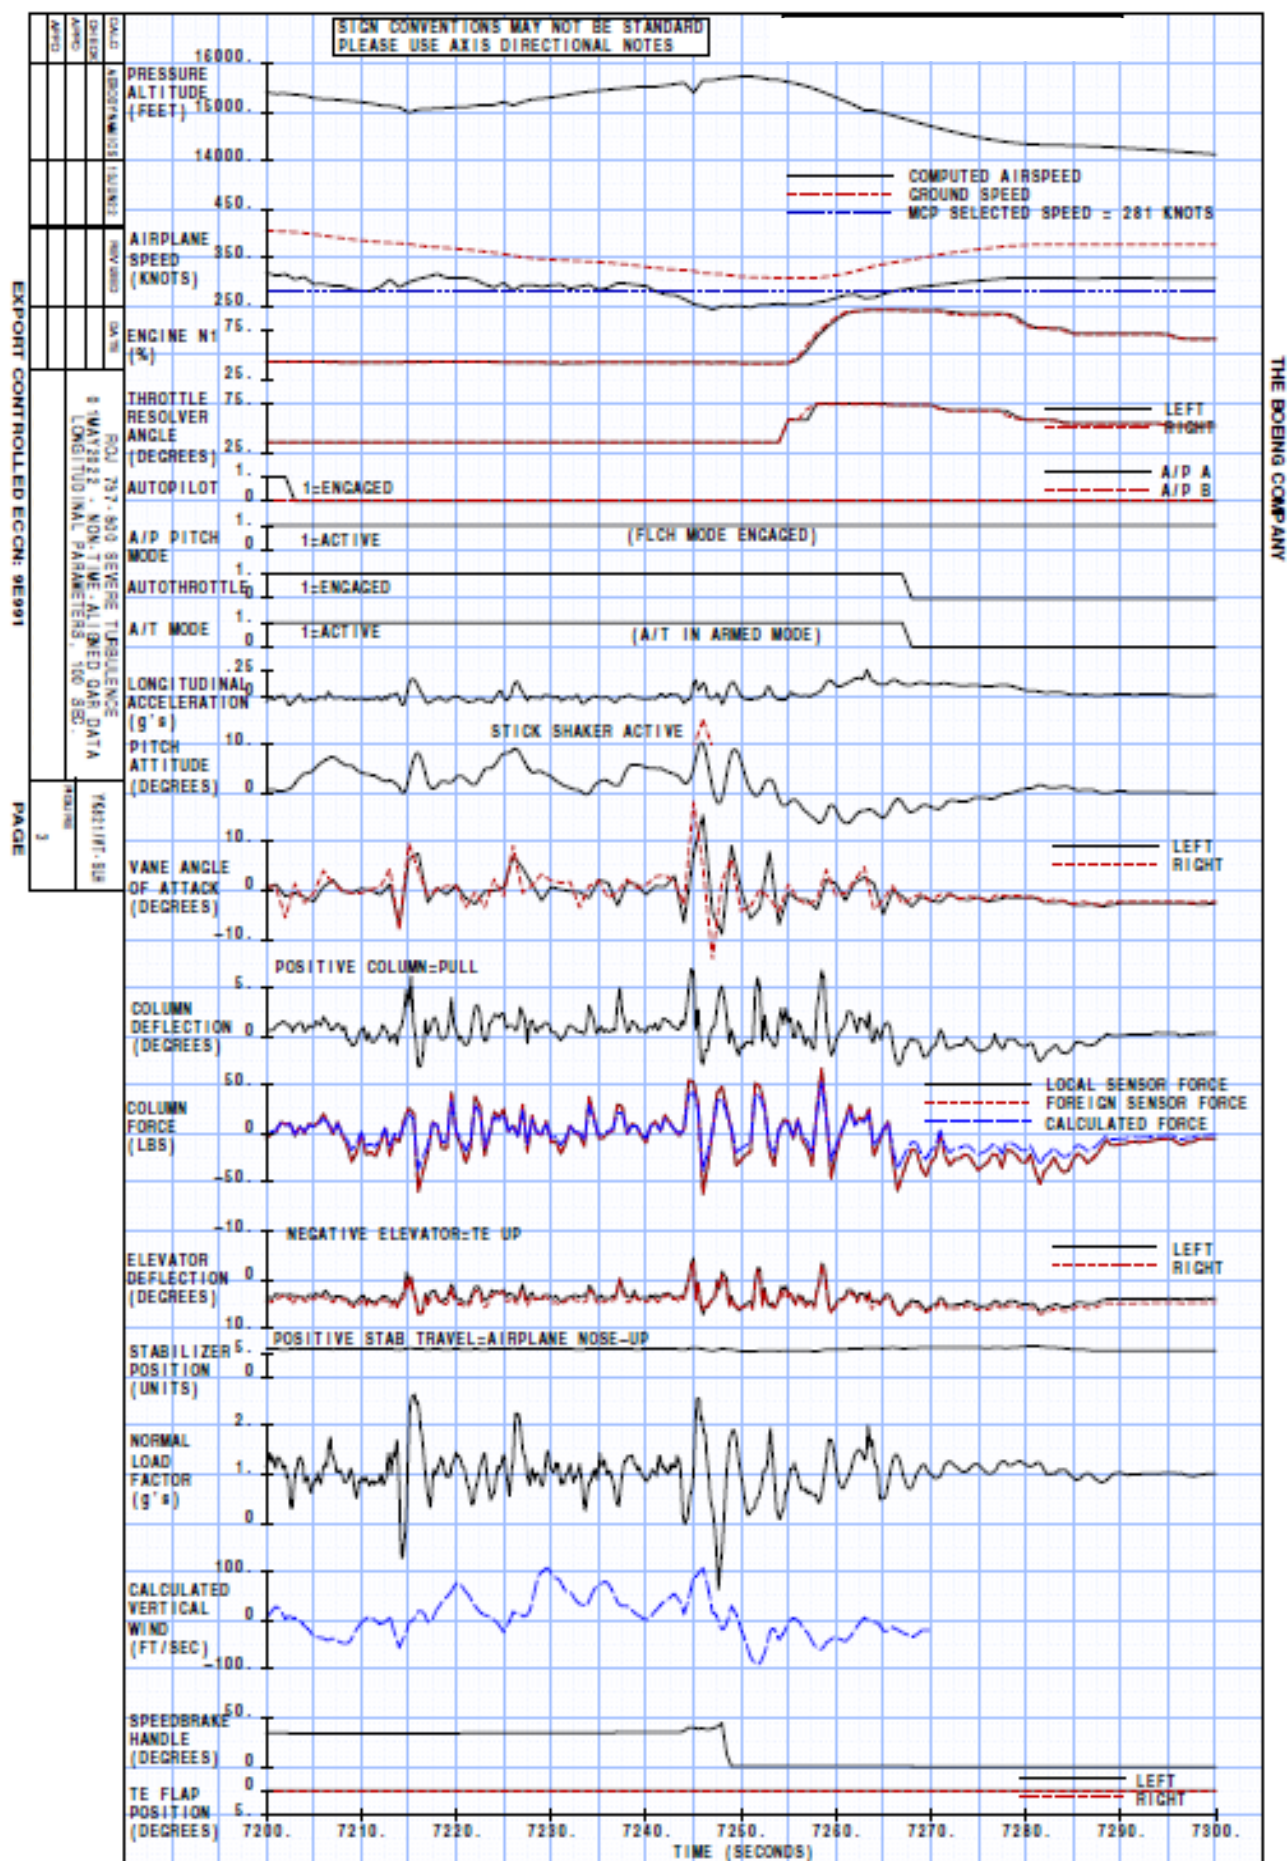
Figure 36

After time 7210 seconds, the airplane began to experience greater positive and negative calculated vertical wind gusts and larger variations in normal load factor (Figures 36 and 38). Over the next 60 seconds, normal load factor cycles between g-levels of -1.3 and +2.6 occurred. During this time, calculated vertical winds were between -91 fps (downdraft) and +109 fps (updraft). Column inputs became more frequent and larger, between -3.2 (push) and 6.9 degrees (pull). Calculated column force ranged between -30 pounds (push) and +50 pounds (pull).

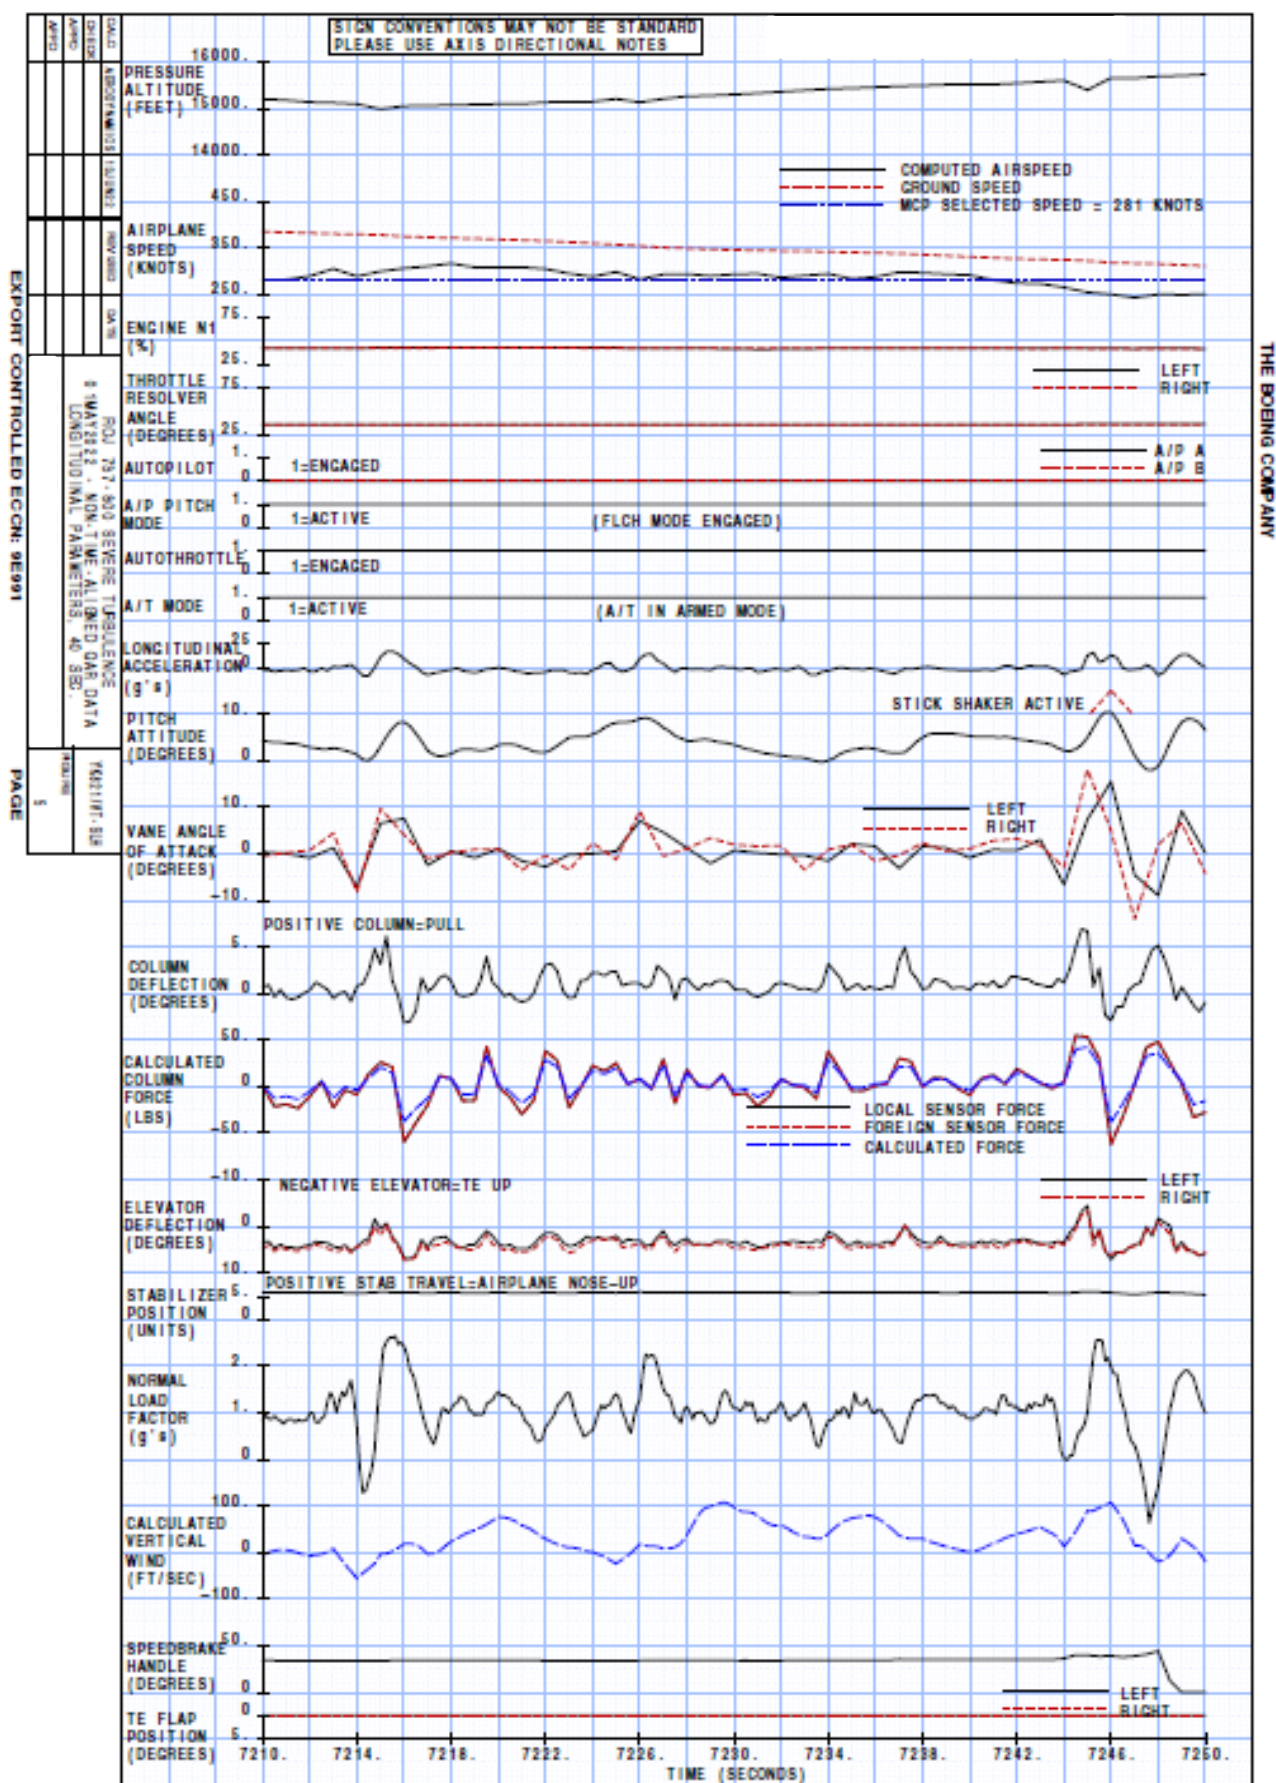
Figure 38

The largest excursion in normal load factor occurred at time 7246 seconds (Figure 38). Over 3 seconds, the normal load factor changed from +2.6 g's to -1.3 g's. During this period, the stick shaker activated for at least 1 second. Around time 7220 seconds, airplane heading began to deviate to the left of the Mode Control Panel (MCP) selected heading and eventually changed approximately 50 degrees to the east over a period of 40 seconds, consistent with the varying bank angle that was to the left, on average (Figures 37 and 39). Later at time 7310 seconds, the heading eventually returned to the original course. The DFDR data was used to create flight path on a satellite map and various events were plotted on the map.
