**Final Investigation Report on accident involving Cessna 172S aircraft  
VT-CHP belonging to M/s Chimes Aviation Academy at Guna airport,  
Madhya Pradesh on 06 March 2024.**

**Aircraft Accident Investigation Bureau  
Ministry of Civil Aviation  
Government of India**

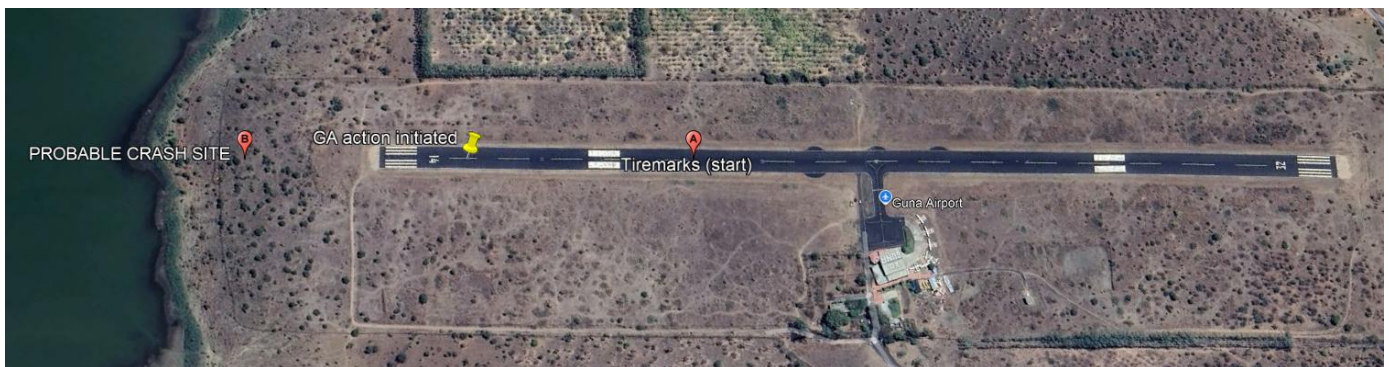
**Figure 2. Aircraft touchdown point, Go-around initiated and Crash Site**

Before joining the downwind leg, student pilot commenced one orbit. After completing the orbit, aircraft flew straight for about 0.5 nm, made a 90° left turn at an altitude of 844 ft to join the downwind towards Runway 32. Based on the tire marks and analysis of data, retrieved from both ECU as well as SD card, crew action and aircraft position superimposed on the google map are shown below:

Post accident, measurements of tire marks revealed following about the aircraft landing. Aircraft flared for approximately 2028 ft before touching down slightly right of the centerline. Subsequently, heavy brakes were applied for approximately 08 seconds as tire marks were prominently visible on the runway and this braking action assisted in deacceleration of aircraft speed up to 32 knots within 556 feet of runway (Refer Fig: 6). The tire marks further changed course to the left and continued onto the runway slope before they again changed their course to right near runway marking 14 (see Figures 3 and 4).

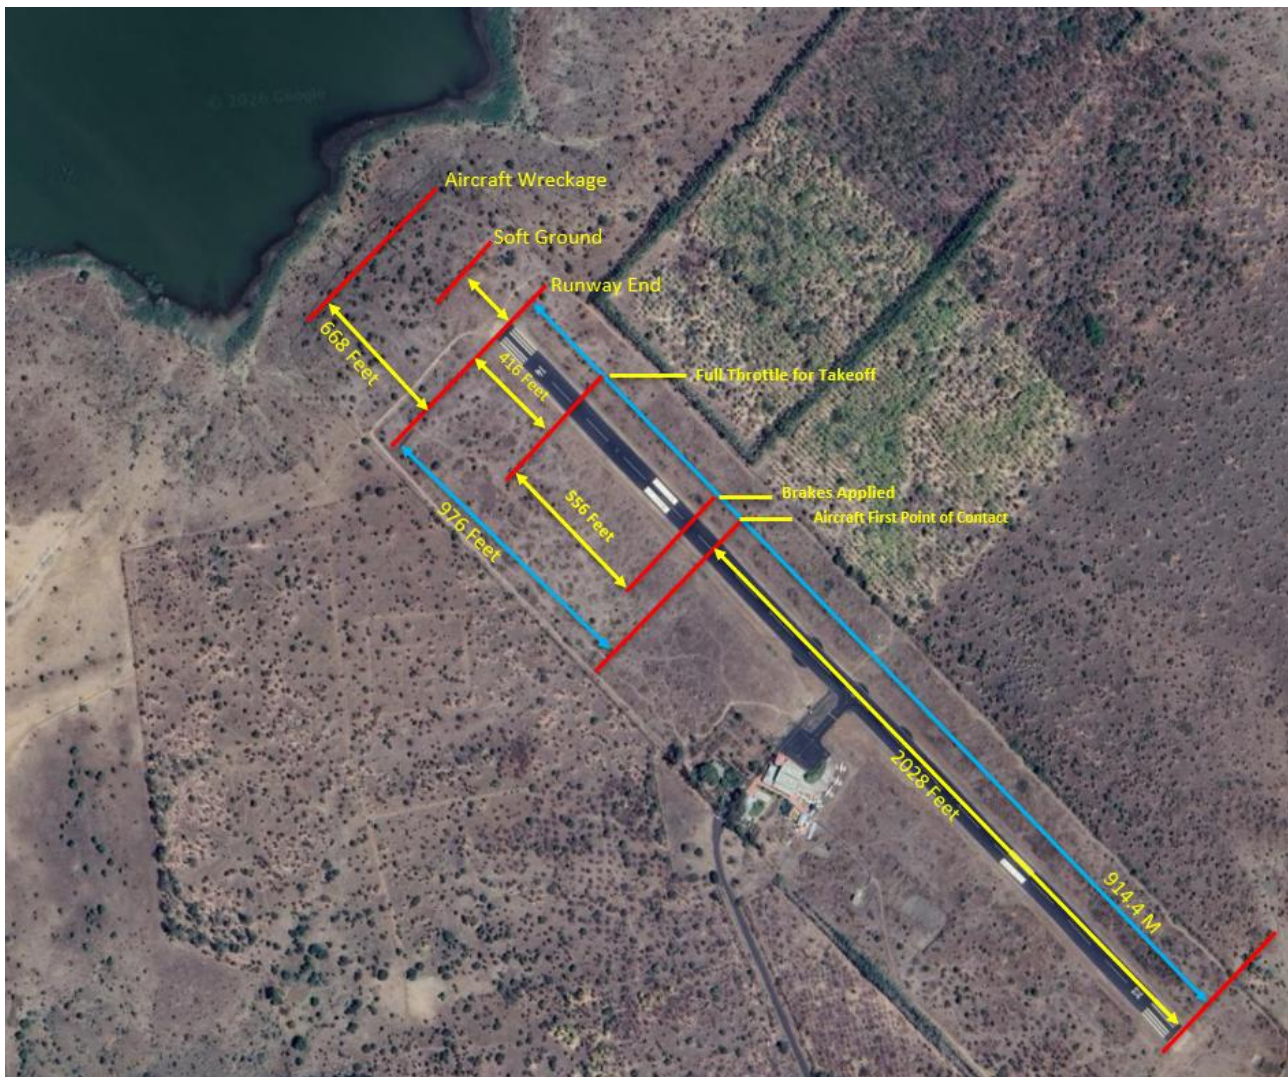
**Figure 7. Projection of aircraft distance at different locations along the runway**

The aircraft's left main landing gear along with left wing collided with this tree which was approximately 10 ft in height.

No impact marks were observed on the aircraft fuselage other than on main landing gears and left wing's leading edge. After the impact, left main landing gear detached from the fuselage. It appears that to avoid the collision with the tree and make the aircraft climb; in fear Student pilot pulled the control column back. As the control column was pulled back instantaneously, aircraft pitch significantly increased and reached upto 13° in one second. Since the Student pilot was completely unable to make out the aircraft's attitude at all, aircraft lift suddenly dropped and it could not sustain the flight. As the tree acted as pivot at the time of impact, aircraft heading suddenly changed and thereafter, aircraft collided with the ground in left attitude resulting into detachment of left wing from attachment points due to impact load.

Aircraft finally came to stop on its left side resulting into right wing up in the air. All the three wooden propeller blades sheared off from root section after hitting on ground and this consequently resulted into engine shut down. Since the aircraft was resting on its left side, the left door could not be opened as there was insufficient space between the door and the ground. The right door present above the head area of Student pilot could not be opened by due to its own weight acting towards the ground. Consequently, the student pilot decided to evacuate from broken windshield area.

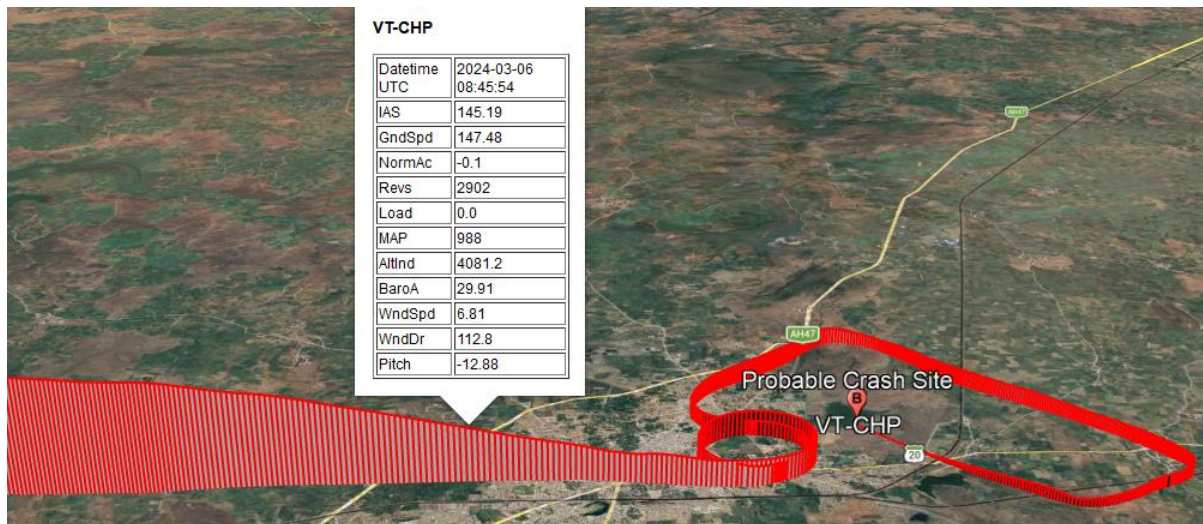
**Figure 15. Descent profile**

During cruise, aircraft maintained around 6000-6500 feet AGL. At **08:43:16**, TOD was initiated to join the circuit altitude. Garmin data showed that at **08:45:54**, when the aircraft was descending below 2500 feet AGL, aircraft descent rate and speed reached to 3011 fpm and 145 knots respectively whereas load recorded was zero.

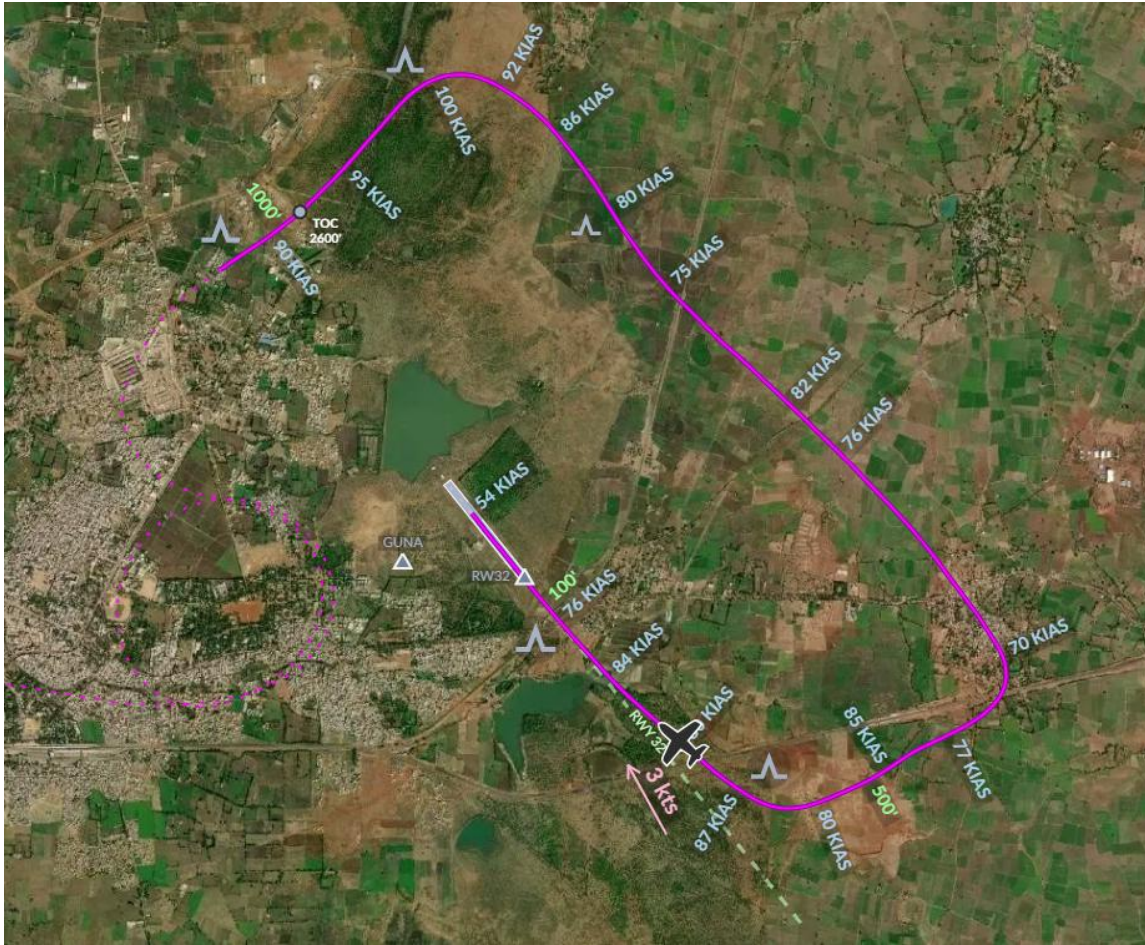
**Figure 16. Aircraft speed along circuit**

At **08:50:17**, the trainee joined the downwind leg at 780' AGL (2399.5 ft MSL) with the engine at 2947 Revs, a Load of 15.2%, and a MAP of 1144. Subsequently, the aircraft further descended to 576' AGL at **08:50:31** (2257.3 ft MSL), where power parameters increased to 3240 Revs, 48.4% Load, and 1611 MAP. On downwind, the aircraft altitude kept varying between 800 feet to 600 feet.

At **08:53:28**, after completion of the Base leg, the aircraft made a turn at 381 feet AGL (2017.7 ft MSL) to join the final leg using 3217 Revs, 51.9% Load, and 1697 MAP. However, a cut in approach was observed before the aircraft joined the Final leg. On the Base leg, the aircraft's descending altitude varied between 575 feet to 381 feet.

At **08:53:36**, the aircraft joined the final leg at 359 feet AGL (2019.6 ft MSL) with 3190 Revs, 52.6% Load, and 1702 MAP, when it was approximately 1 Nm away from the runway 32 threshold. After joining Finals, the aircraft started climbing once. At **08:53:43**, the aircraft reached approximately 488 feet (2111.4 ft MSL) while operating at 3067 Revs, 40.6% Load, and 1481 MAP. At this point, the aircraft was flying significantly higher than the standard 3° glide slope.

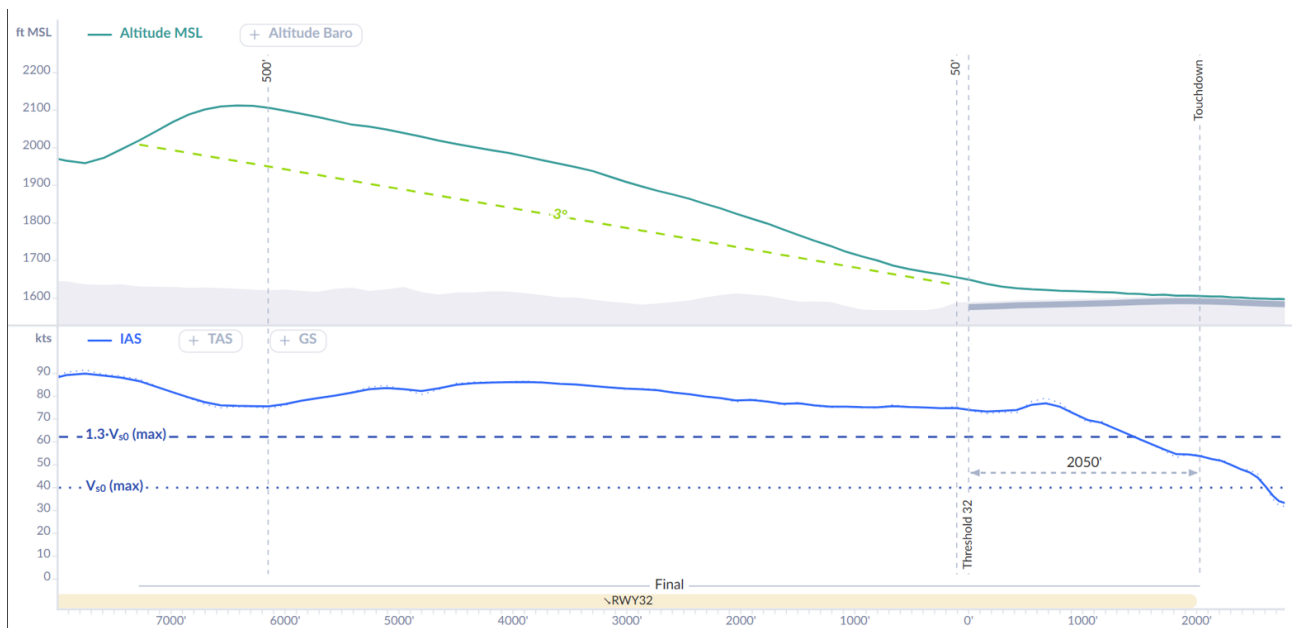
**Fig: Graphs showing Landing Phase of Accident Sortie**

At **08:54:20**, while approaching runway 32, aircraft speed was around 75 knots and its ROD reached 928 fpm when engine was running at 2471 Revs, 0% Load and 1029 MAP. Seven seconds later, the aircraft flew above the threshold at approximately 56 feet AGL (1647.9 ft MSL) with 2407 Revs, 0% Load, and 1024 MAP.

At **08:54:45**, the ground speed had dropped to 52 knots and the vertical speed became positive (+45.7 fpm), indicating the transition from flight to the ground rollout, with the engine at 1731 Revs, 0% Load, and 988 MAP. Further, at the start of the flare sequence, the aircraft was at an indicated altitude of 1,604.2 ft MSL. By the time of touchdown, the altitude had decreased to approximately 1,580 ft MSL. Subsequently, braking action was observed for 08 seconds and aircraft airspeed and ground speed reduced to 32 kts.
