## Contents

**Aircraft and Serious Incident details of Airbus A-320 Aircraft VT-ATF  
on 18 May 24**

## SYNOPSIS

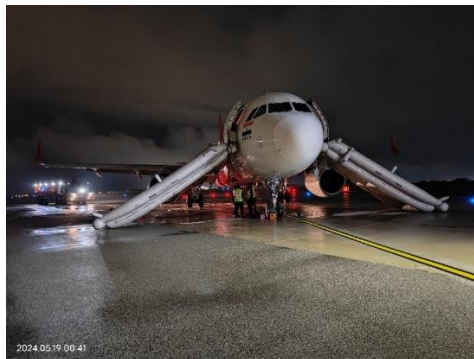
**Fig 9 Aircraft after landing and emergency evacuation, with all sides deployed**

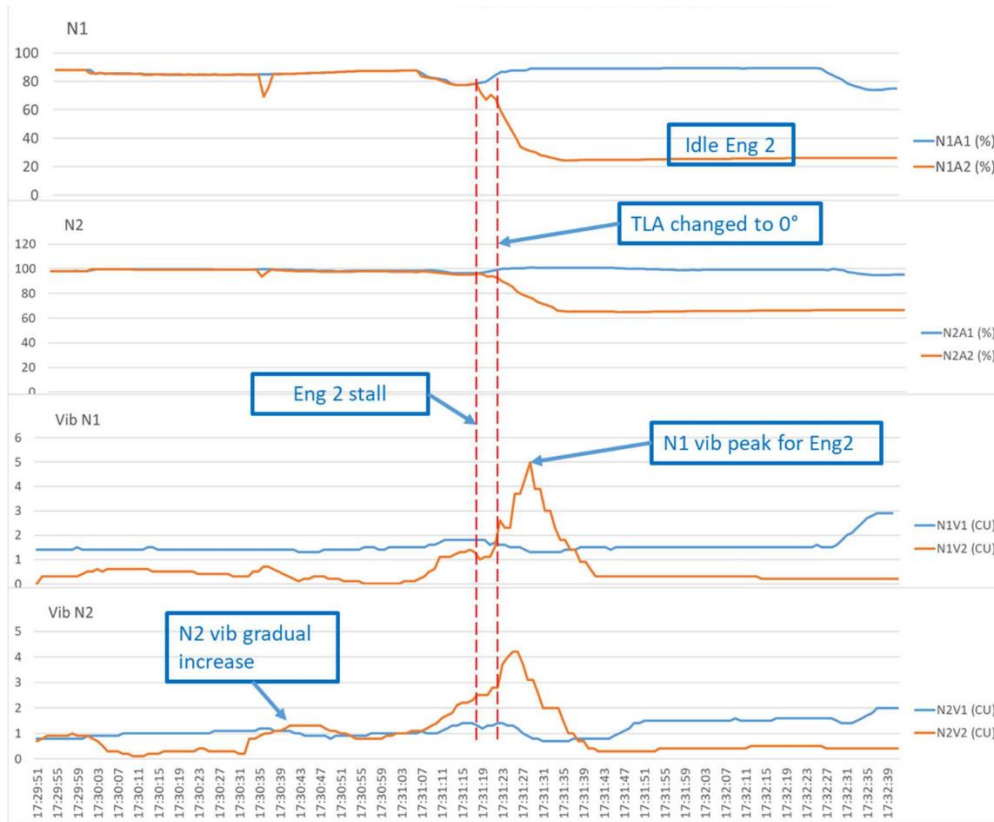
Figure 20

The ENG2 STALL and its associated master caution triggered in the cockpit (Fig20).

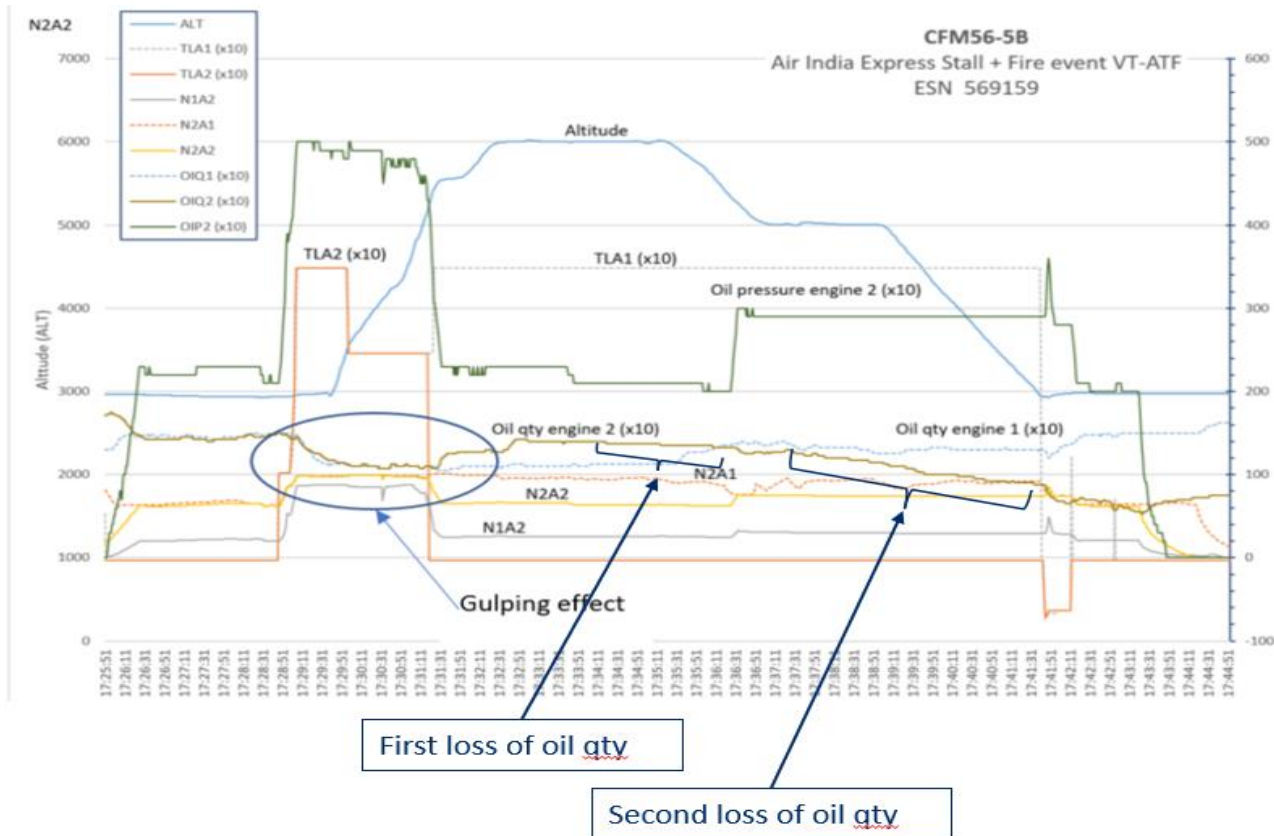
Figure 21

The FDR Plot above shows that both the stalls occurred shortly after during climb phase started. PFR indicates the Eng2 stall at 17:31 UTC which is coherent with the Flight data.

- Gulping effect from 17:28:11 to 17:31:11 when TLA is pushed from ground idle to TO/climb for around 2 minutes (Fig21).
- When TLA pulled to idle, oil level becomes near before TLA pushed to TO/climb at 13:32:51.
  - First loss of oil quantity, ~ 1quart in 2 minutes (between 17:34:31 et 17:36:31),
  - Second oil loss quantity, ~ 5 quarts in 4 minutes (between 17:37:31 et 17:41:51)
  - Loss of oil increasing from 17:41:21 and 17:43:31.

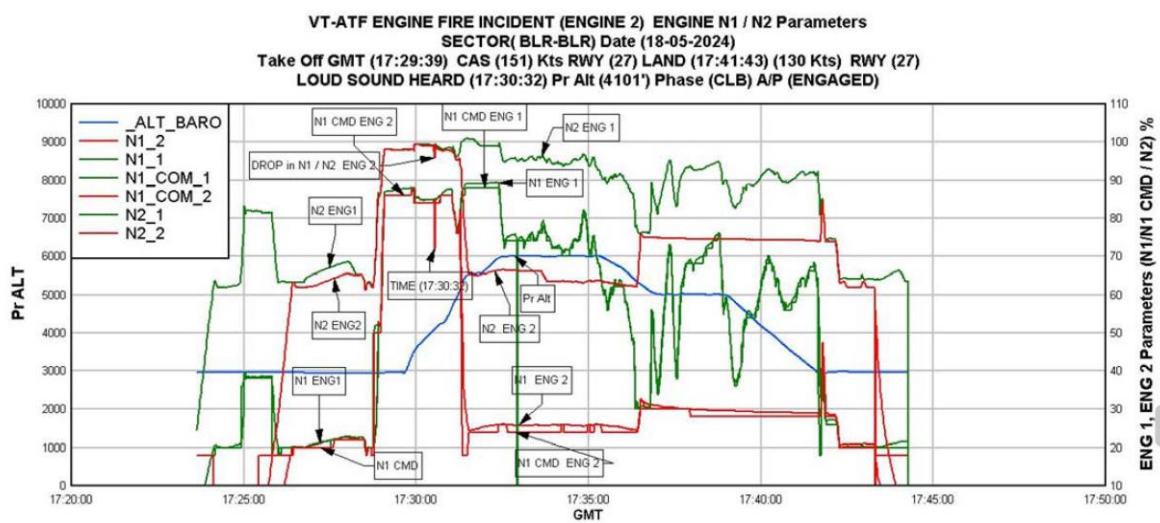
Figure 22

The plot was generated by OEM software to correlate with in-house readout. The parameters and events were correlated with PCMCIA Card reflecting vital parameters of the Incident (Fig22).

The crew reported engine stall in their statement post incident as well as the crew discussion recorded on the CVR. This fact could be corroborated with the FDR Data at time 17:30:33 the N2 rpm dropped from 99.06% to 93.75% and again came back to 99.63% at time 17:30:33 and 99.44% at time 17:30:34. This the most probable point of event.

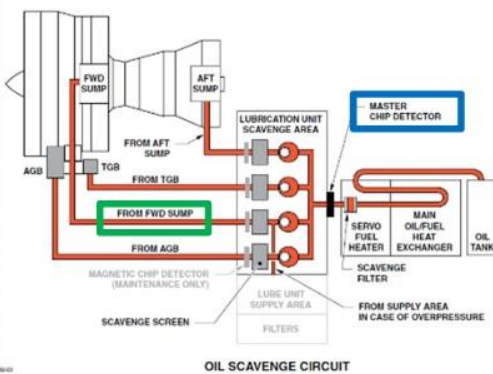
OIL SCAVENGE CIRCUIT

MCD (Magnetic Chip Detector) removed and checked as per AMM 79-00-00-281-002-A found chips. Scavenge screens plugs checked for particles as per AMM 79-21-10-000-007-a. Observed particles from no: 3 scavenge screen plug (Fwd sump) (Fig24,25,26,27 &28).

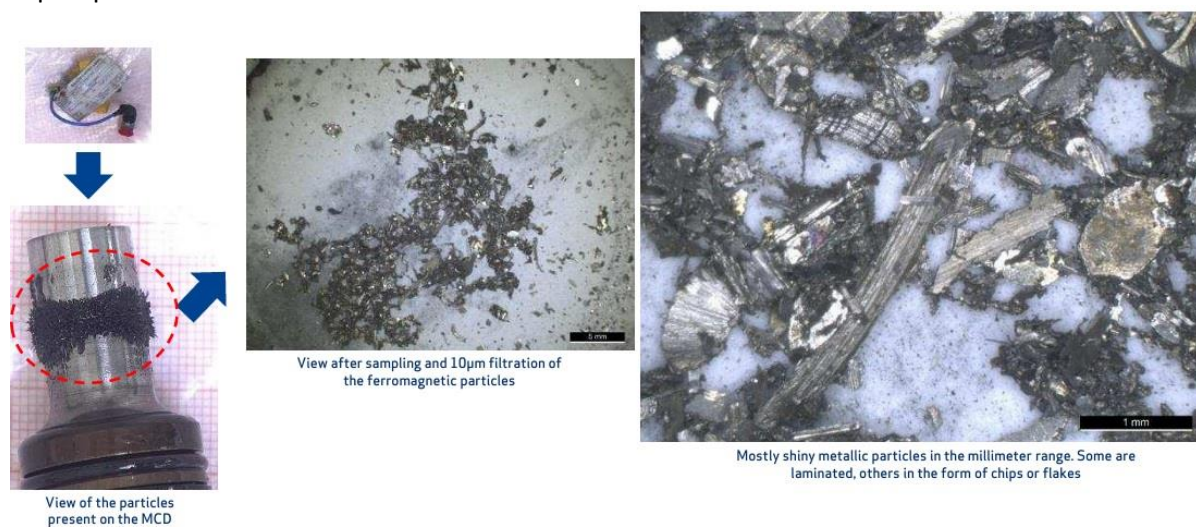
Figure 26

FWD sump inspection:

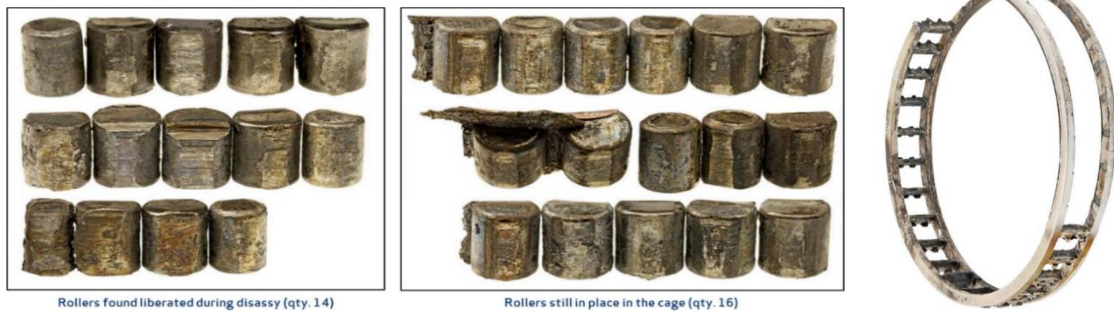
**Figure 40**

Rollers have been removed at Safran’s laboratory before inspection (Fig40).

No metallurgical anomaly on rollers was found due to lack of lubrication. Local overheating was observed, following #4 bearing failure (Fig41).

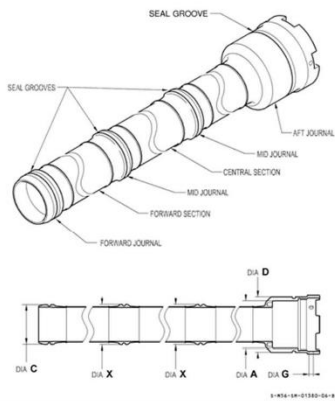
Figure 49

The repair agency responsible for the CVT was BP Aero. Accordingly, follow-up actions were initiated to verify whether similar repair non-conformances may have been exported to other engines in the fleet. During this review, multiple non-conformances related to Repair R007 and Repair R010 (fig 49 & Fig 50) were identified

Locating Hole (Dia G) - Insp *SUBTASK 72-55-06-220-097*  
Repair - R007 - Weld Build up
