**Final Investigation Report on Serious Incident of Airprox between A321
aircraft VT-IUO (IGO2113) and A320 Aircraft VT-ISO (IGO2206) operated
by M/s Indigo at IGI Airport, Delhi on 17.11.2023**

**AIRCRAFT ACCIDENT INVESTIGATION BUREAU
MINISTRY OF CIVIL AVIATION
GOVERNMENT OF INDIA**

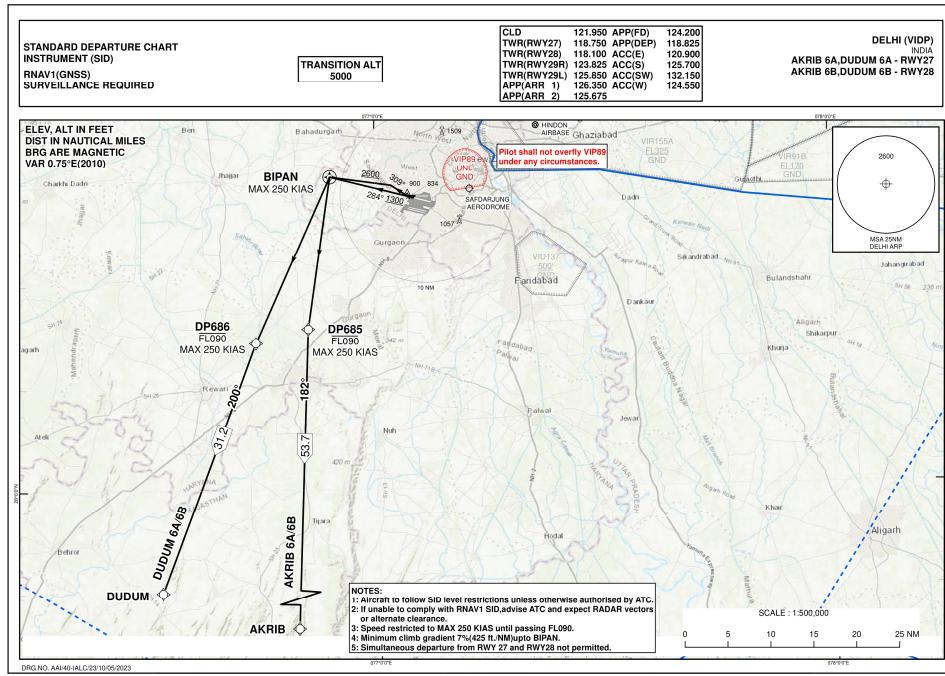
Clearance was requested by IGO2113 at time 063035 Hrs. At time 063359 Hrs clearance was transmitted “AKRIB 6A /Flight Level 70” (Refer Fig:8 of Annexure). The same was acknowledged by aircraft at time 063653 Hrs.

Figure 8 SID AKRIB 6A RWY27 given to IGO2113)

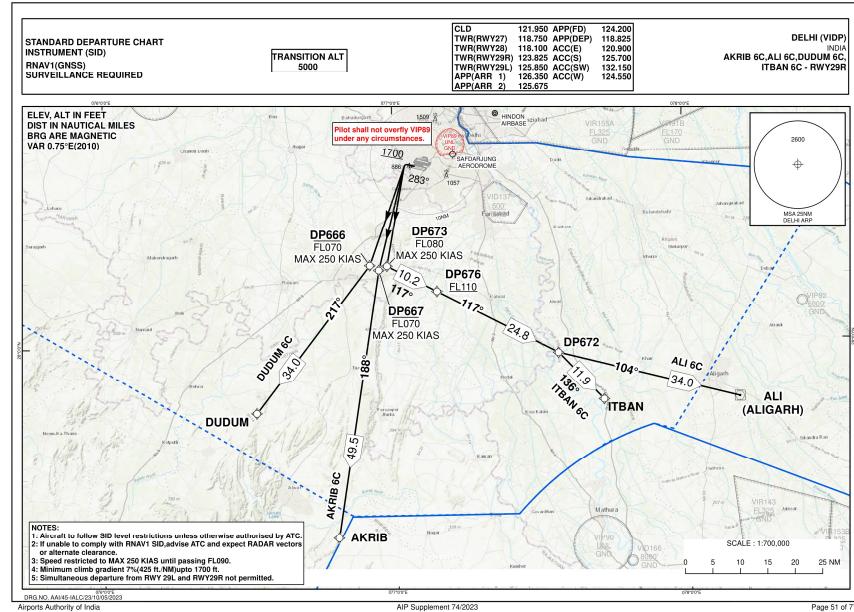
Figure 9 SID ITBAN 6C given to IGO2206
