**Final Investigation Report on Serious Incident of Runway Undershoot involving  
M/s Alliance Aircraft VT-RKF on 08.10.2024 at Bhubaneswar Airport**

**Aircraft Accident Investigation Bureau  
Government of India  
Ministry of Civil Aviation**

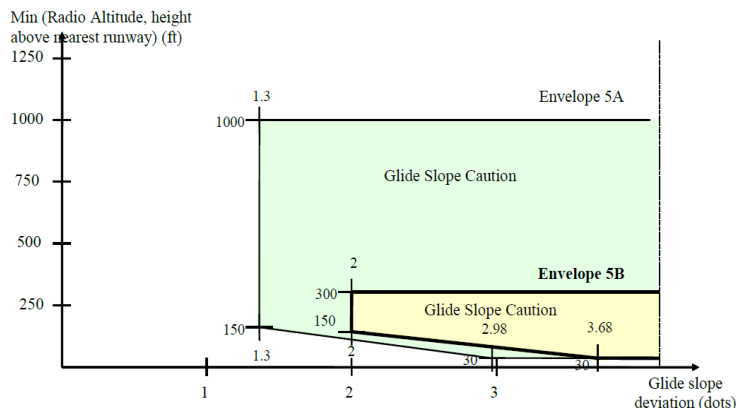
**Figure 14. Actual Mode 5 Envelope for Aural Warning**

As per DFDR report of occurrence involved Aircraft, at 100ft RA, the glide deviation was -2 DOTS. However, during the CVR playback, no glideslope aural alert was heard in the cockpit. Therefore, in order to confirm whether any Mode 5 Glideslope warning was triggered by the T2CAS during this event. So T2CAS computer has removed and sent to the OEM facility for further analysis.
