**Final Investigation Report on Serious Incident: Airprox
Between
Turkish Airlines, Airbus, A330-223F, Türkiye, TC-JOO
and
Flydubai, Boeing, B737 MAX 8, United Arab Emirates, A6-FKR
On
30 August 2025 in Mumbai FIR (INDIA)**

**AIRCRAFT ACCIDENT INVESTIGATION BUREAU
MINISTRY OF CIVIL AVIATION
GOVERNMENT OF INDIA**

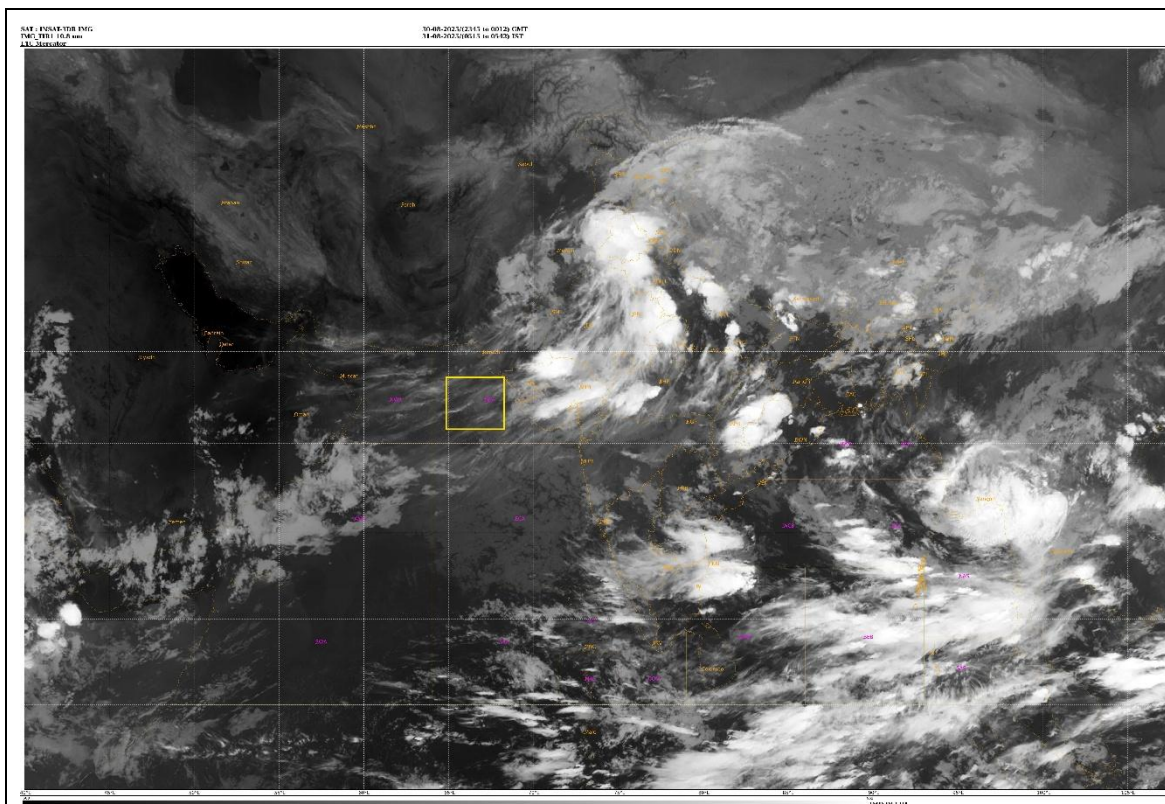
Yellow box marked on the Satellite image represents the approximate location at which the incident occurred. There were no significant convective clouds present around the location of the incident. There were some patches of medium cloud i.e Altocumulus clouds.

Fig:03 Satellite Image from Aviation Meteorological office, Mumbai. Yellow Box marked represent approximate location of the Latitude 20°24.56'N, Longitude 65° 13.32' E where the incident occurred.
