**FINAL INVESTIGATION REPORT ON
SERIOUS INCIDENT INVOLVING
M/s AIR ARABIA A320 AIRCRAFT A6-AOT
WHILE OPERATING SECTOR CHITTAGONG- ABU DHABI ON 6 JUNE 2022**

**GOVERNMENT OF INDIA
MINISTRY OF CIVIL AVIATION
AIRCRAFT ACCIDENT INVESTIGATION BUREAU**

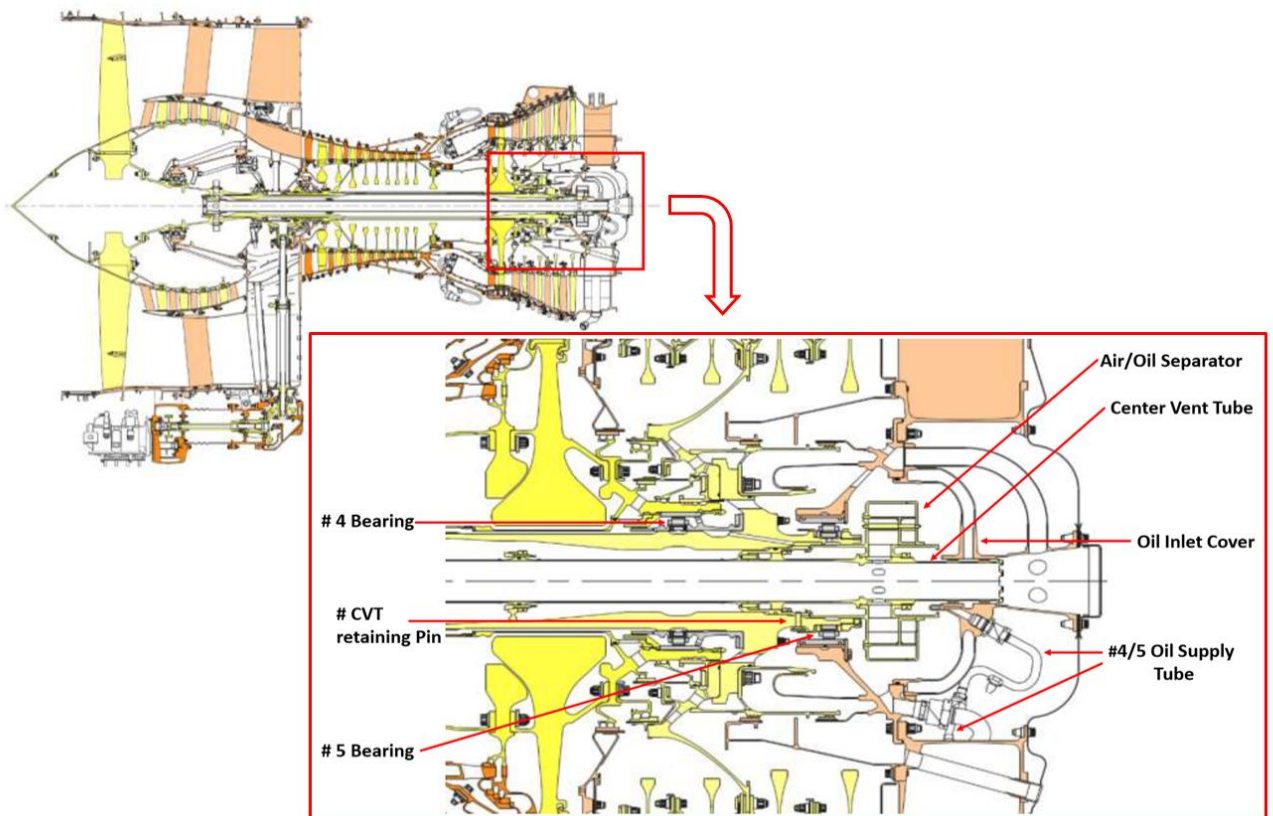
Figure 5

The strip examination was carried out at OEM's facility in Morocco, and detailed examination of various components and modules were carried out later at Labs. The figure 5 below shows cross section of Engine and aft sump area.

1. HPT Blades were found with heavy rubbing and the HPT rear shaft was damaged.

2. LPT nozzle guide vanes were observed with distress signs. Vanes from 6 to 8 o'clock position were severely burnt. LPT 2 Nozzle guide vanes were fully burnt.

The correlation of damages on LPT stator vanes with Fuel Nozzle's flow distribution or observations on Combustion Chamber does not indicate any significant linking. The distress and damages were likely caused due to excessive fuel flow during engine roll back.

3. Rubbing marks were found on LPT shaft.

4. LPT #4 bearing was found damaged. No. 4 roller bearing was subjected to detailed examination. The failure was characterized by the heavy metallization of the inner and outer ring tracks, rolling elements and cage with the presence of melted deposits of metal and silver, a dull grey aspect of the rollers as well as an important diameter reduction for some of the rollers and the absence of prior fatigue cracking-rupture of the cage spacers which allow to rule out a degradation mode by primary spalling of the track(s) and/or the rollers.
