Final Investigation Report
on
Serious Incident involving M/s InterGlobe Aviation Limited,
Airbus A320 Aircraft, VT-IFM on 28 October 2022

Government Of India
Ministry of Civil Aviation
Aircraft Accident Investigation Bureau

On 28 October 2022, M/s InterGlobe Aviation Limited's A320 aircraft, bearing registration VT-IFM, while operating a scheduled flight (6E-2131), Delhi to Bengaluru was involved in an engine failure occurrence.

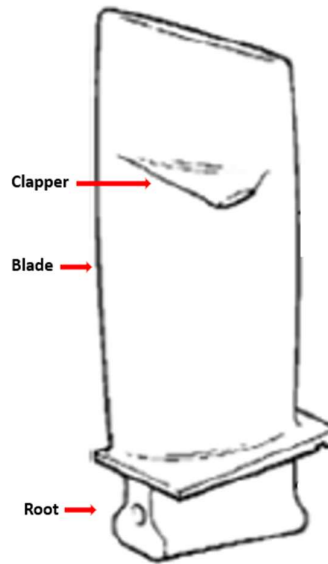
Figure 10: HPC 3rd Stage Blade

HPC 3rd Stage is the very first stage of HPC section. It contains total 31 rotor blades. The HPC 3rd stage blades are made up of titanium alloy Ti-6Al-4V. The part no. of HPC 3rd stage blades of the event engine is 6A8688.

In 2005, clapper wear was identified as a major in-service issue affecting the HPC 3rd Stage Blade. This degradation led to rotor blade fractures. The fracture of the 3rd Stage HPC rotor blade ultimately resulted in engine failure. To address this issue OEM has issued a SB 72-0487. In addition to this OEM has also added inspections for clapper of the HPC 3rd stage blade after FOD or bird strike into its Aircraft Maintenance Manual (AMM Task 72-00-00-210-012).

Wear of the abutment faces of the HP Compressor Stage 3 Blade clappers may occur. In severe cases this can lead to premature fatigue deterioration of the blade. The problem has been attributed to a combination of high stresses and differential movements between adjacent clappers.
