**Final investigation report on accident involving Diamond DA-40 aircraft VT-FGC
belonging to M/s IGRUA
on 13 June 2022 near Fursatganj, Uttar Pradesh.**

**Aircraft Accident Investigation Bureau
Government of India
Ministry of Civil Aviation**

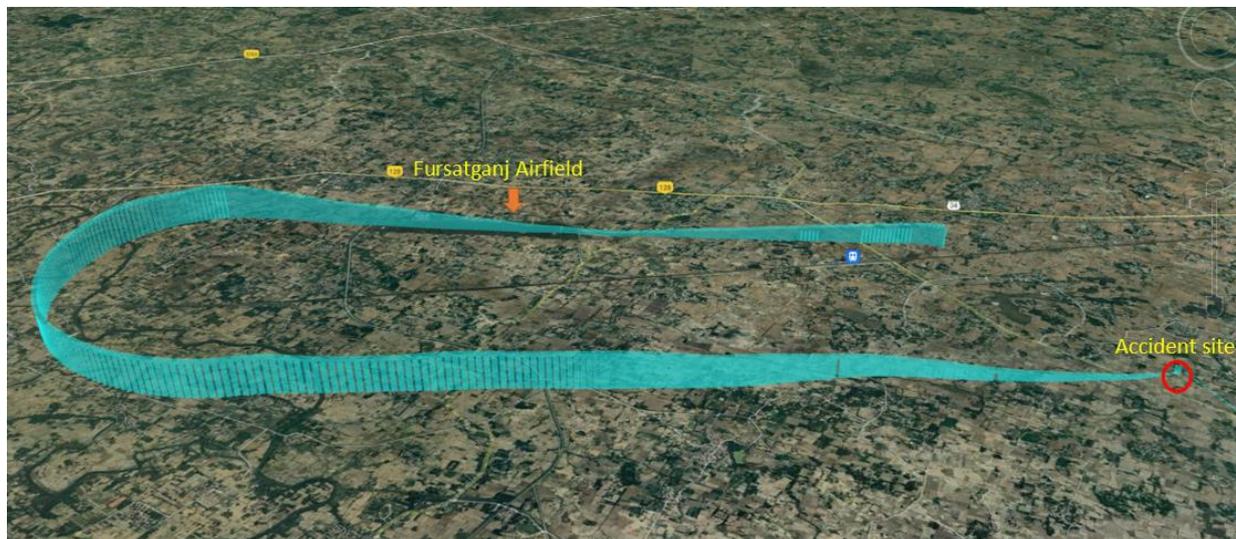
Figure 9: Aircraft profile (Final leg)

After ATC instruction, the student pilot initiated a go-around and the path followed by the aircraft during the final leg is shown in Figure No. 9. While the aircraft was about to join the base leg, the trainee observed a sudden drop in engine RPM. Consequently, the aircraft also started losing height continuously. A slight deviation towards right was observed as the aircraft started approaching forced landing site.

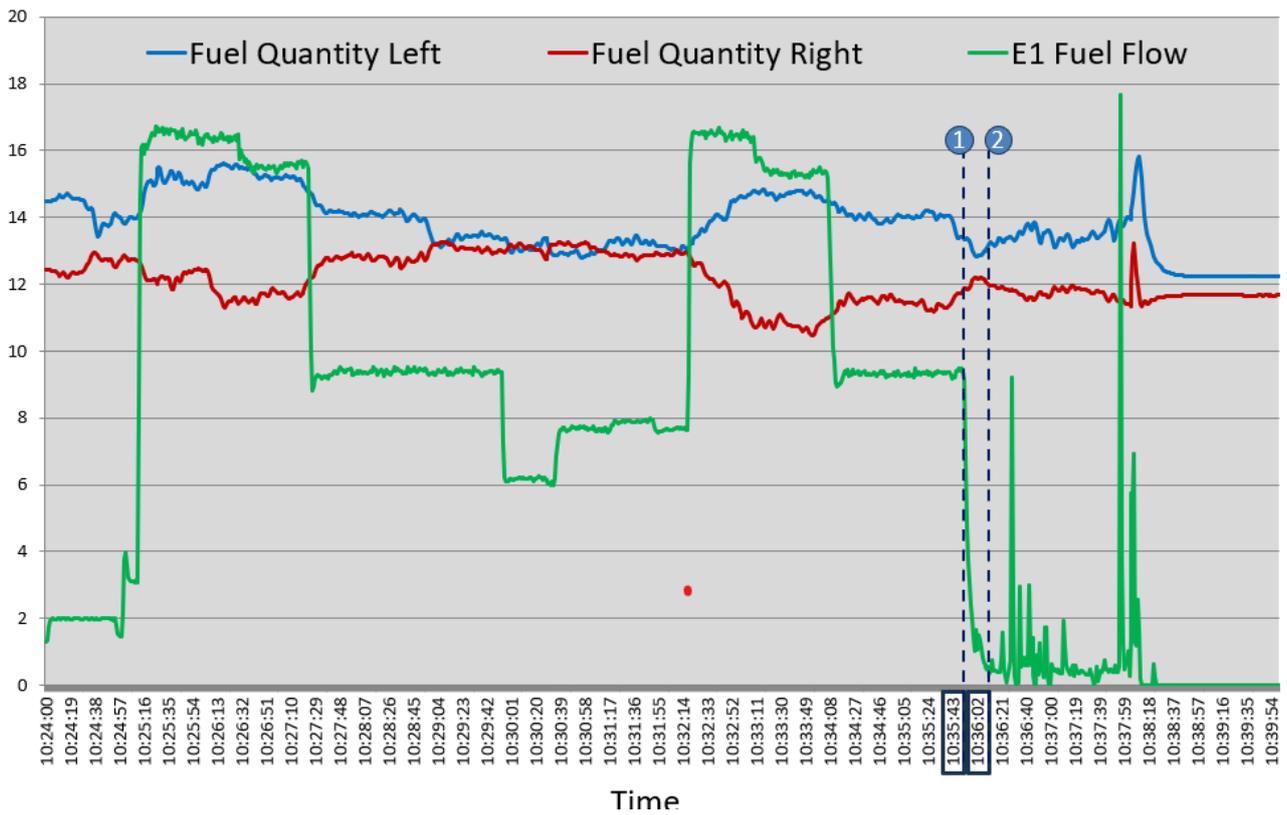
Figure 18: Graph 3 (Flight Time versus Fuel Parameters)

1. Fuel flow suddenly dropped from 9 gal/hr to 1 gal/ hr.
2. Between point 2 and 3, Fuel flow was not uniform and two peaks were also observed

- A1. MAP initially increased from 21 psi and reached upto 26 psi
 A2. Suddenly dropped from 26 psi to 7 psi
 A3. MAP again reached upto 27 psi and remained constant thereafter till the aircraft collided with trees. MAP did not varied as per the fuel flow readings.

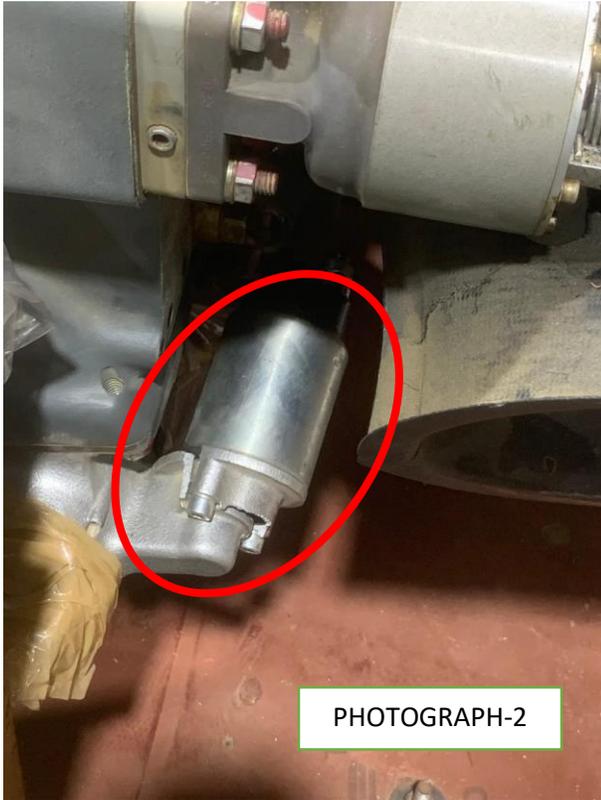
PHOTOGRAPH-2

1. All the accessories were found at their mounting locations.
2. Starter, though in its place on engine the top portion found broken (Photograph-2).
3. The Fuel Injector Throttle could not be moved. (Photograph-3).
4. Fuel pump found broken. (Photograph-4).
5. Rotation of the crankshaft in as received condition found satisfactory.
6. Dent noticed on No.2-cylinder induction tube. (Photograph-5)

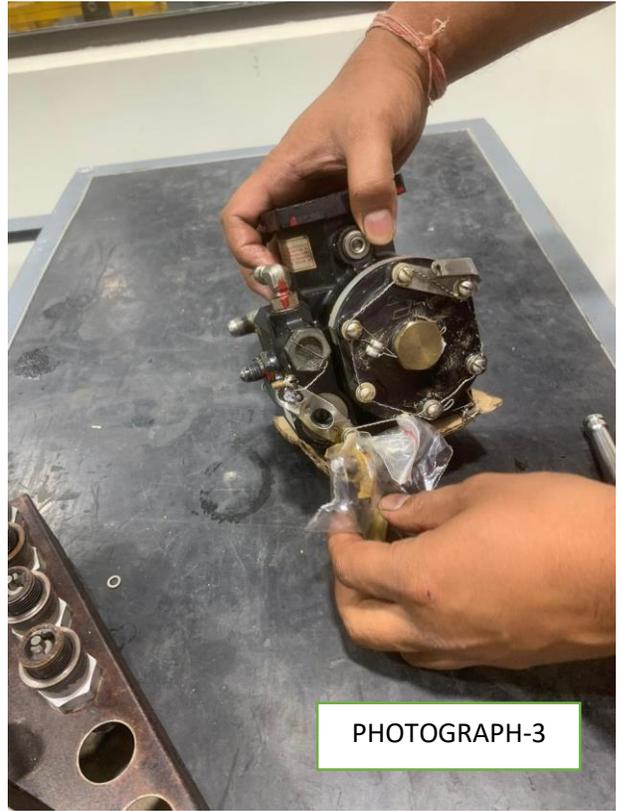
PHOTOGRAPH-3

There is no damage observed on the internal parts of the engine. The external damages observed on parts and accessories were due to impact of the engine. The Carbon deposits noticed on the piston dome is a normal as observed on engines received for overhaul. The Stuck fuel injector throttle lever and fuel injector mixture shaft broken could be due to impact.

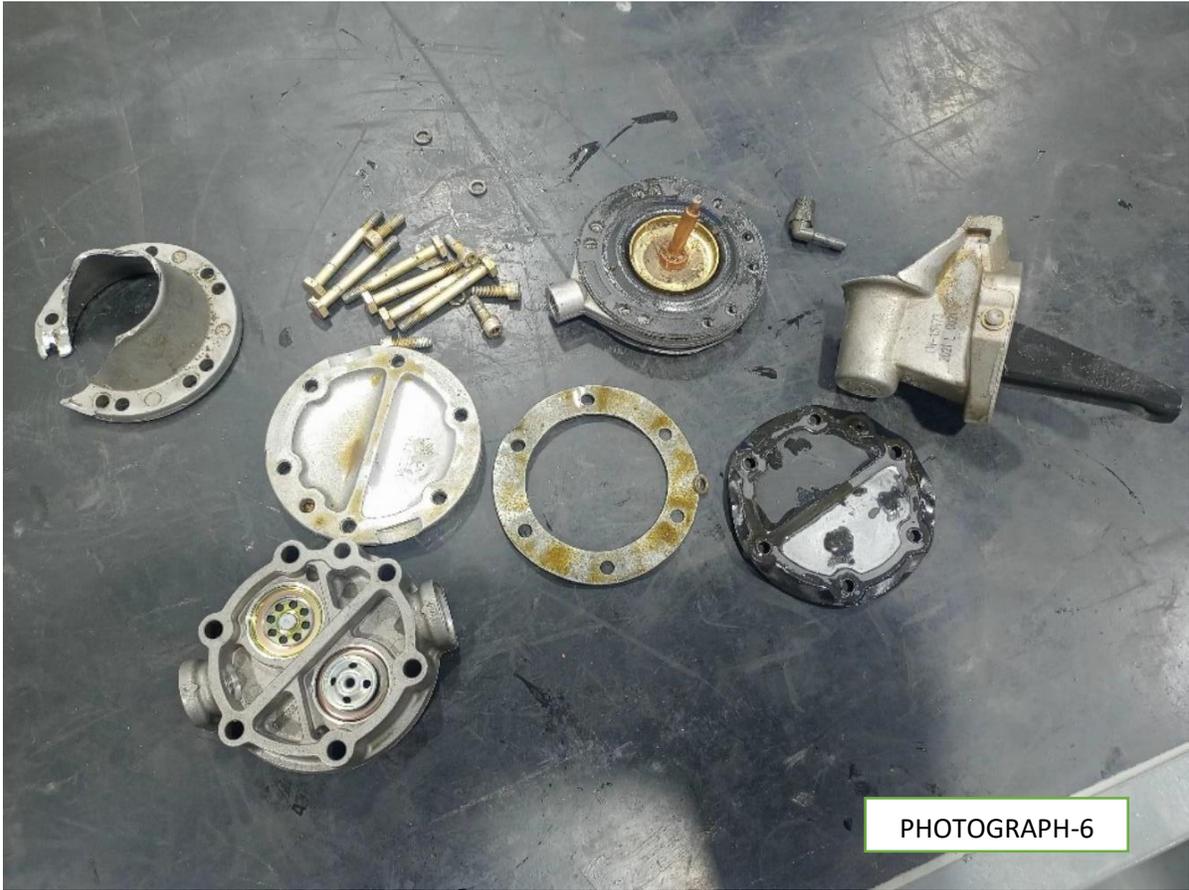
PHOTOGRAPH-6

- a) Flow divider external condition was good and checked for flow of fuel on a rig found satisfactory.
- b) All fuel lines conditions were found satisfactory.
- c) Fuel pump dislodged form its mounting location and broken. Fuel pump disassembled in detail no abnormalities was noticed. (Photograph-6).

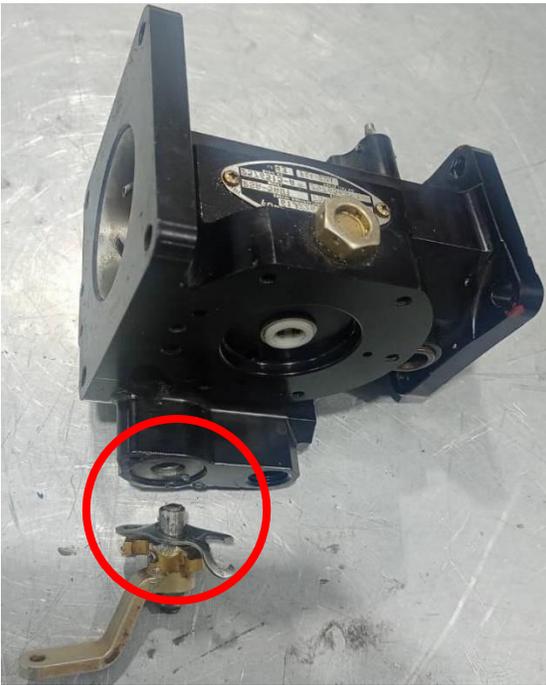
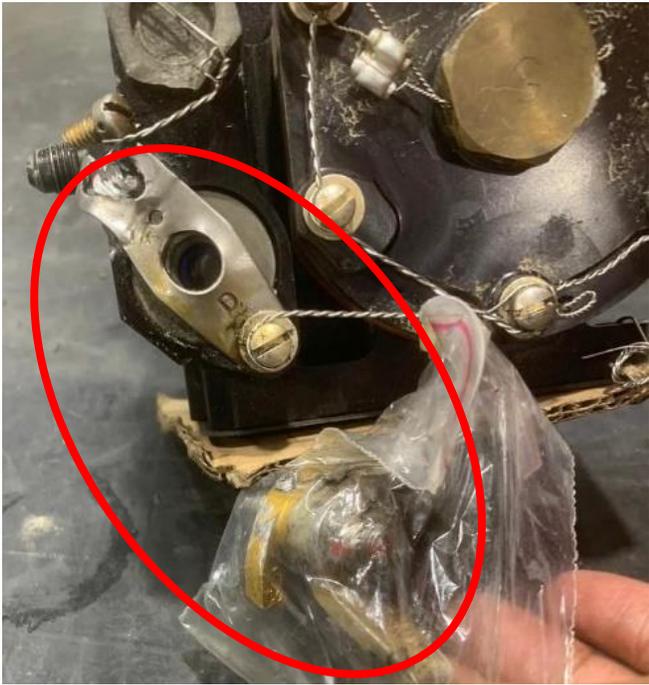
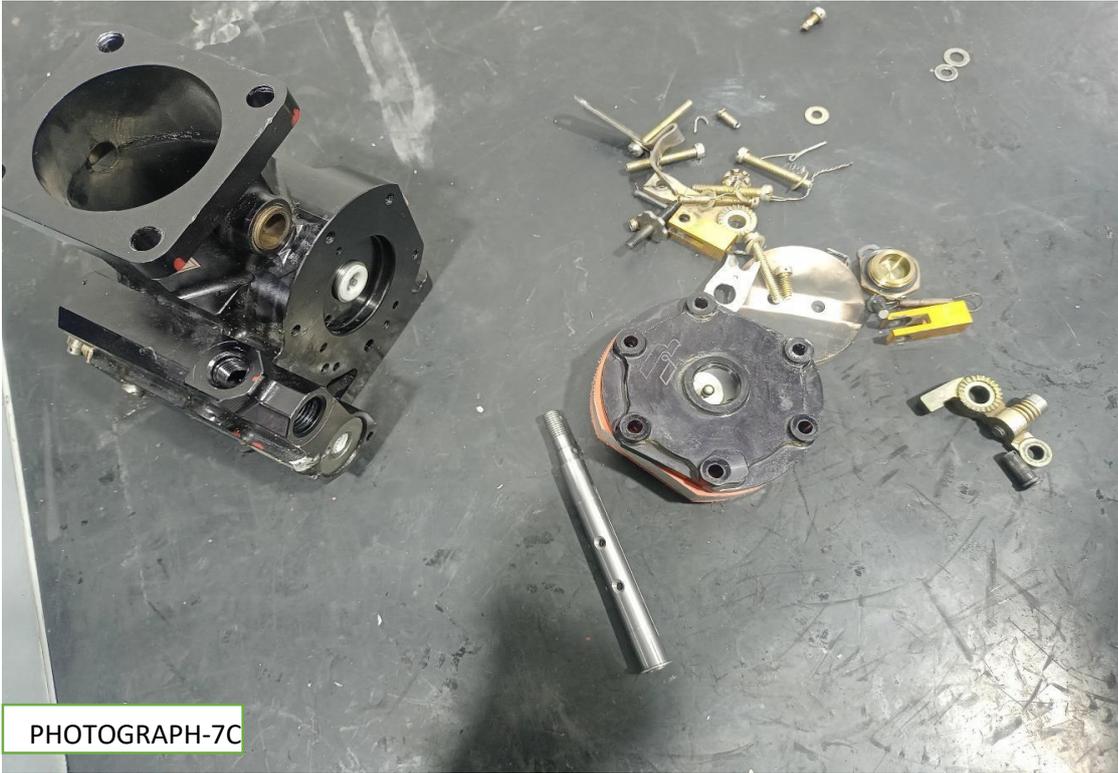
- d) Fuel Injector throttle lever could not be moved. Injector mixture shaft was found broken. (Photograph-7).

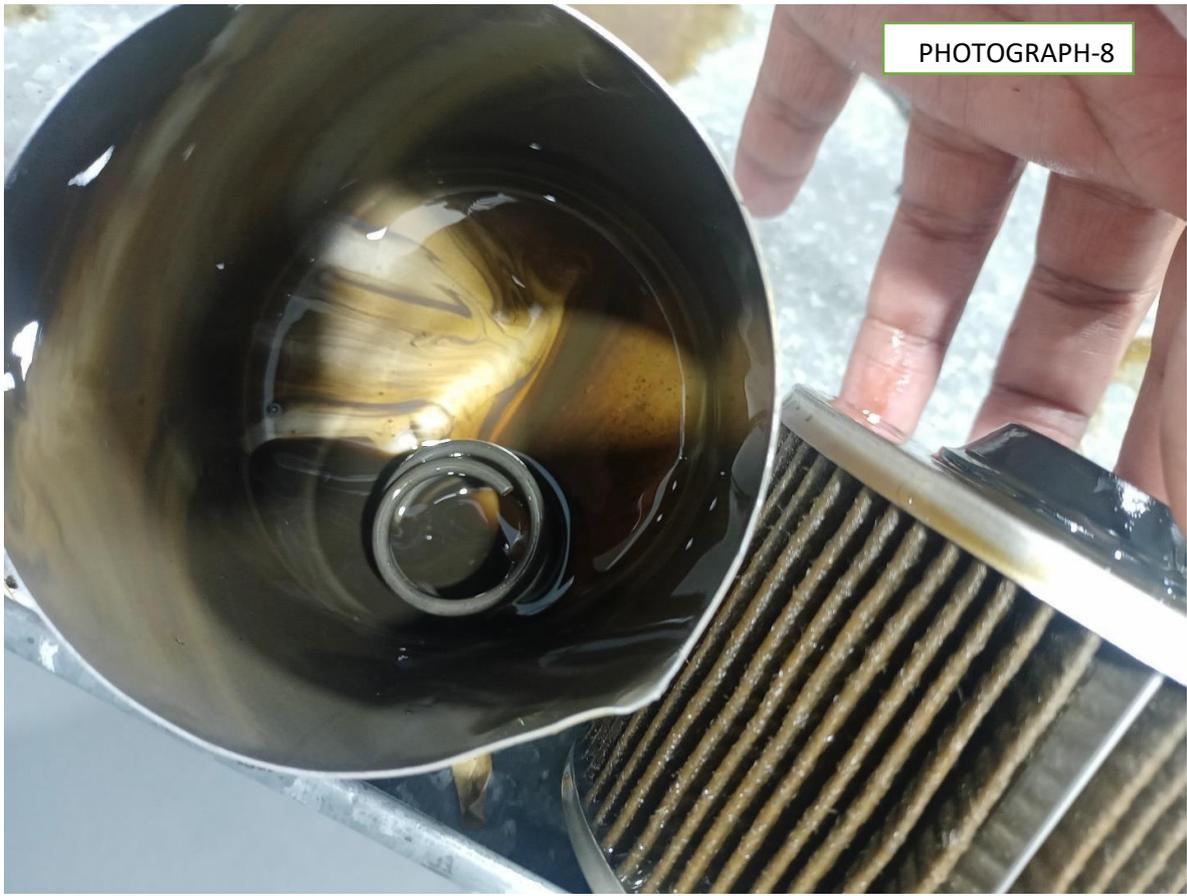
PHOTOGRAPH-8

1. The oil filter was cut opened and no metal particle was found (Photograph-8).
