FINAL INVESTIGATION REPORT OF ACCIDENT TO
M/s ACADEMY OF CARVER AVIATION PVT. LTD., CESSNA 172 R AIRCRAFT
VT- BUD ON 29-06-2013 AT BARAMATI AIRFIELD, BARAMATI.

SYNOPSIS:

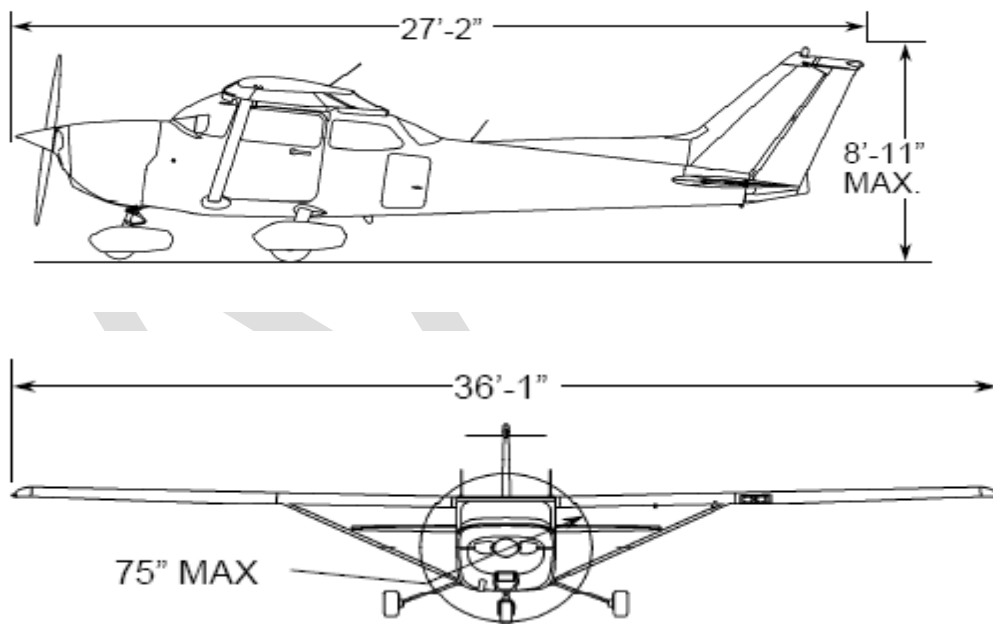
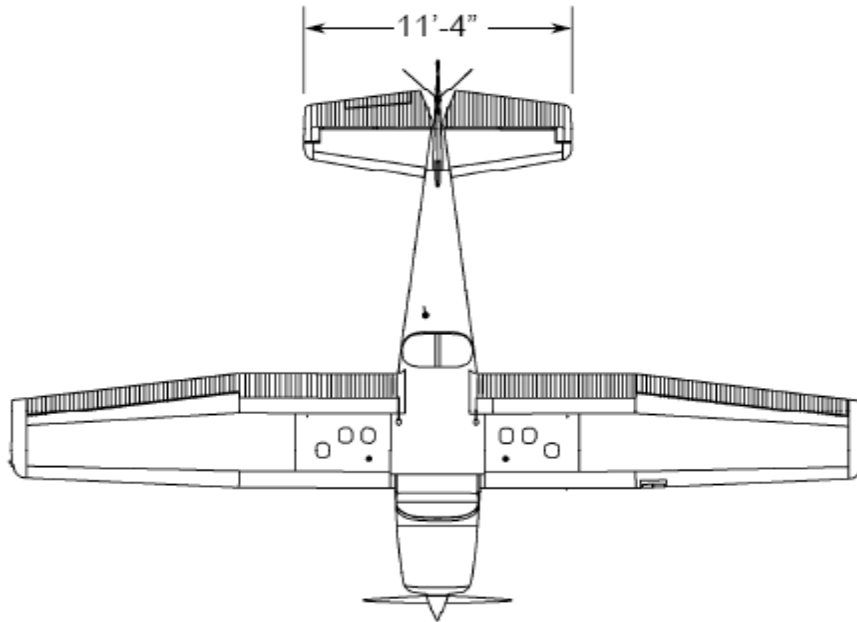
Cessna 172R aircraft Dimensions

Cessna 172R is a high-wing monoplane of all metal semi monocoque construction. The aircraft is equipped with fixed tubular spring steel main landing gear struts and a steerable nose landing gear. The aircraft is powered by an AVCO-Lycoming Engine, Model No. Lycoming IO-360 L2A. It is normally-aspirated, direct drive, air-cooled, horizontally opposed, carburetor equipped, four cylinder engine with horse Power rating of 160 BHP at 2700 RPM. The aircraft is fitted with 02 Blades, fixed pitch Maculey Propellers, model No. IC 235/LFA 7570. The aircraft is certified for single pilot operation. There are two doors one for each seat. There is provision for additional two passenger seat at the rear.

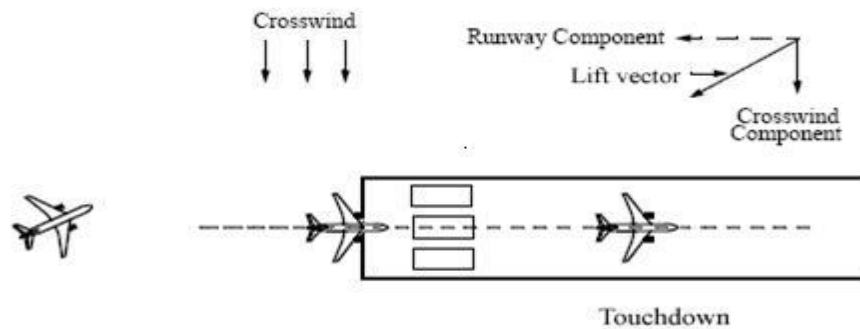
A crosswind landing is a landing maneuver in which a significant component of the prevailing wind is from crosswind, wind perpendicular to the Runway center line. In simpler words "a cross-wind landing is when you have some amount of wind coming from the left or right". In situations where a crosswind is present, the aircraft will adopt a yaw orientation with respect to the Runway and will drift laterally as it approaches the Runway. These pose significant safety issues when safe operation of the undercarriage requires the body and the velocity of the aircraft to be aligned with the Runway at touch-down.

Aircraft Landing in Cross Wind

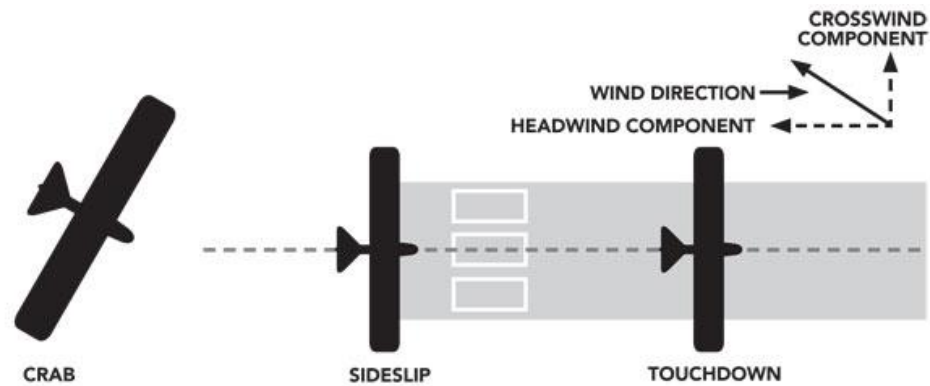
Initial Approach with "crab Method" and for last approximately 100-150 ft above ground use "Side Slip" method.

There are three accepted methods of Cross wind landing Techniques:-

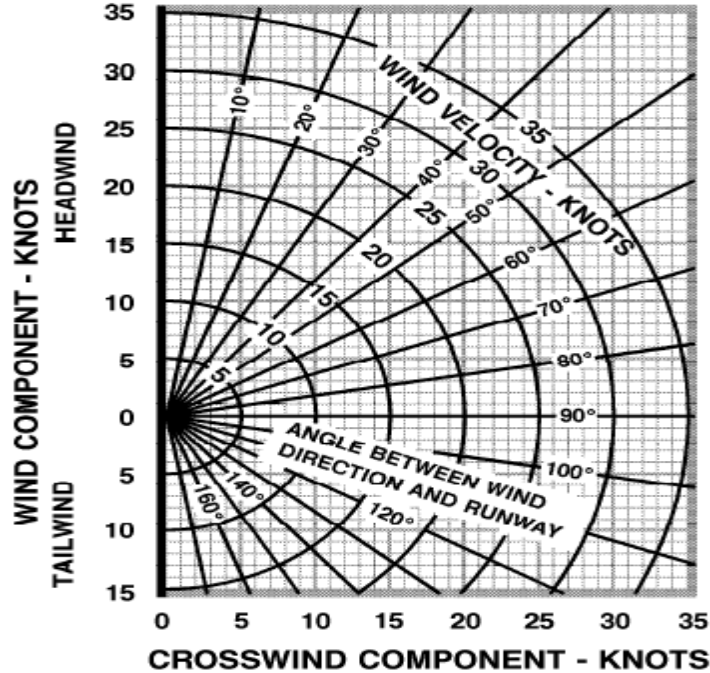
WIND COMPONENTS

NOTE:
Maximum demonstrated crosswind velocity is 15 knots (not a limitation).

Maximum demonstrated crosswind component is 15 knots (not a limitation).

According to Pilot Operating Handbook (POH) of Cessna 172 R Aircraft the maximum demonstrated cross wind component is 15 Knots and it is also mentioned that 15 knots is not a limitation.
