FINAL INVESTIGATION REPORT
ON
SERIOUS INCIDENT TO M/S INDIGO
AIRBUS A320(NEO) AIRCRAFT VT-ITA
ON 25th OCTOBER 2019

AIRCRAFT ACCIDENT INVESTIGATION BUREAU
MINISTRY OF CIVIL AVIATION
GOVERNMENT OF INDIA

FINAL INVESTIGATION REPORT ON SERIOUS INCIDENT INVOLVING M/S INDIGO
AIRBUS A320 (NEO) AIRCRAFT VT-ITA ON 25/10/2019

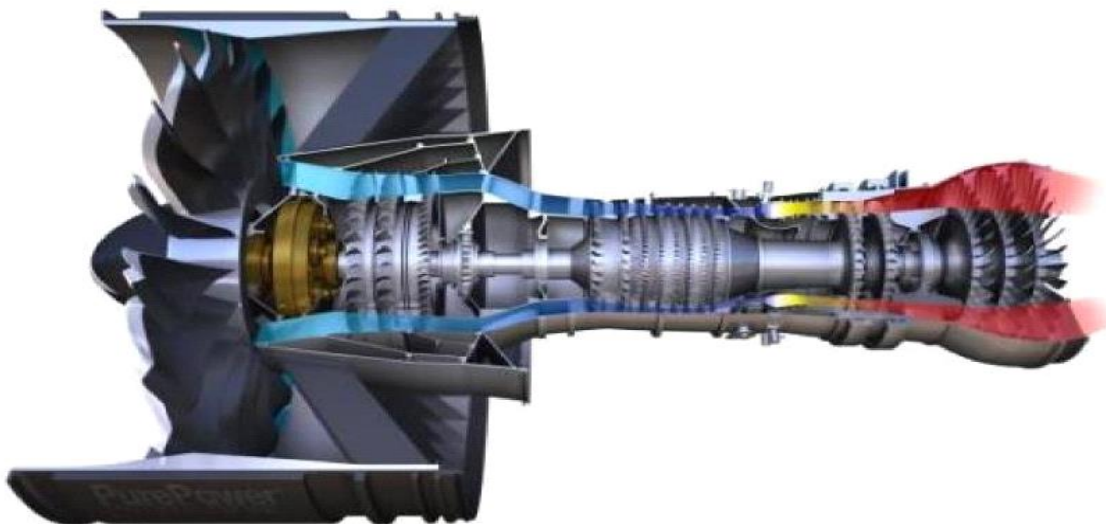
The PW1127G-JM turbofan engine is an axial-flow, twin spool turbofan engine with an ultra-high bypass ratio, low speed gear-driven fan.

Figure 1: ENGINE CROSS SECTION

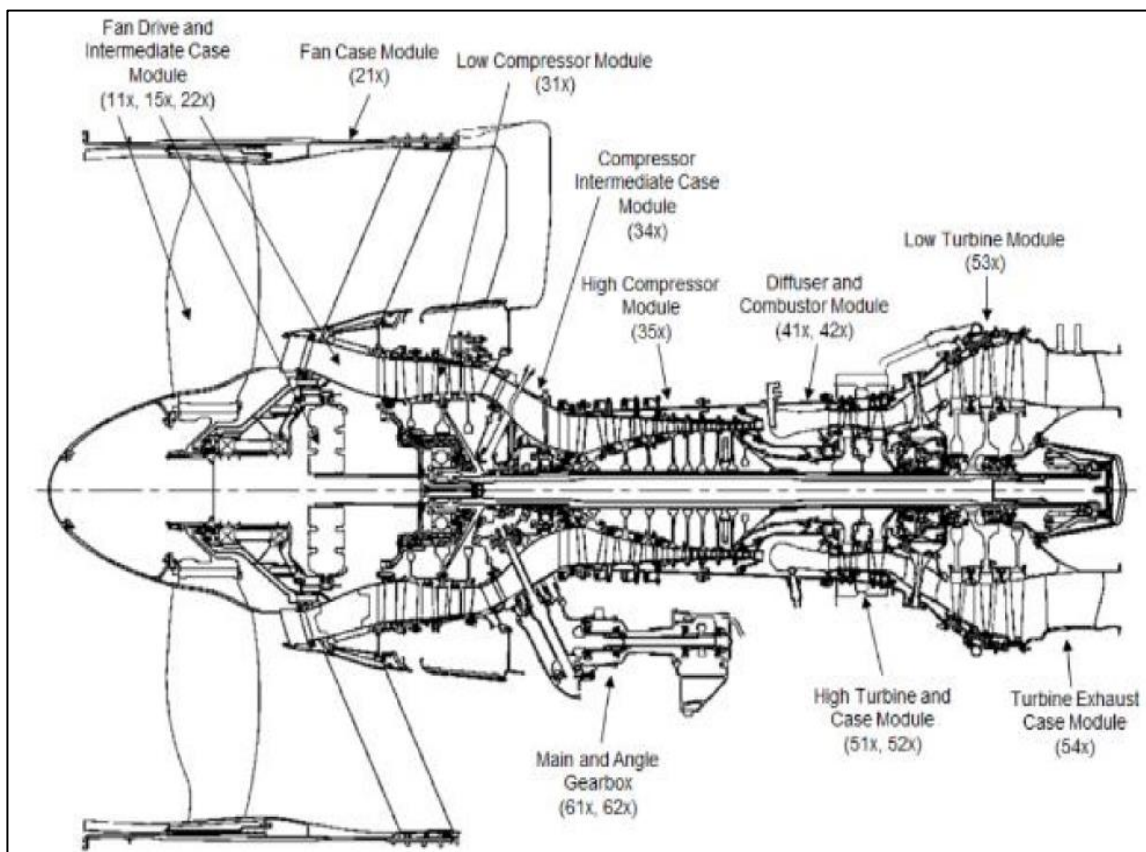
The engine comprises of Modules/Build Groups as shown below: -

1. Fan Rotor Group	13. High Compressor Front Case Group
2. Fan Drive Bearing Group	14. High Compressor Rotor Group
3. Fan Drive Gear Group	15. Diffuser Case Group
4. Fan Intermediate Case Group	16. Combustor and Turbine Nozzle Group
5. No. 2 Bearing Group	17. High Turbine Stator Group
6. Fan Case Group	18. High Turbine Rotor Group
7. Low Compressor Stator Group	19. Turbine Intermediate Case Group
8. Low Compressor Rotor Group	20. Low Turbine Stator Group
9. 2.5 Bleed Group	21. Low Turbine Rotor Group
10. Compressor Intermediate Case Group	22. Turbine Exhaust Case Group
11. No. 3 Bearing Group	23. Main Gearbox Group
12. High Compressor Rear Stator Group	24. Angle Gearbox Group

Figure 2: Engine Modules/ Build Group

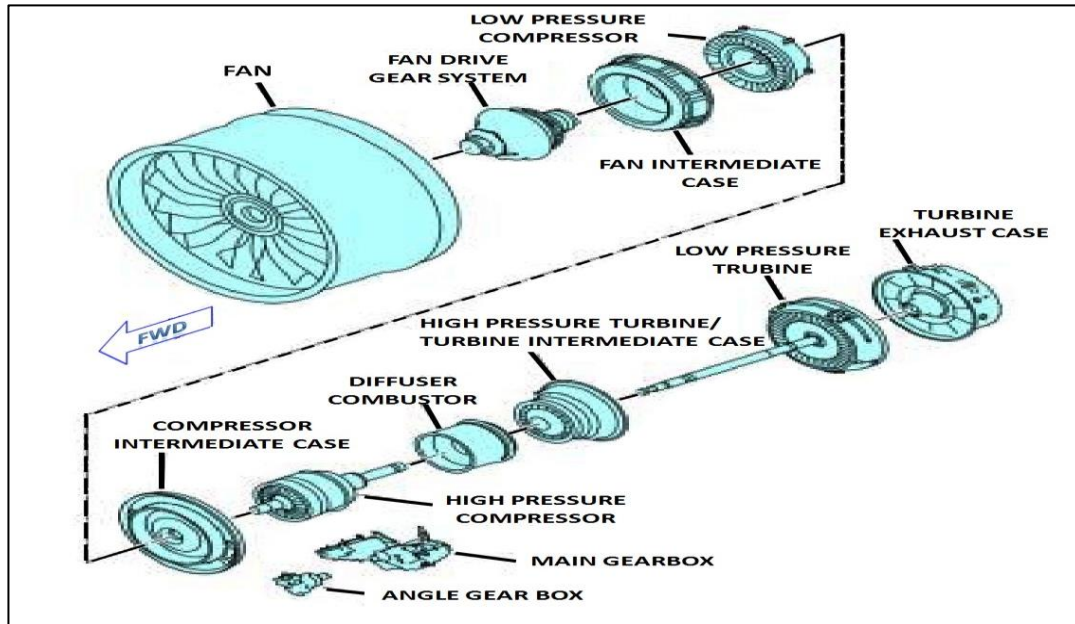
Figure 3: Engine Modules/ Build Group
