## **FOREWORD**

### 1.6.2 Brief Technical Description of NEO Engine

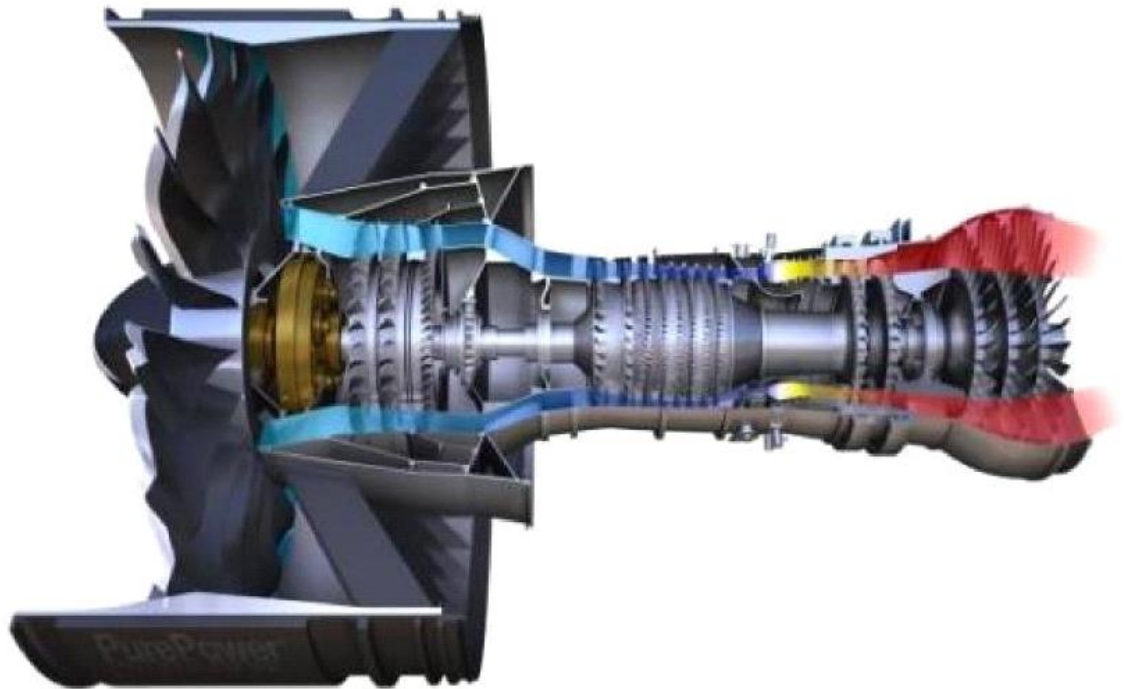
The PW1127G-JM turbofan engine is an axial-flow, twin spool turbofan engine with an ultra-high bypass ratio, low speed gear-driven fan.

**Figure 1: ENGINE CROSS SECTION**

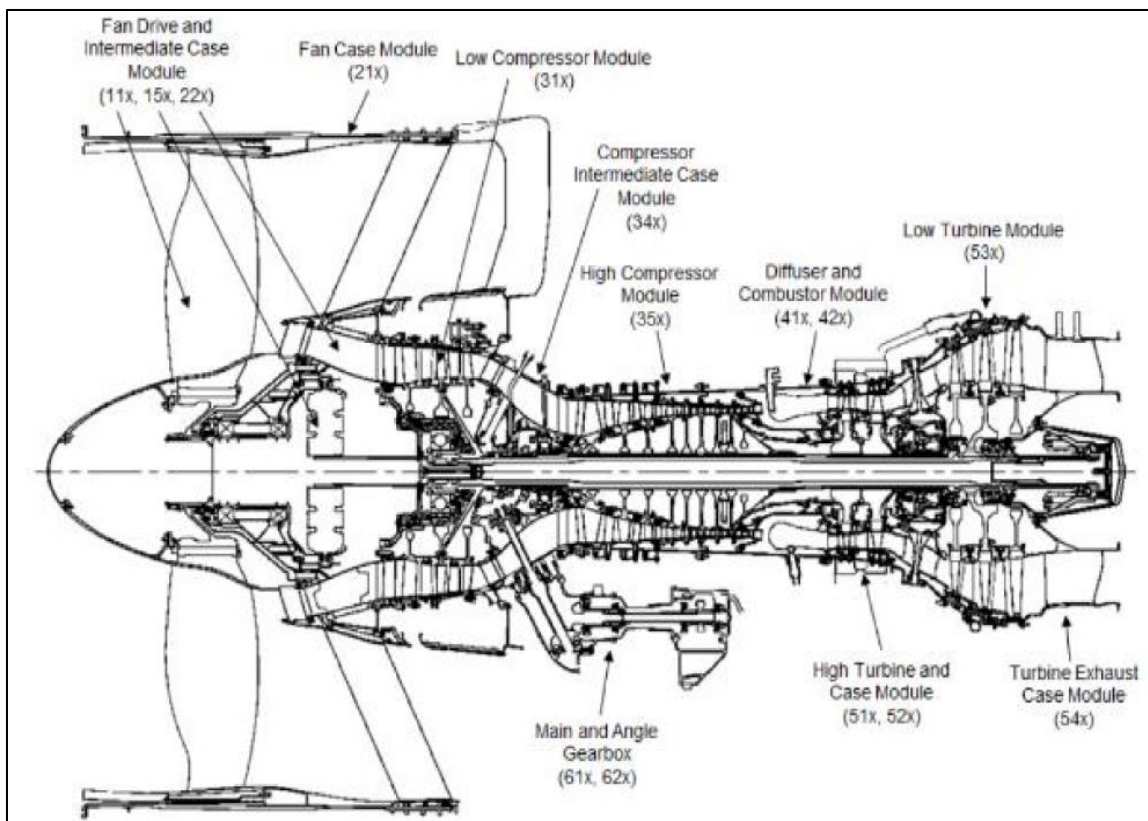
The engine comprises of following Modules/Build Groups as shown below: -

1. Fan Rotor Group	13. High Compressor Front Case Group
2. Fan Drive Bearing Group	14. High Compressor Rotor Group

3. Fan Drive Gear Group	15. Diffuser Case Group
4. Fan Intermediate Case Group	16. Combustor and Turbine Nozzle Group
5. No. 2 Bearing Group	17. High Turbine Stator Group
6. Fan Case Group	18. High Turbine Rotor Group
7. Low Compressor Stator Group	19. Turbine Intermediate Case Group
8. Low Compressor Rotor Group	20. Low Turbine Stator Group
9. 2.5 Bleed Group	21. Low Turbine Rotor Group
10. Compressor Intermediate Case Group	22. Turbine Exhaust Case Group
11. No. 3 Bearing Group	23. Main Gearbox Group
12. High Compressor Rear Stator Group	24. Angle Gearbox Group

**Figure 2: Engine Modules/ Build Group**

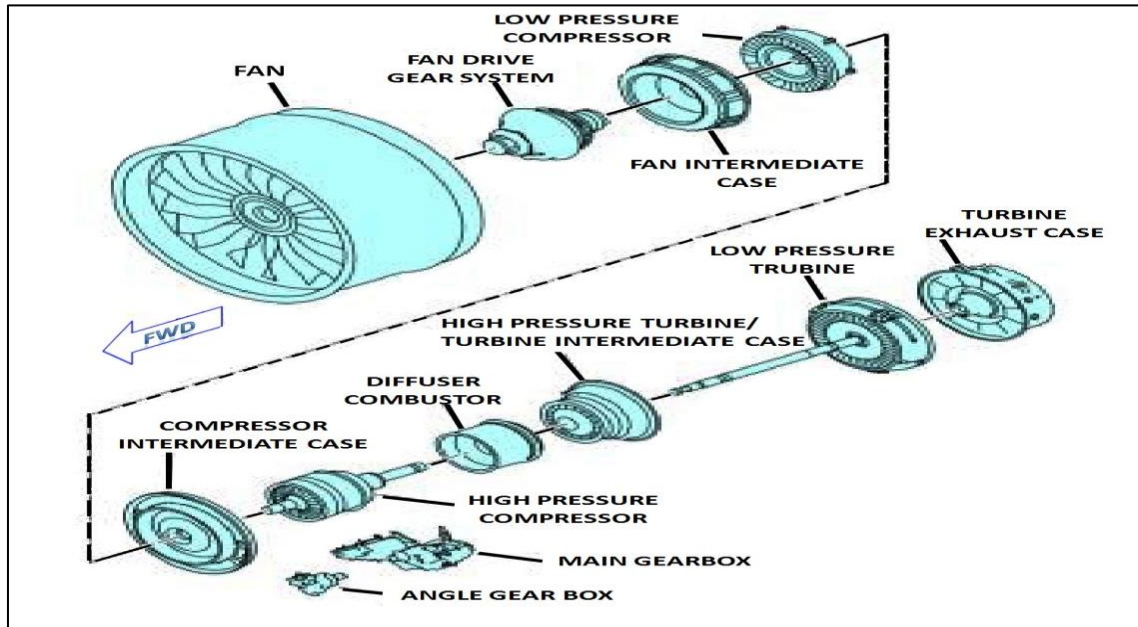
**Figure 3: Engine Modules/ Build Group**
