FINAL INVESTIGATION REPORT
ON
SERIOUS INCIDENT TO M/S INDIGO
AIRBUS A320(NEO) AIRCRAFT VT-ITU
AT GOA ON 15th JULY 2019

AIRCRAFT ACCIDENT INVESTIGATION BUREAU
MINISTRY OF CIVIL AVIATION
GOVERNMENT OF INDIA

**FINAL INVESTIGATION REPORT ON SERIOUS INCIDENT TO M/S INDIGO AIRBUS
A320 (NEO) AIRCRAFT VT-ITU AT GOA ON 15/07/2019**

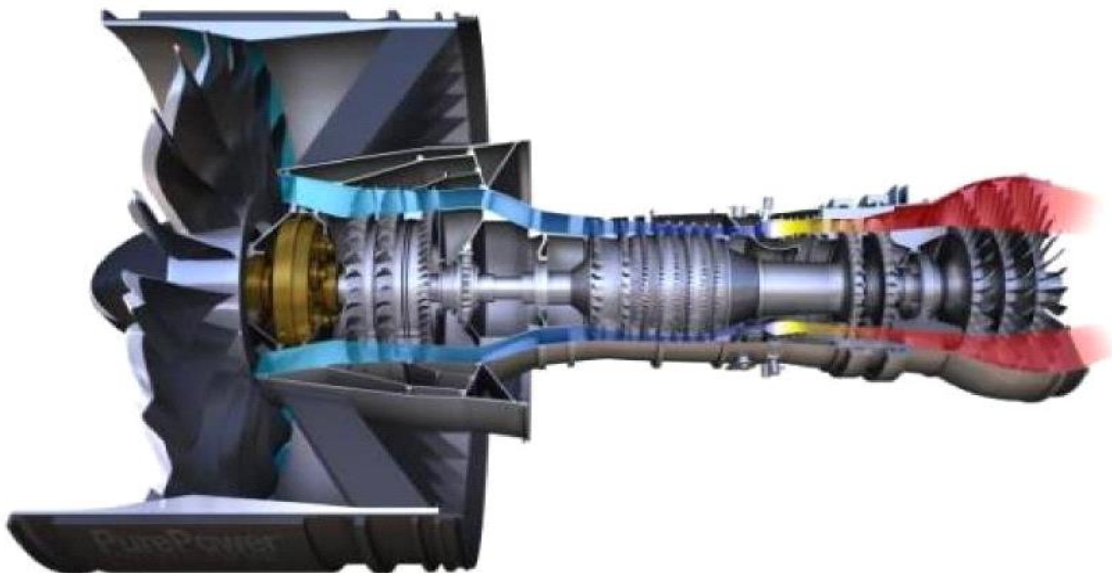
Figure 1: ENGINE CROSS SECTION

The PW1127G-JM turbofan engine is an axial-flow, twin spool turbofan engine with an ultra-high bypass ratio, low speed gear-driven fan.

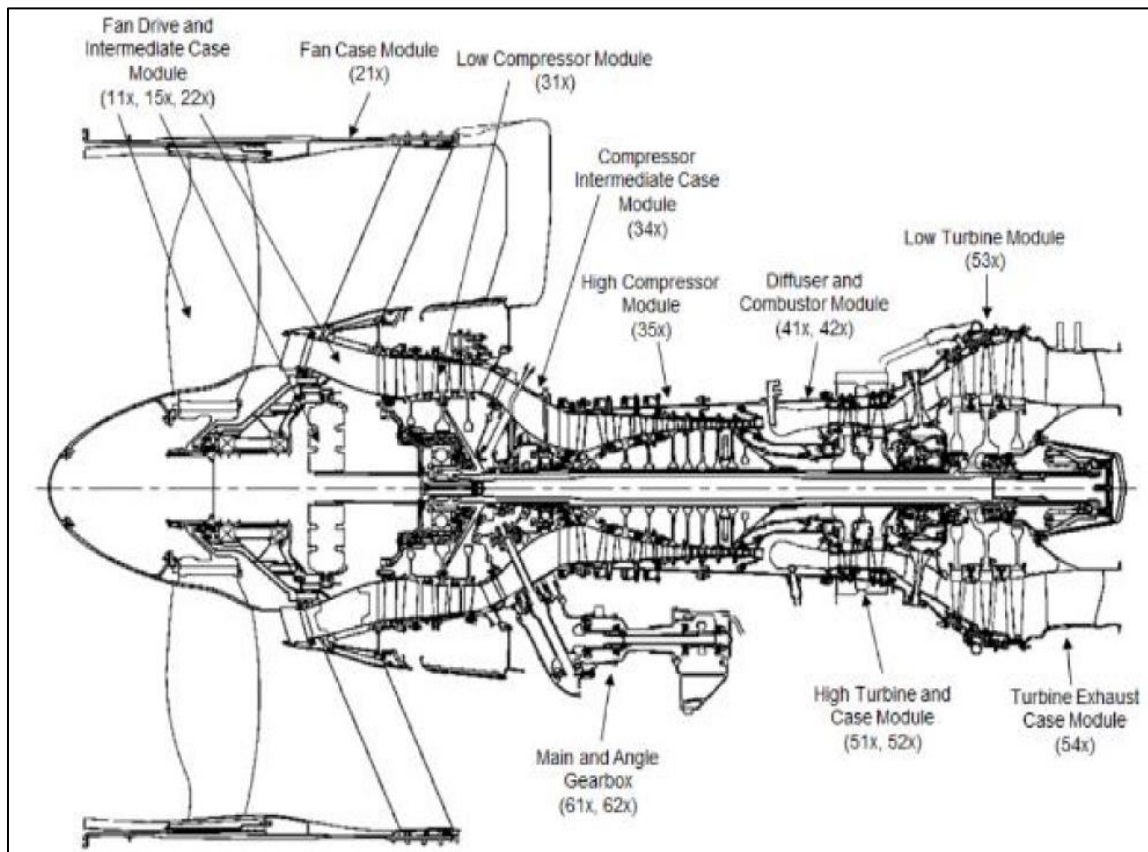
Figure 2: Engine Modules/ Build Group

The engine comprises of following Modules/Build Groups as shown below: -

1. Fan Rotor Group	13. High Compressor Front Case Group
2. Fan Drive Bearing Group	14. High Compressor Rotor Group
3. Fan Drive Gear Group	15. Diffuser Case Group
4. Fan Intermediate Case Group	16. Combustor and Turbine Nozzle Group
5. No. 2 Bearing Group	17. High Turbine Stator Group
6. Fan Case Group	18. High Turbine Rotor Group
7. Low Compressor Stator Group	19. Turbine Intermediate Case Group
8. Low Compressor Rotor Group	20. Low Turbine Stator Group
9. 2.5 Bleed Group	21. Low Turbine Rotor Group
10. Compressor Intermediate Case Group	22. Turbine Exhaust Case Group
11. No. 3 Bearing Group	23. Main Gearbox Group
12. High Compressor Rear Stator Group	24. Angle Gearbox Group

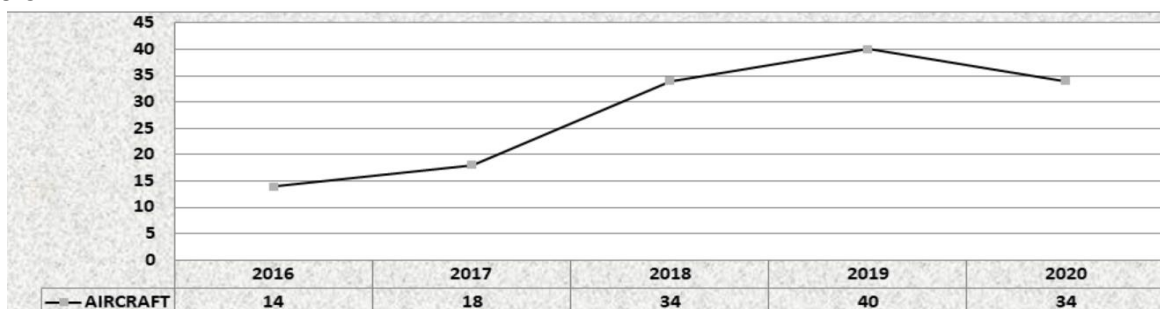
Figure 4: Year wise induction of NEO fleet

The year wise induction of NEO fleet (Graphical Representation) by M/s Indigo is shown below: -

The operator first inducted Neo aircraft in the year 2016. Initially, a total of 14 Neo aircraft were inducted by M/s Indigo in the year 2016.
