FINAL INVESTIGATION REPORT
ON
SERIOUS INCIDENT TO M/S INDIGO
AIRBUS A320(NEO) AIRCRAFT VT-IVO
AT GUWAHATI
ON 19th AUGUST 2019

AIRCRAFT ACCIDENT INVESTIGATION BUREAU
MINISTRY OF CIVIL AVIATION
GOVERNMENT OF INDIA

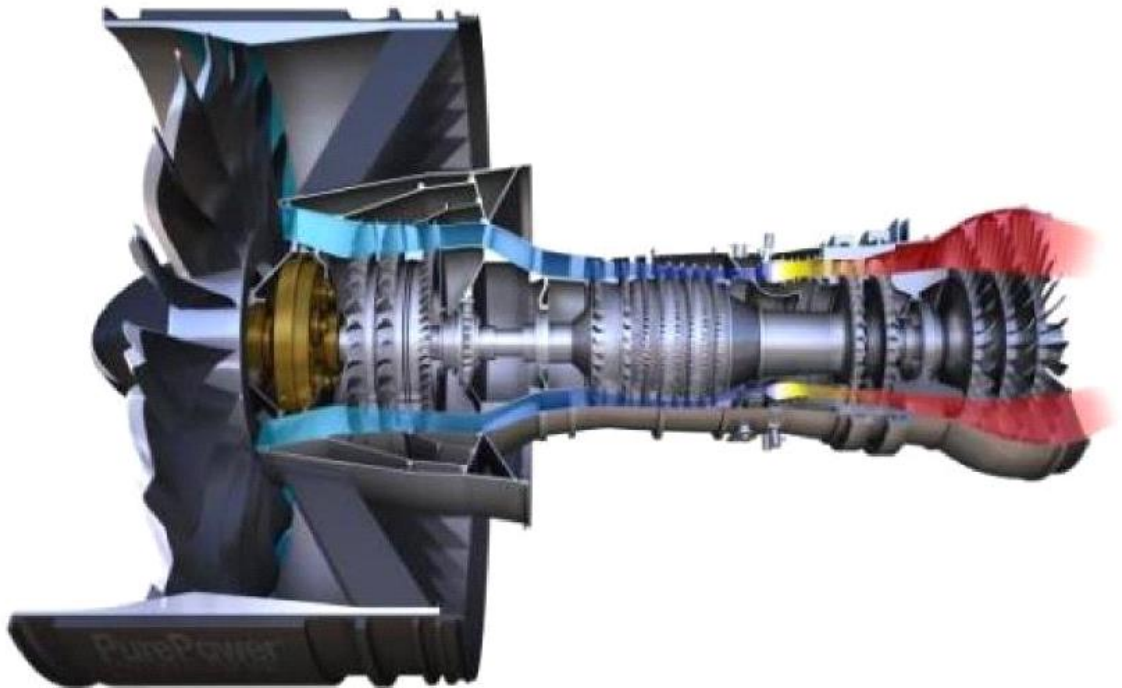
Figure 1: ENGINE CROSS SECTION

The PW1127G-JM turbofan engine is an axial-flow, twin spool turbofan engine with an ultra-high bypass ratio, low speed gear-driven fan.

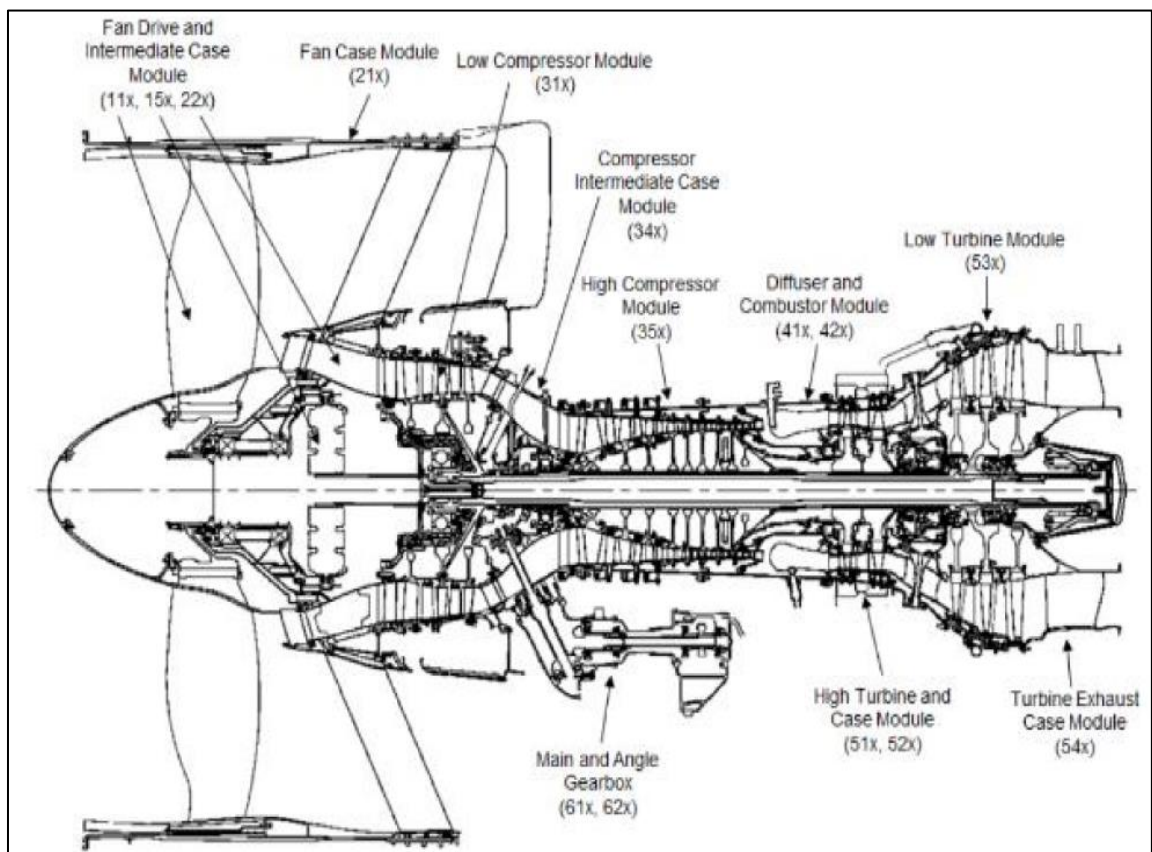
Figure 2: Engine Modules/ Build Group

The engine comprises of following Modules/Build Groups as shown below: -

1. Fan Rotor Group	13. High Compressor Front Case Group
2. Fan Drive Bearing Group	14. High Compressor Rotor Group
3. Fan Drive Gear Group	15. Diffuser Case Group
4. Fan Intermediate Case Group	16. Combustor and Turbine Nozzle Group

5. No. 2 Bearing Group	17. High Turbine Stator Group
6. Fan Case Group	18. High Turbine Rotor Group
7. Low Compressor Stator Group	19. Turbine Intermediate Case Group
8. Low Compressor Rotor Group	20. Low Turbine Stator Group
9. 2.5 Bleed Group	21. Low Turbine Rotor Group
10. Compressor Intermediate Case Group	22. Turbine Exhaust Case Group
11. No. 3 Bearing Group	23. Main Gearbox Group
12. High Compressor Rear Stator Group	24. Angle Gearbox Group

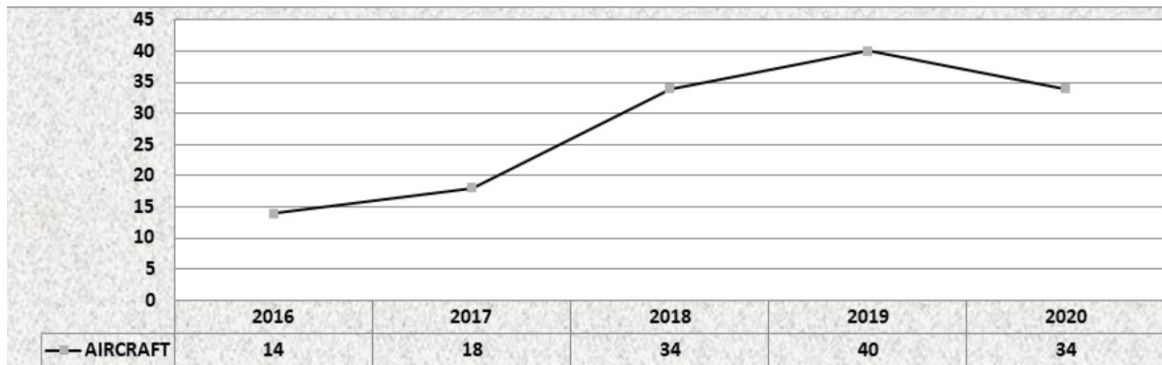
Figure 4: Year wise induction of NEO fleet

The year wise induction of NEO fleet (Graphical Representation) by M/s Indigo is shown below: -

The operator first inducted Neo aircraft in the year 2016. Initially, a total of 14 Neo aircraft were inducted by M/s Indigo in the year 2016.
