FINAL INVESTIGATION REPORT
ON
SERIOUS INCIDENT TO M/S INDIGO
AIRBUS A320(NEO) AIRCRAFT VT-IZC
ON 8th SEPTEMBER 2019

AIRCRAFT ACCIDENT INVESTIGATION BUREAU
MINISTRY OF CIVIL AVIATION
GOVERNMENT OF INDIA

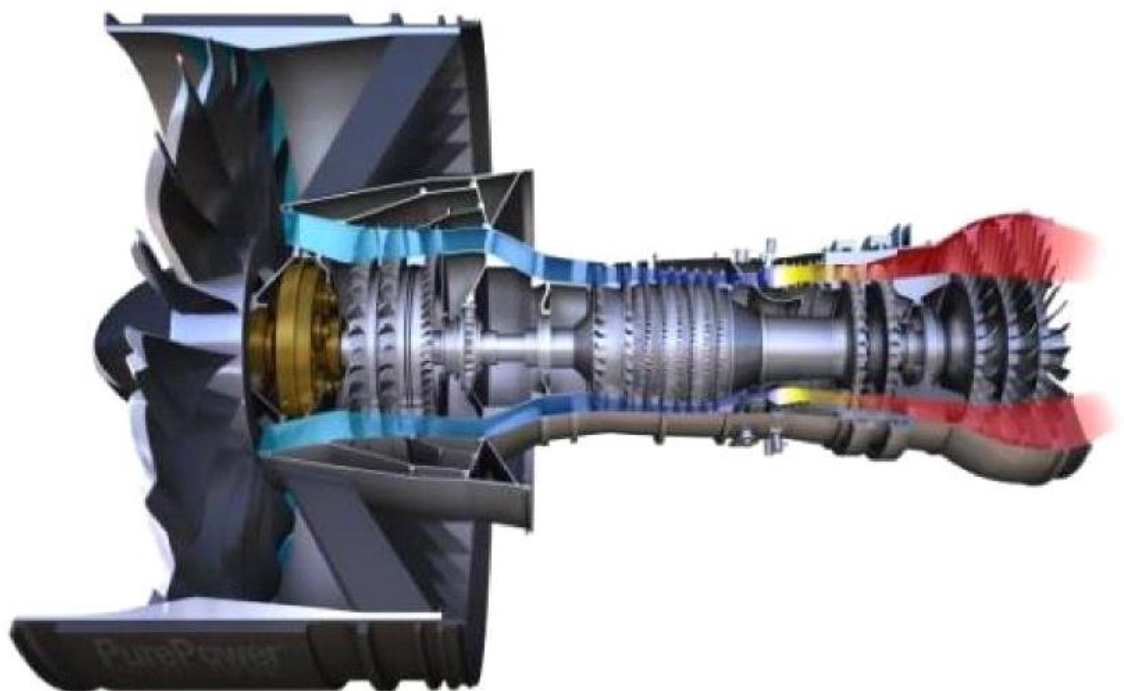
The PW1127G-JM turbofan engine is an axial-flow, twin spool turbofan engine with an ultra-high bypass ratio, low speed gear-driven fan.

Figure 1: ENGINE CROSS SECTION

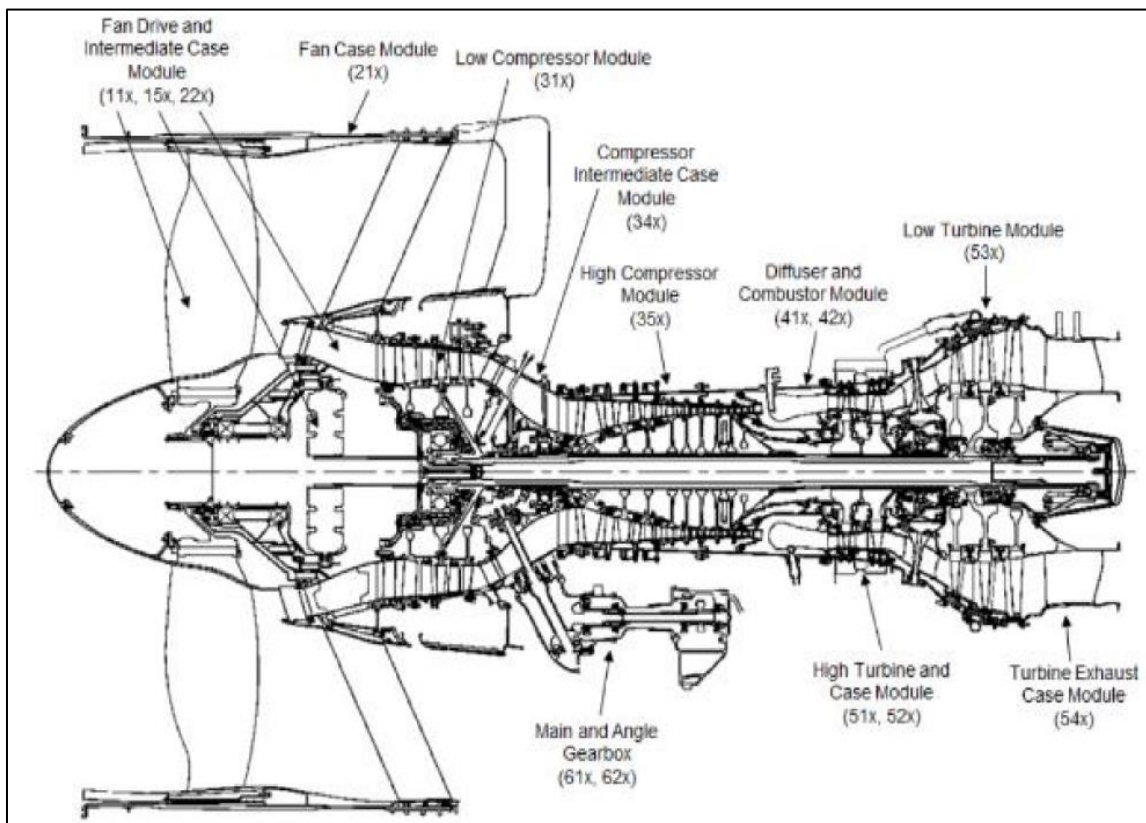
The engine comprises of following Modules/Build Groups as shown below: -

1. Fan Rotor Group	13. High Compressor Front Case Group
2. Fan Drive Bearing Group	14. High Compressor Rotor Group
3. Fan Drive Gear Group	15. Diffuser Case Group
4. Fan Intermediate Case Group	16. Combustor and Turbine Nozzle Group
5. No. 2 Bearing Group	17. High Turbine Stator Group
6. Fan Case Group	18. High Turbine Rotor Group
7. Low Compressor Stator Group	19. Turbine Intermediate Case Group
8. Low Compressor Rotor Group	20. Low Turbine Stator Group
9. 2.5 Bleed Group	21. Low Turbine Rotor Group
10. Compressor Intermediate Case Group	22. Turbine Exhaust Case Group
11. No. 3 Bearing Group	23. Main Gearbox Group
12. High Compressor Rear Stator Group	24. Angle Gearbox Group

Figure 2: Engine Modules/ Build Group

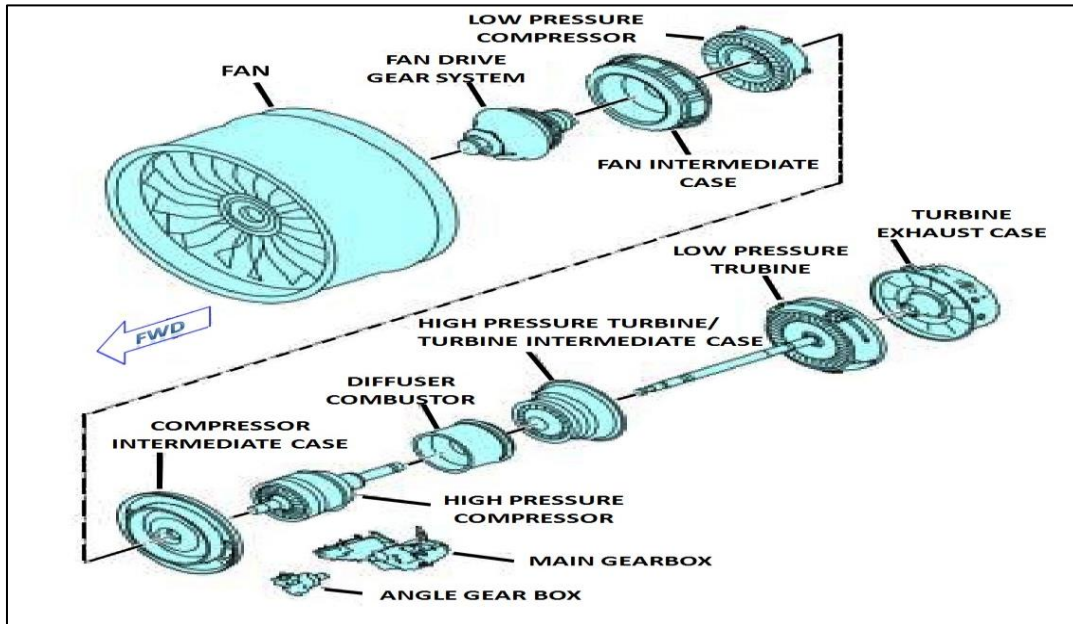
Figure 3: Engine Modules/ Build Group
