FINAL INVESTIGATION REPORT ON SERIOUS INCIDENT TO M/S SPICEJET PVT. LTD. BOEING 737-800 AIRCRAFT VT-SXE AT VARANASI ON 27TH FEBRUARY 2020

AIRCRAFT ACCIDENT INVESTIGATION BUREAU MINISTRY OF CIVIL AVIATION GOVERNMENT OF INDIA

FINAL INVESTIGATION REPORT ON SERIOUS INCIDENT TO M/S SPICEJET LIMITED B737-800 AIRCRAFT VT-SXE AT VARANASI ON 27th FEB 2020

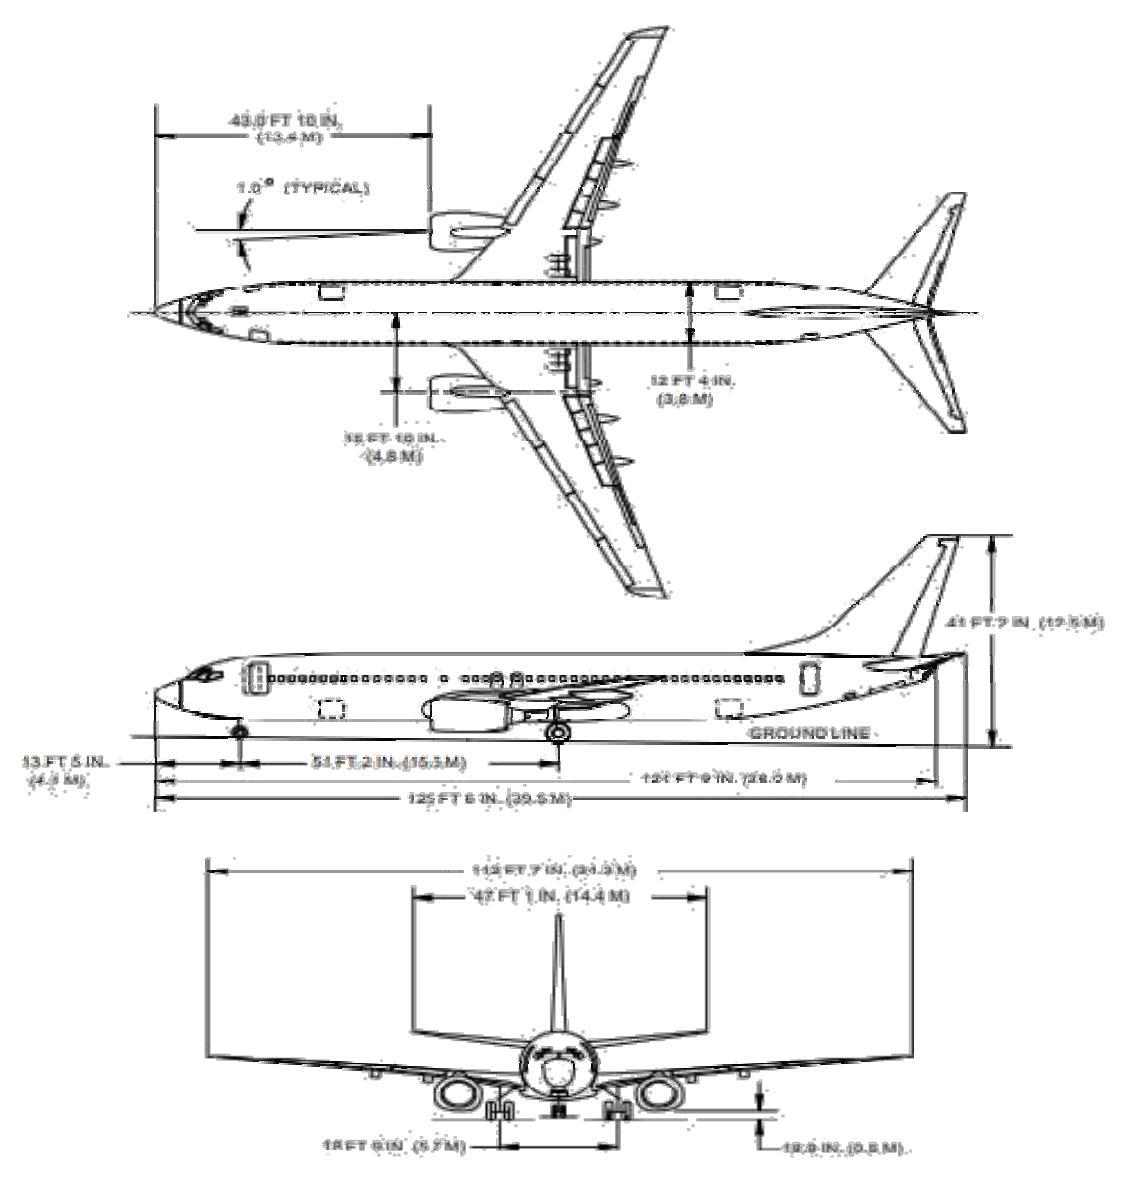
Figure-1: Three View Diagram of Boeing 737-800 aircraft

The Aircraft length is 39.472 meters, wingspan is 34.3 meters and height is 12.459 meters. The distance between main wheel centers is 5.715 meters. The Ground Clearance is 0.53 meters.

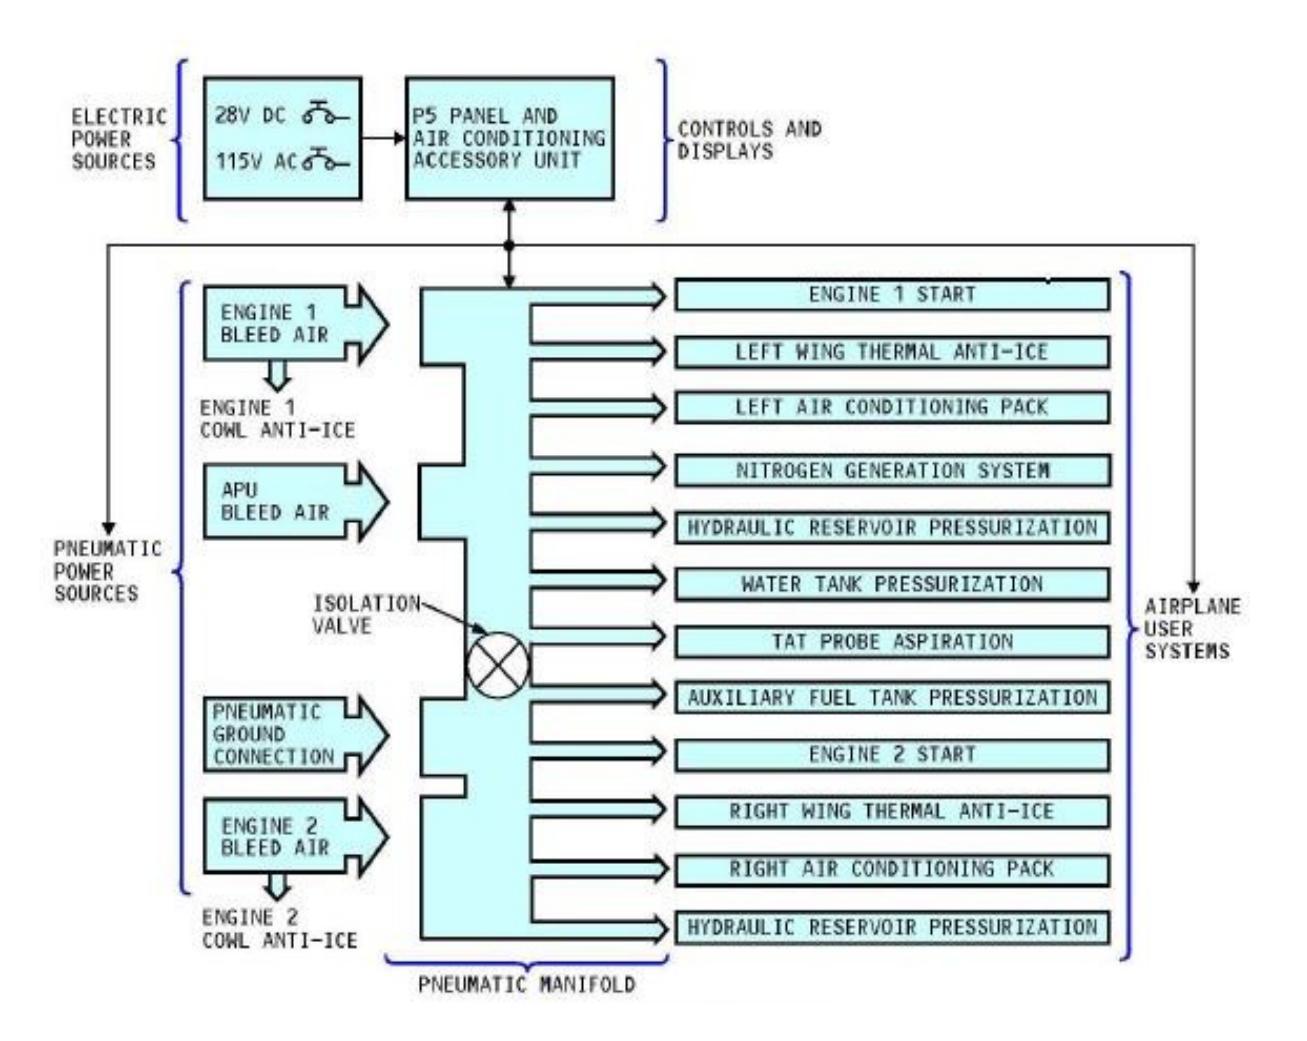
Figure-2 below is a schematic of the different user units and sources of the pneumatic system.

Figure-2: Schematic of Pneumatic System on Boeing 737NG Aircraft

Engine 1 and 2 bleed air is tapped from the 5th and 9th stage compressors. APU bleed air is active during certain conditions, including when the aircraft is on the ground or when it is in the air up to FL170. The system is protected by an APU check valve. The ground connection is located in the right underbelly of the aircraft. It's main purpose is to serve as a connector port for a ground pneumatic supply.

High temperature, high pressure air is pooled in the pneumatic manifold. This acts as a reservoir to hold all the fluids, as well as a supply line for the user systems from the pneumatic sources. The pneumatic manifold is equipped with an isolation valve that is able to isolate the left pneumatic system from the right pneumatic system, and vice versa. This is especially useful in the event of a component failure. The isolation valve is normally closed.

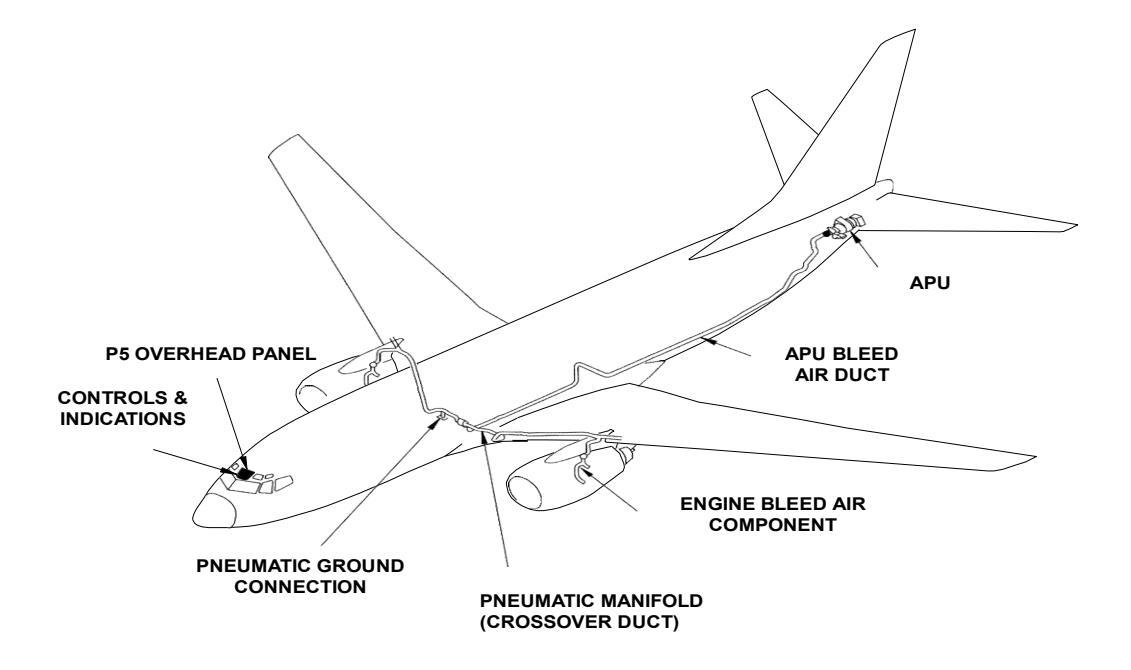
Figure-3: The location of the pneumatic system within the aircraft

The isolation valve consists of strong, lightweight, corrosion resistant ducts, protected by gold coating and held in tension by support. As mentioned, the ducts are separated into the left and right system. Figure-3 above describes the location of the pneumatic system onboard the aircraft.
