FINAL INVESTIGATION REPORT ON SERIOUS INCIDENT OF
AIRPROX BETWEEN M/s AIR ASIA ,IAD811 (A320
AIRCRAFT, REGISTRATION VT-MLE)AND M/s INDIGO,
IGO747 (A320 AIRCRAFT, REGISTRATION VT-IAL) IN
MUMBAI AIRSPACE ON 29/01/2021

**FINAL INVESTIGATION REPORT ON SERIOUS INCIDENT OF AIRPROX
BETWEEN M/s AIR ASIA ,IAD811 (A320 AIRCRAFT VT-MLE)AND M/s INDIGO,
IGO747 (A320 AIRCRAFT VT-IAL) IN MUMBAI AIRSPACE ON 29/01/2021**

SYNOPSIS

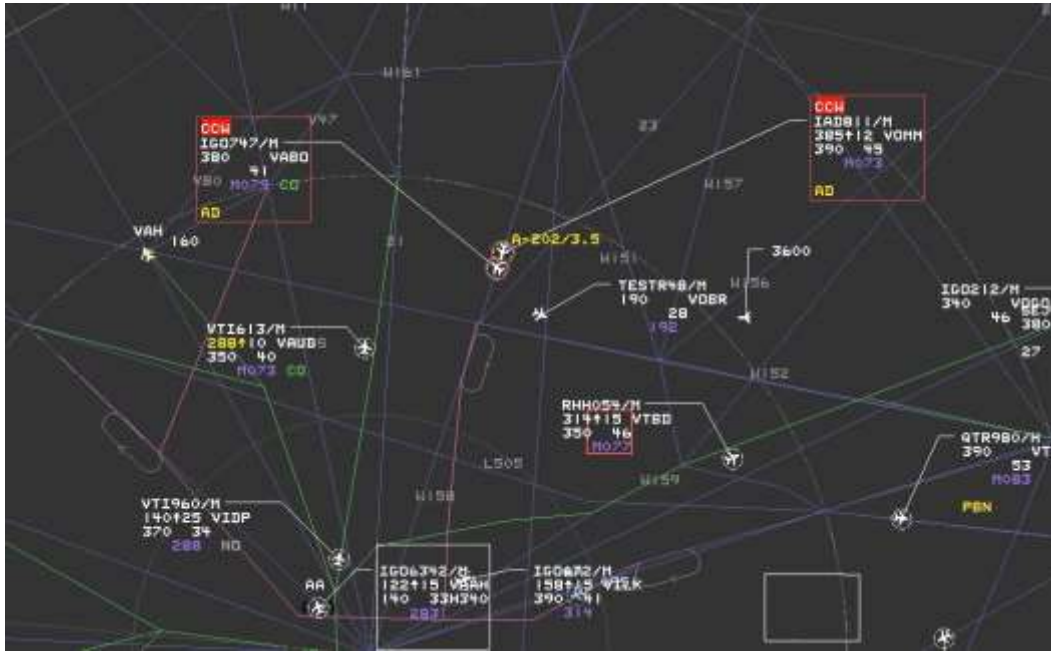
After some time, the tracks of both aircraft became reciprocal to each other. PCW came on automation system at time 05:53:05 UTC. But, controller didn't react in time to the warning. When IAD811 was at FL371, Controller instructed to stop climb at FL370. But IAD811 continued its climb. By the time CCW was generated and IAD811 reported getting TCAS RA at 05:54:29 UTC.

IAD811 had climbed to FL390, passing through the level assigned to IGO747 which was on reciprocal track. IGO747 reported that they got TCAS TA only.

Figure : Showing Current Conflict Warning on Automation System

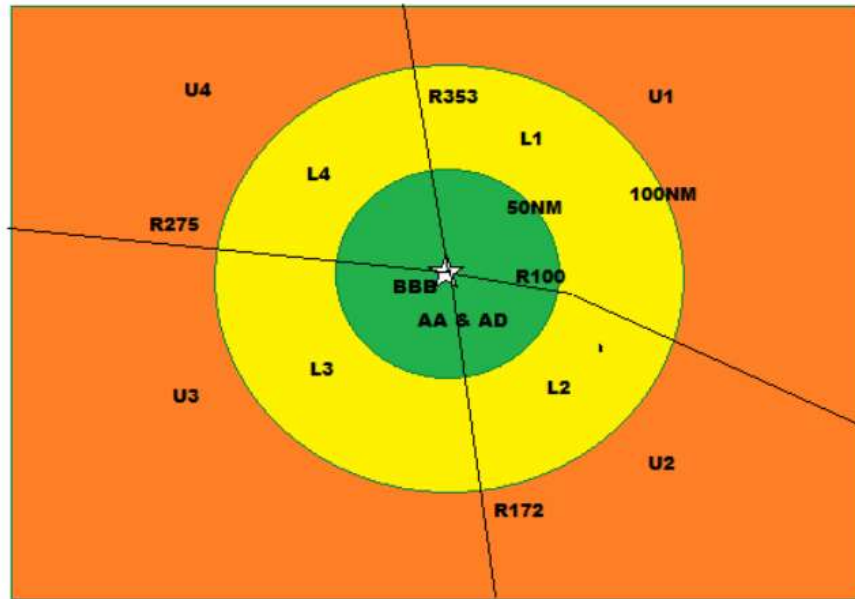
ACC(N) covers the area denoted as U1, in the figure given below.

ACC(S) covers the area denoted as U2 and U2+U3, in the figure given below.

ACC(W) covers the area denoted as U4 and U4+U3. in the figure given below.

U1: from radial 353 to radial 100 clockwise,

U2: from radial 100 to radial 172,

U3: from radial 172 to radial 275,

U4: from radial 275 to radial 353.

Figure : Showing Area sector jurisdiction

Thus, on the date of incident there was no LAC and Area Control North was controlling traffic from FL150 to FL460 and area covered comprised of sector U1 and U4 i.e. R275 to R100 clockwise from BBB. This increased the surveillance area.

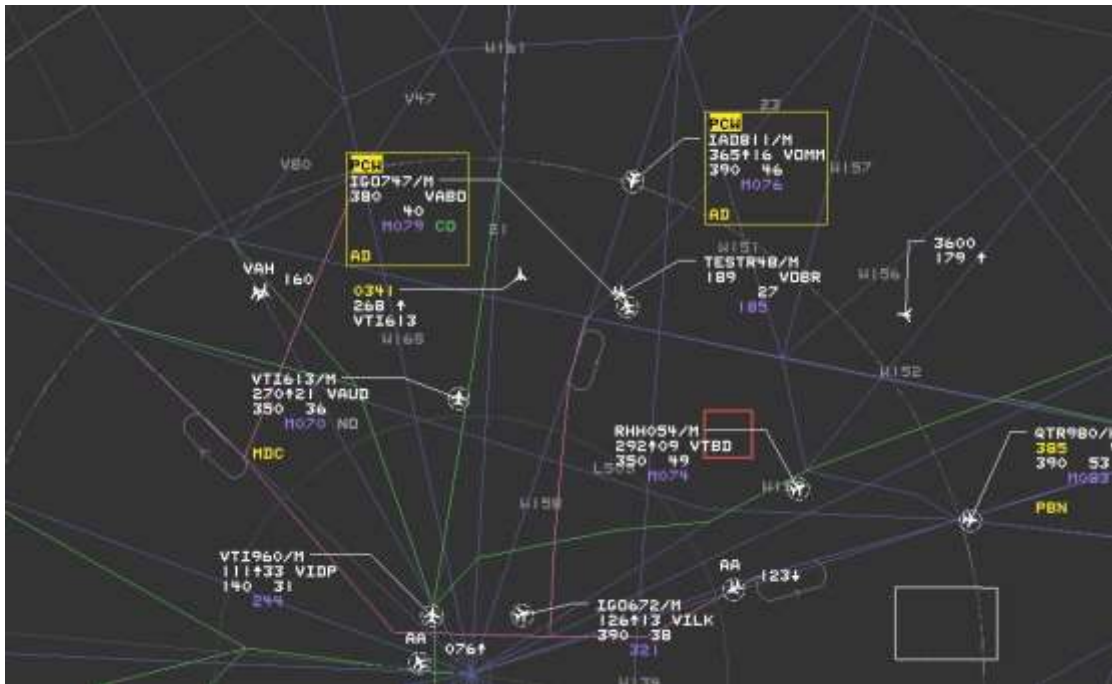
At 05:53:10 UTC, Predicted Conflict Warning (PCW) came on automation system. At that time there was enough lateral separation. When PCW came IAD811 was at FL365 and it was climbing for FL390. But, Controller did not respond to the visual warning (Yellow).

Figure: At 05:53:10 UTC, Predicted Conflict Warning got generated on Automation System.

- (i) Loss of situational awareness by Controller.

(ii) Evaluation of the present situation under the influence of preconceived mind by the concerned controller.

1. It is recommended that suitable corrective training may be imparted to involved Radar Controller giving emphasis on situational awareness and importance of warning generated on Automation System .
2. It is recommended that Airports Authority of India may reassess the volume of traffic in all sectors which were withdrawn due to less number of traffic during the lockdown and may implement sectors as before pandemic.

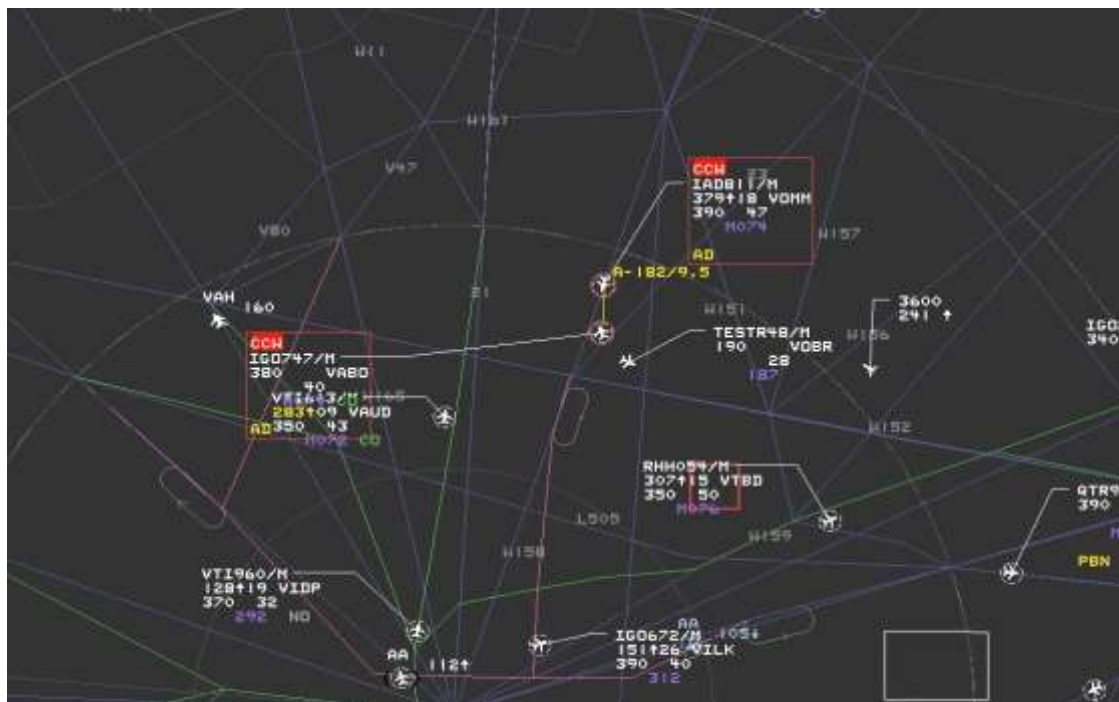
was too late to resolve the conflicting traffic. At 05:54:10 UTC, Current Conflict Warning (CCW) came on Automation System. At 05:54:16 UTC, TCAS RA was triggered on IAD811 Automation System when it was at 38008 ft. Controller was still trying to resolve the traffic by giving avoiding traffic to both aircraft. At 05:54:29 UTC, aircraft reported getting TCAS RA. At the time of TCAS RA, IGO747 was maintaining FL380. IGO747 later reported that they got only TCAS TA.

Figure: At 05:54:10 UTC, Current Conflict Warning got generated.

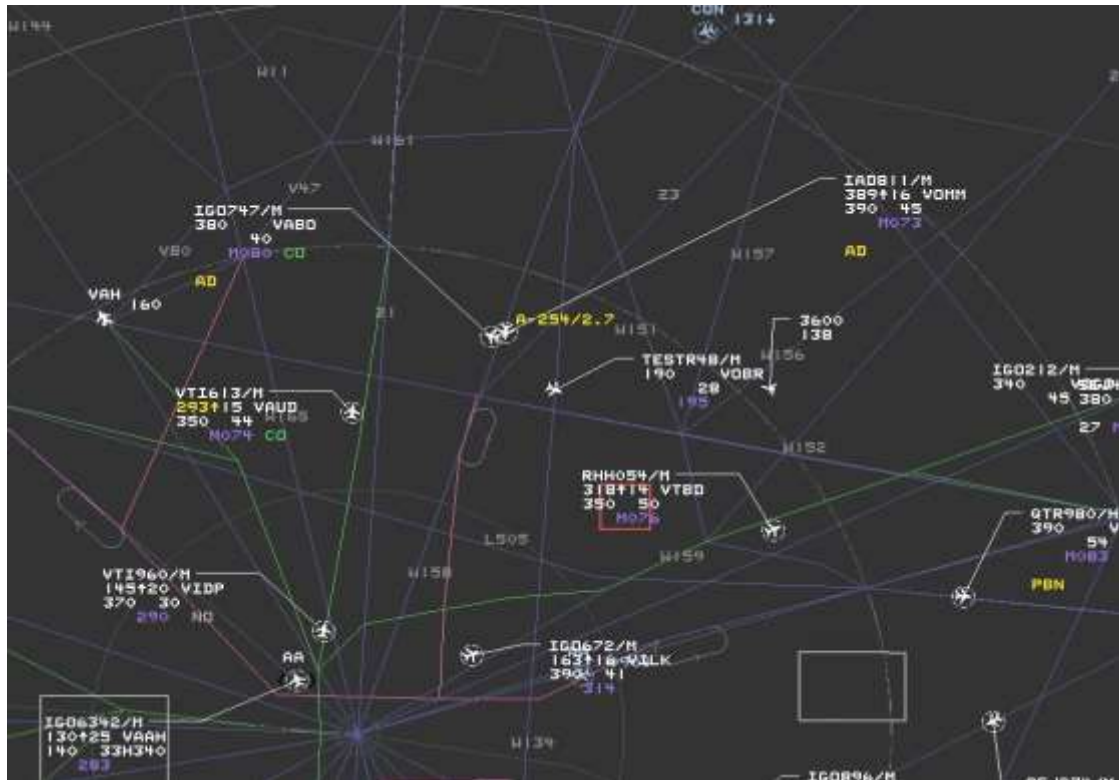
At 05:54:55 UTC, IAD811 reported clear of traffic. It was at 38396 ft when the conflicting traffic was resolved. IAD811 climbed through the level of IGO747 which was maintaining FL380.

Figure: At 05:54:55 UTC, Clear of Conflict.

Minimum separation recorded was 4.3 NM laterally while vertical separation was 300 ft when IAD811 was below IGO747 and 3.5 NM laterally while vertical separation was 500 feet when IAD811 was above IGO747.
