Preliminary Report: Accident involving M/s Alchemist Aviation Pvt Ltd Cessna 152 aircraft VT-TAJ near Jamshedpur on 20 Aug 2024

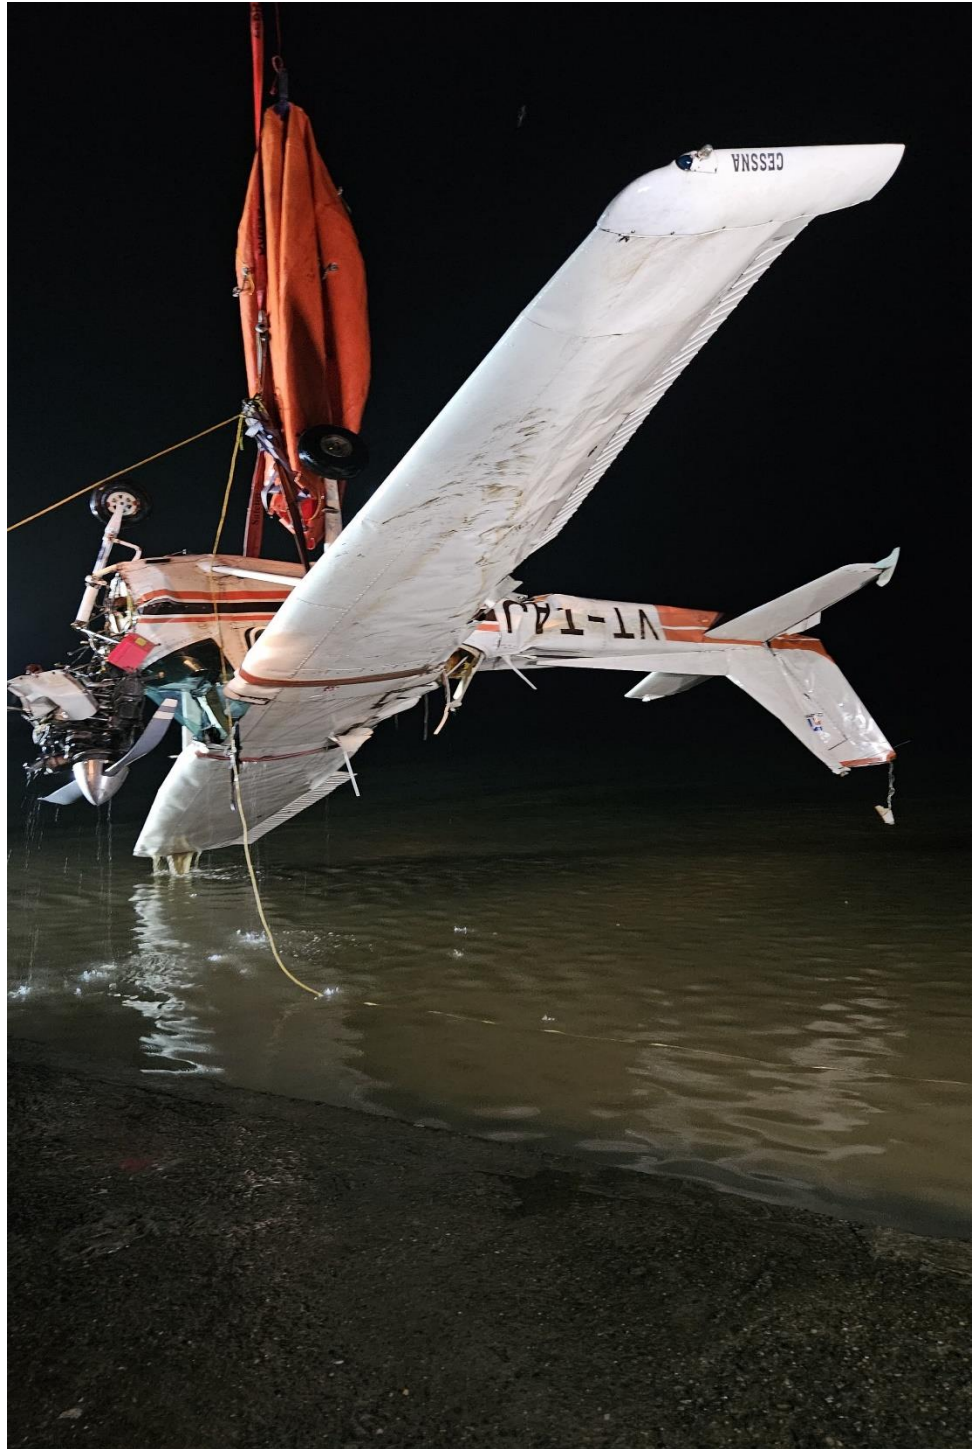
On 25th Aug 2024, while carrying out the SAR operation in Chandil Dam, the Navy team, deployed for search and rescue, observed that the aircraft was lying in an inverted position at a depth of approximately 10 meters in the dam reservoir. Subsequently, on 26th Aug 2024, arrangements were made and aircraft was pulled out from the reservoir.

During initial assessment, major damage was observed at the nose section of the aircraft and, Nose landing gear was also found broken. In addition , other damages were also observed on both wings, the vertical fin, the rudder and the tail boom.

Figure 1: Aircraft's main wreckage taken out from the Chandil Dam
